SERVICE INFORMATION BULLETIN

APPLICABILITY: 2001-2016MY Impreza (4Dr and 5Dr)
 2017-2018MY Impreza (5 Dr Only)
 2013-2018 Crosstrek
 2003-2018MY Forester
 2015-2018MY WRX and WRX STI
 2013-2018MY BRZ

NUMBER: 12-231-18

SUBJECT: Air Vent Grille Design Change

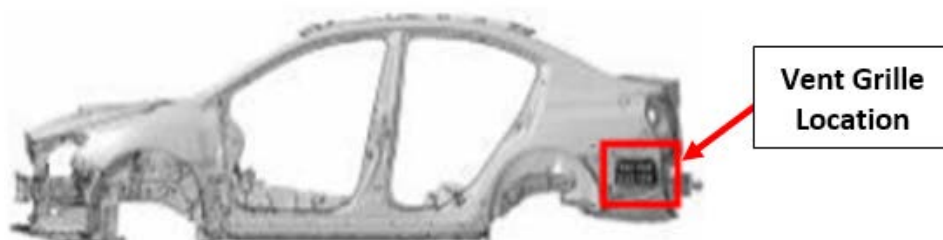
This bulletin announces a design change to the air vent grille located in the lower portion of the trunk (or cargo) area. The shutters of the vent grille are designed to open briefly and relieve cabin pressure when the doors are shut with the windows fully closed. The vent grilles have rubber “shutters” which occasionally, may catch on the frame (case) portion and not close properly allowing outside air / odor to enter the cabin.

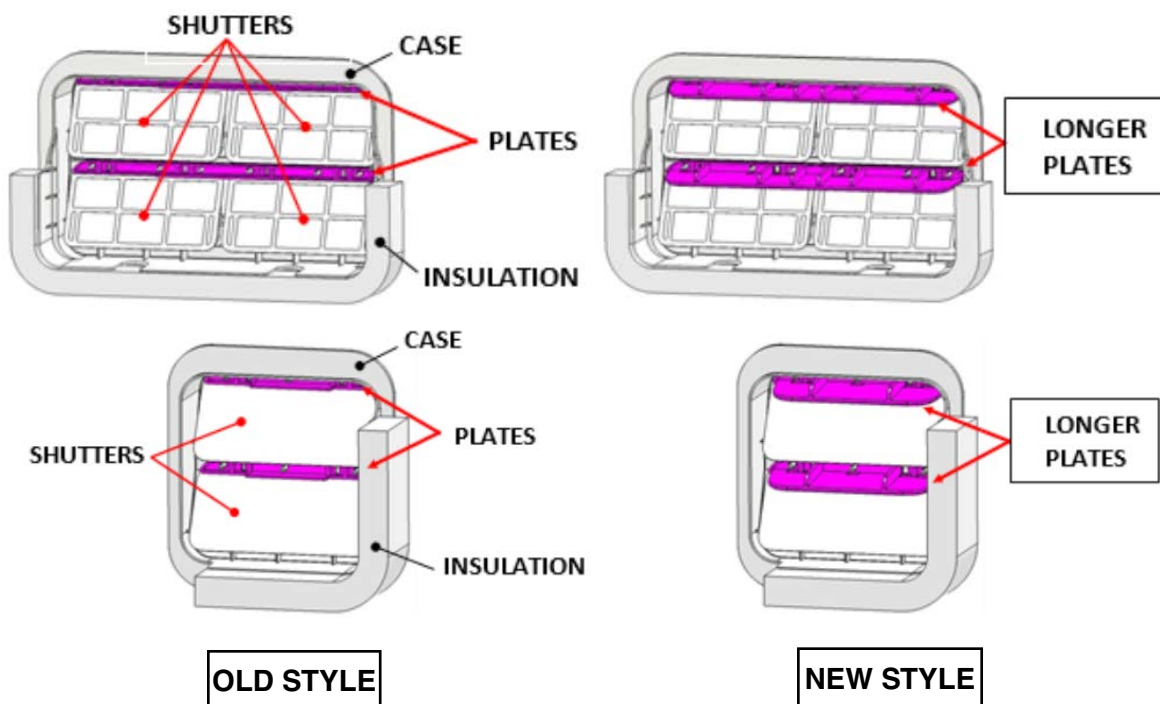
The new vent grilles have been redesigned with longer plate portions to prevent the shutters from becoming stuck open. Comparison images detailing both the Old and New-Style replacement parts are provided below.
