**Low Beam Headlamp Connector Inspection/Repair**

Some customers may comment that the low beam headlamp is inoperative.

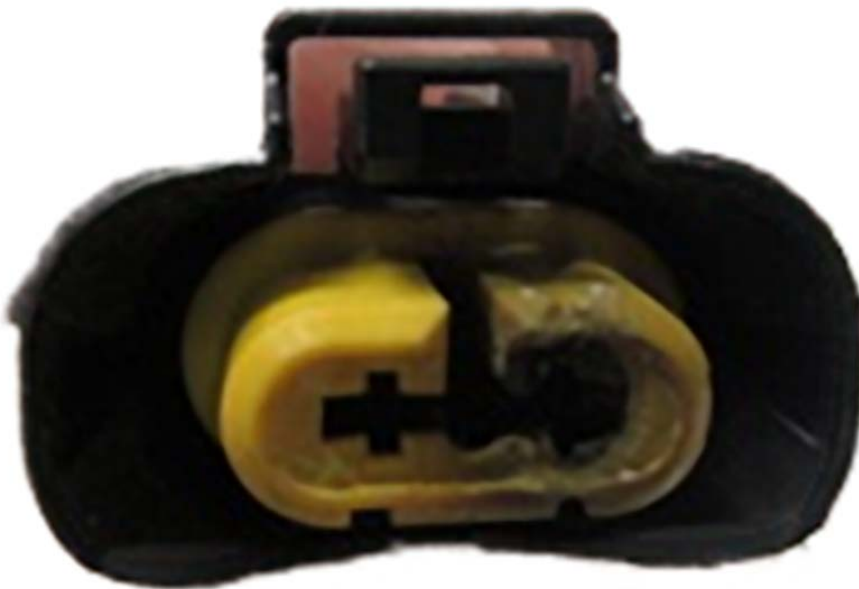
*Figure 1 Defective Connector*

1. Open the back cover and remove the headlamp bulb.
2. Inspect the connector.
  - If the connector is NOT discolored or damaged, replace the bulb only.
  - If the connector is discolored at the bulb interface, replace the connector (service pigtail listed below) and bulb.

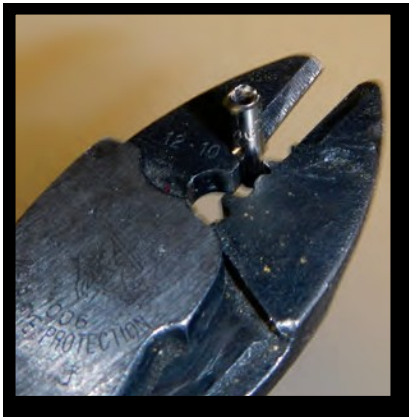
4. Insert the butt splice into the crimp tool. The crimping tool has two slots. Pick the slot that best fits the butt splice connector to ensure proper crimping. If the butt splice has a seam, place the V of the crimper on the opposite side of the seam. Insert the first wire end and start the crimp. Finish the crimp using both hands on the tool.

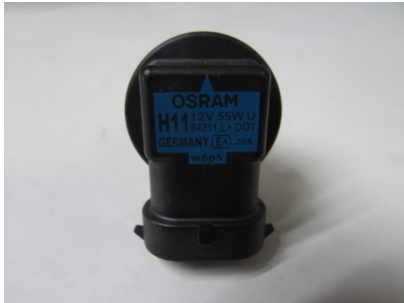
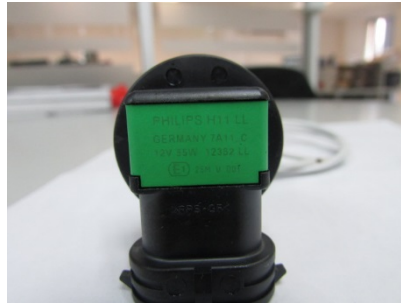
*Figure 2 Preferred Bulbs*

1. Only use DOT approved bulbs H11 55W, preferred original Osram / Philips / General Electric / Federal Mogul Long Life bulb.

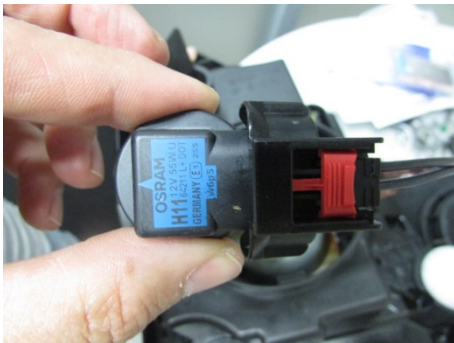
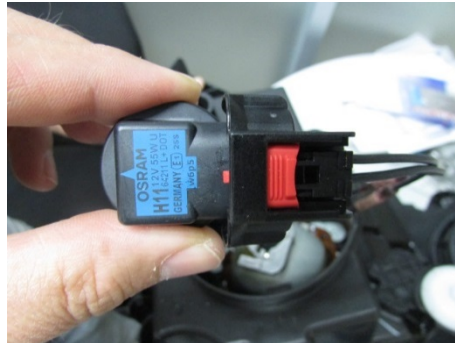
*Figure 3 Clip not engaged / Clip engaged*

2. Install the new H11 headlamp bulb to the connector. Do not touch the glass of the bulb. Contaminants on the glass may shorten the life of the bulb. Then engage the red clip by pushing the red clip toward the bulb to make sure that bulb is correctly connected. **This is only possible if the bulb is correctly connected. In order to remove the bulb, first the red lock must be disengaged using a small key or small flat screw driver and at the same time pull back the red lock. Then the bulb can be unlocked.**

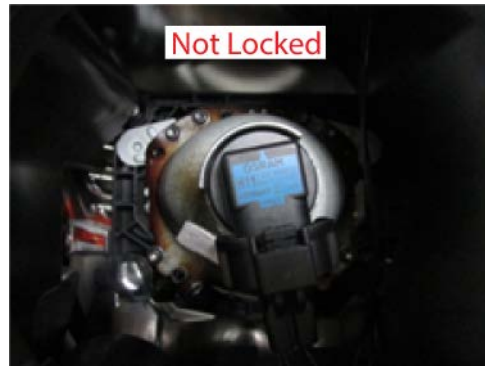
*Figure 4 Bulb locked position / Bulb unlocked position*

3. Install connected bulb to the projector module; make sure that bulb is turned to full locking position.

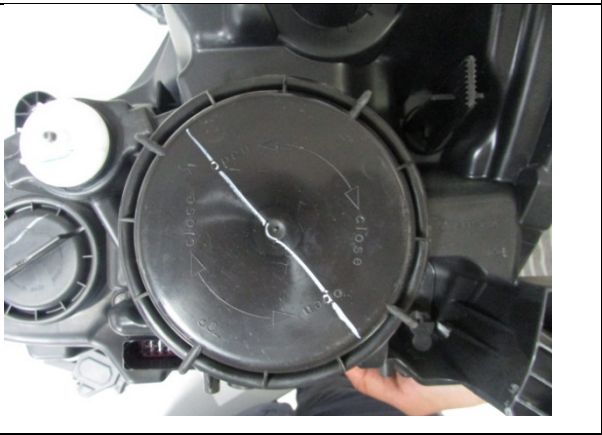
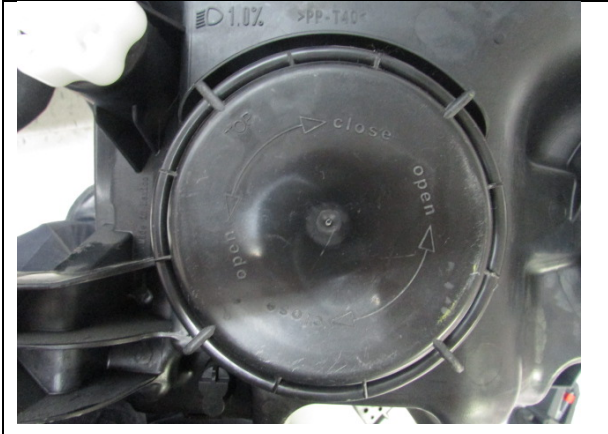
Table 2: Back Cover Locked Position for different headlamps

4. Close the back cover. Make sure that the back cover is turned to full locked position.

| <p>P54-6102-10000 / P54-6102-10000R</p> | <p>P54-6103-10000 / P54-6103-10000R</p> |
| <p>P54-6104-100 / P54-6104-100R</p> | <p>P54-1059-100 / P54-1059-100R</p> |
