**Title:** Left Side Lower Step Misaligned on HX

**Applies To:** HX

This document will guide the user through steps to take when the L/S Lower Step is mis-aligned on HX units.

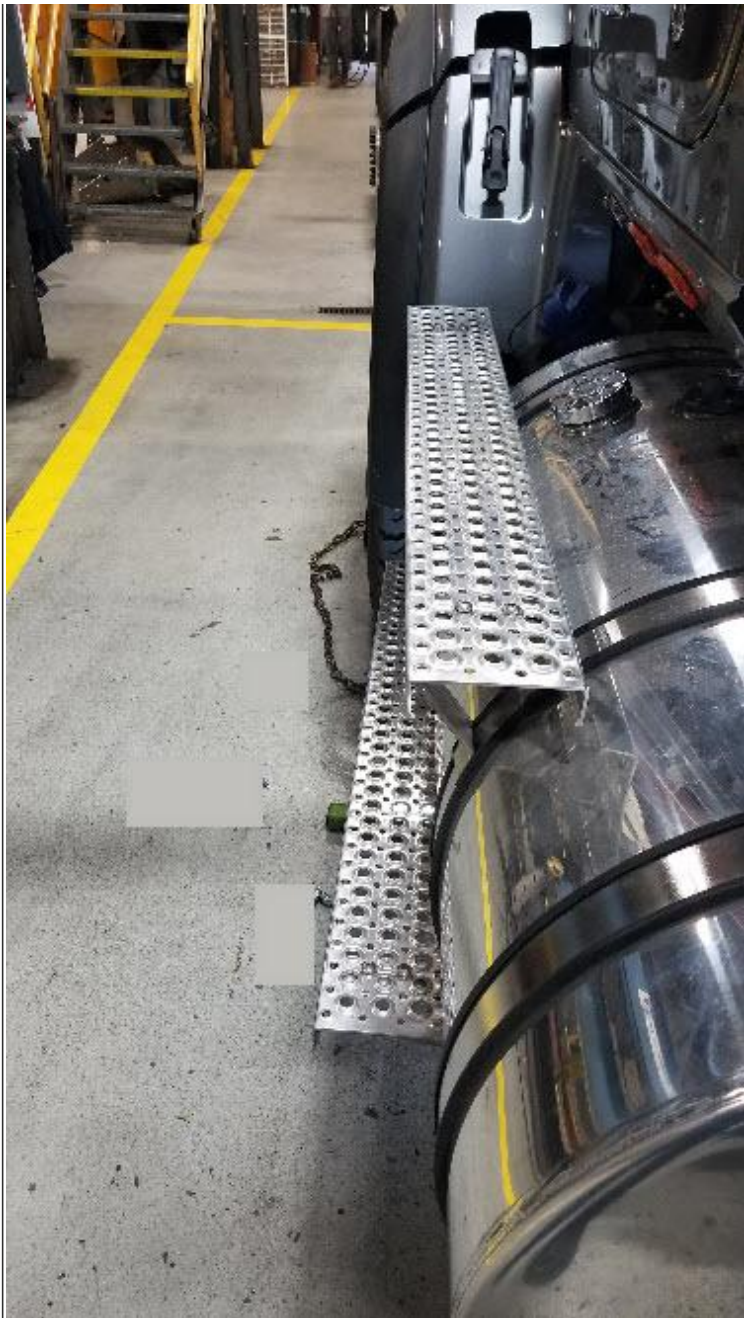
Left side lower step does not line up with the top step.

**Figure 1: Misaligned bottom step**

1. If bottom step is misaligned, as shown in [Figure 1](#), proceed to step 2.
2. Remove the 4 front mounting bolts for the bottom step, [Figure 2](#).
3. Move the 4 bolts out one slot in order for the bottom step to align with the tank/top step, [Figure 3](#).
4. Steps should now line up properly, [Figure 4](#).

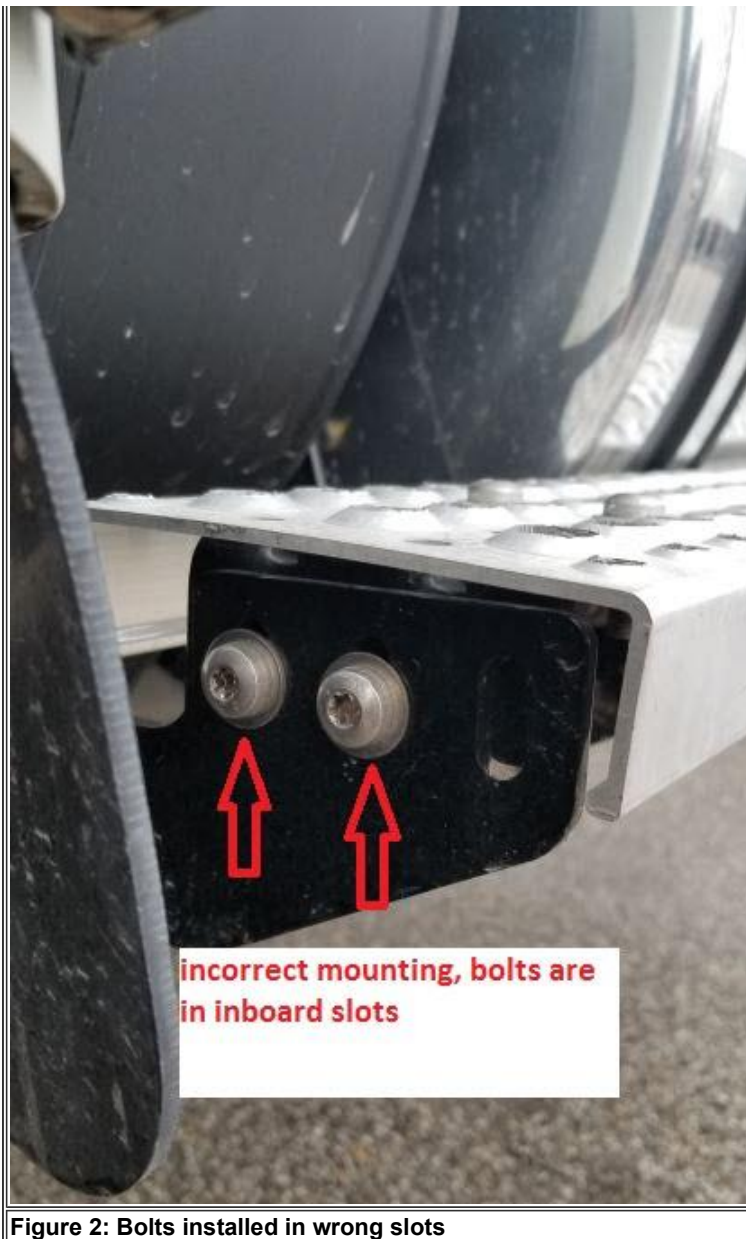
**Figure 2: Bolts installed in wrong slots**

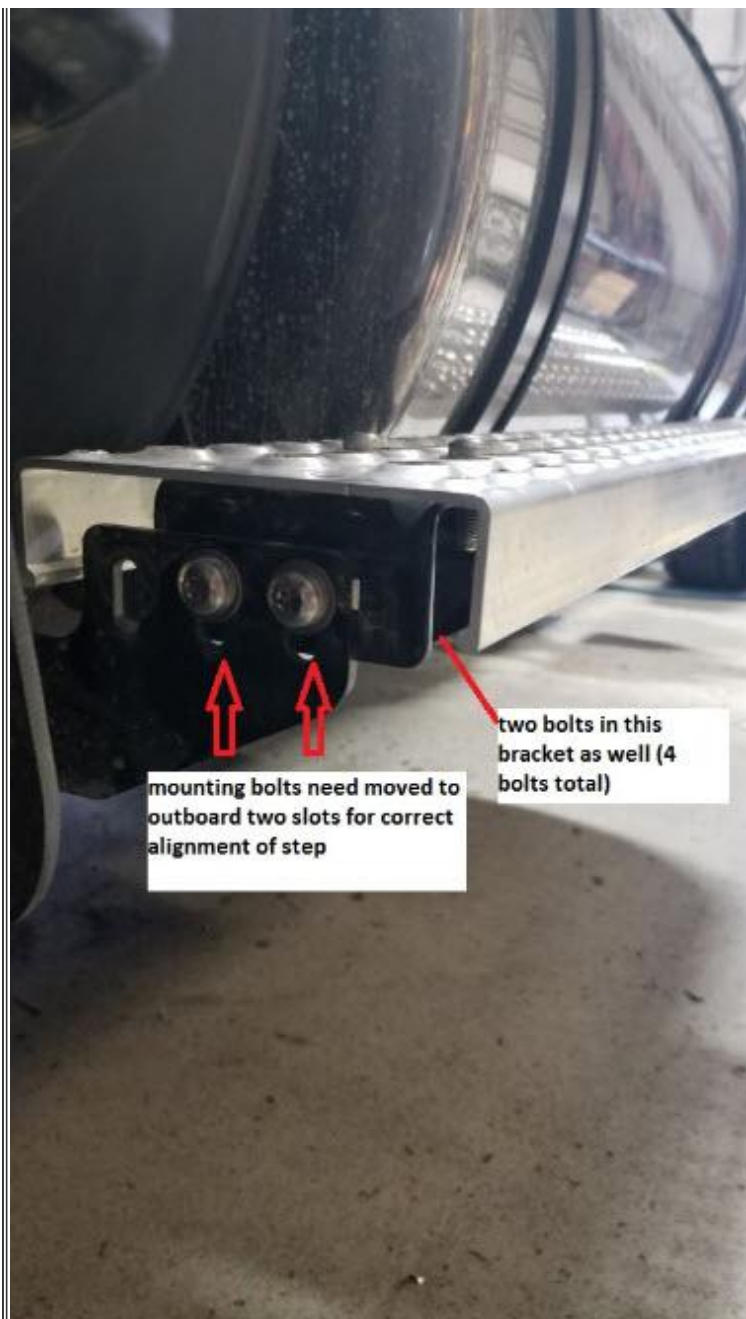
**Figure 3: Bolts installed in the proper location**

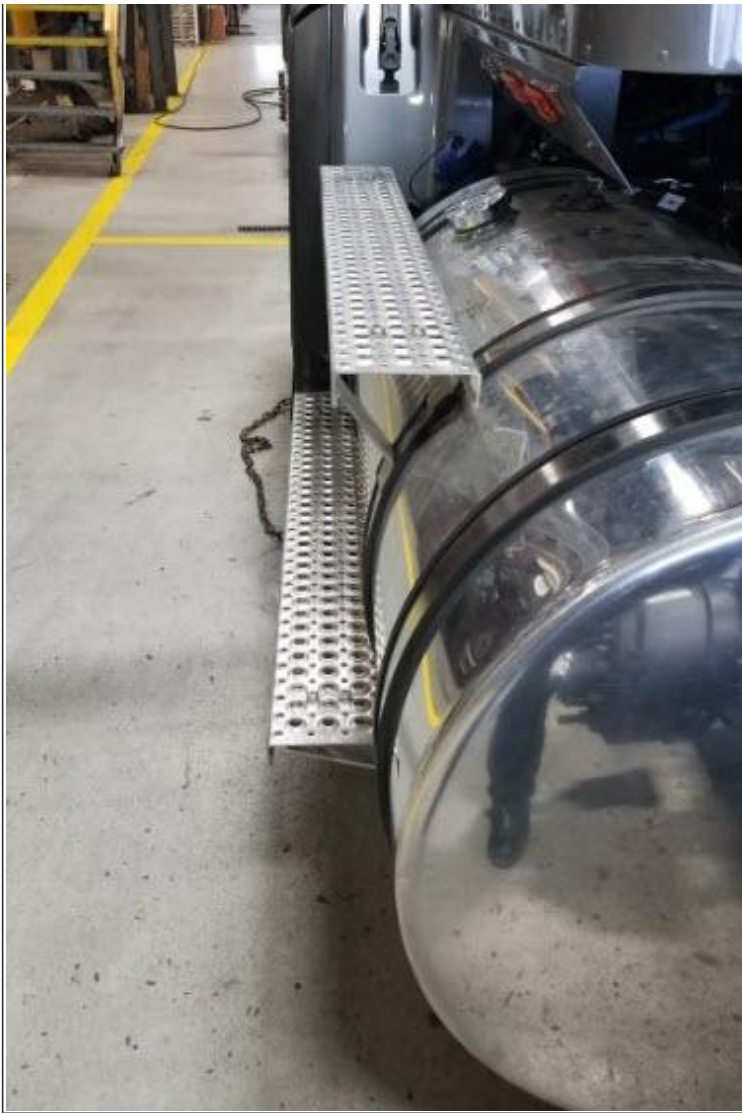
**Figure 4: Bottom step in proper position**
