**MODEL:** Karma Revero

**TITLE:** Pilot-Proximity Cable Harness Overlay

# Service Campaign

CC-17-90-12

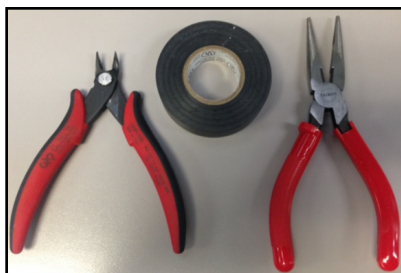
fig. 1a

- wire snips
- needle nose pliers
- highest quality electrical tape
- cable ties (fig. 1a,b)
- standard type automotive connector pick

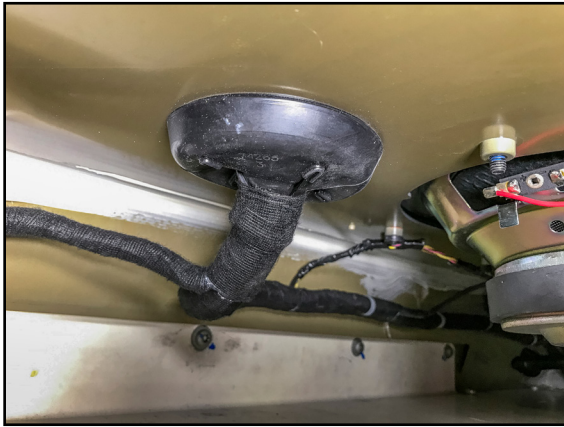
fig. 5a

2. Route the cable overlay as described above, a hole will need to be made in the grommet, towards the center away from the molded arrow (indicated in fig.5b). This is the pass through section from the package tray to the trunk area (fig. 5a).

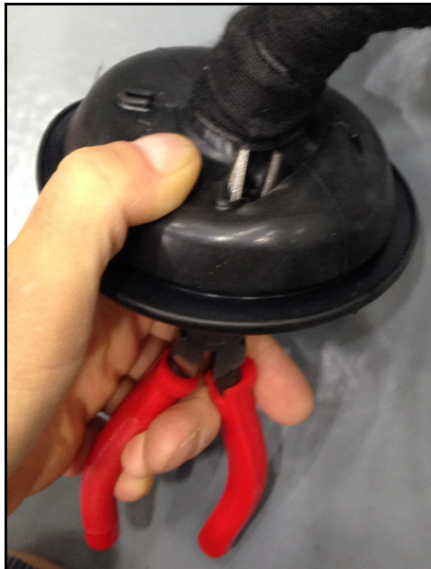
fig. 5c

Spread the hole with pliers (fig. 5c) to allow space to pass the cable assembly through (fig. 5d). This is shown from bench photos for clarity, this procedure can be done in the vehicle.

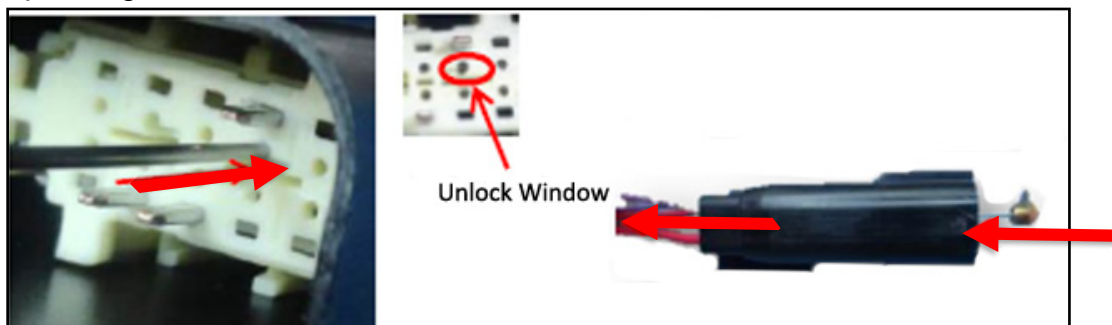
fig. 8e

5. Using the Round Pick, Insert to the corresponding position to unlock the terminal (11,12,13) as shown (fig 8e).

Pull the corresponding cable from the back of the connector to remove it from the connector
