MODEL: Karma Revero**DATE:** February 2018**TITLE:** Brake Squeak Remedy**First Release****PRIORITY:** On Complaint**APPLICABILITY:** MY17 and MY18 Revero**MARKET REGION:** North America**PURPOSE:** To remedy complaint of brake squeak or squeal**Overview:**

Technical Service Bulletin

TB-18-50-01

TITLE: Brake Squeak Remedy

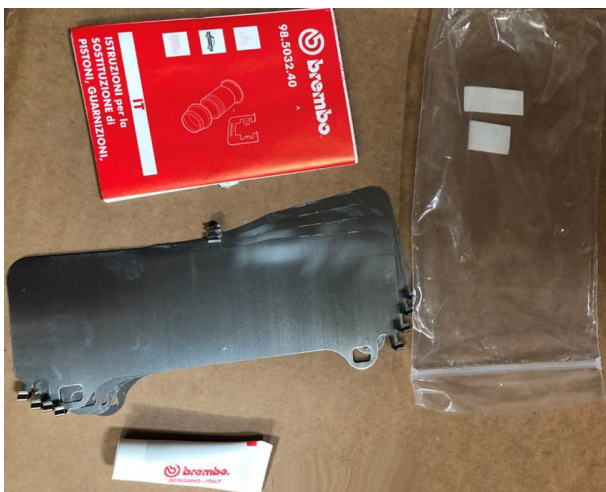
fig. 1a

C161125100300: Kit - Shim and Grease - Front (fig. 1a)

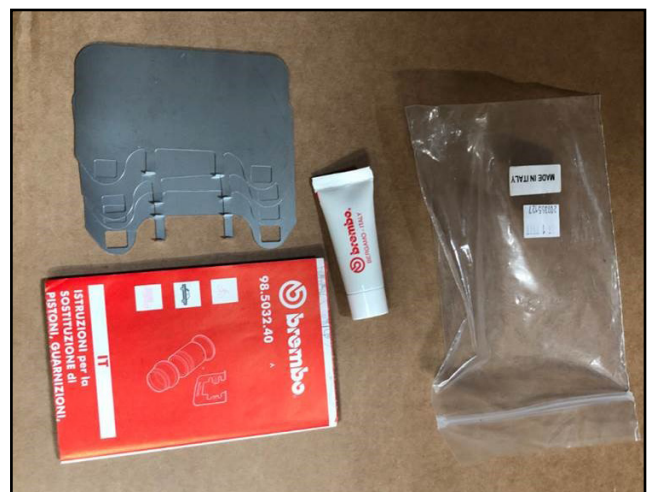
fig. 1b

C161125200300: Kit - Shim and Grease - Rear (fig. 1b)

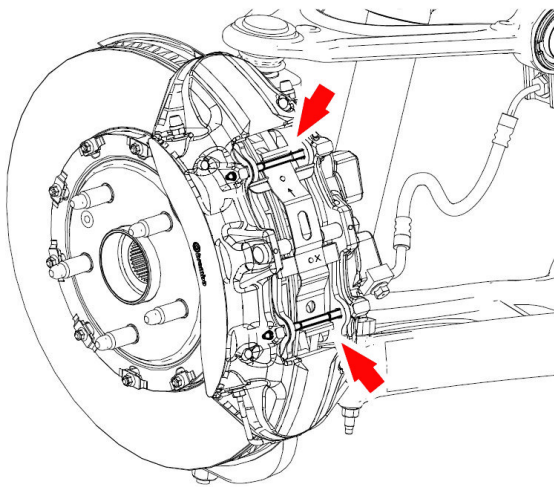
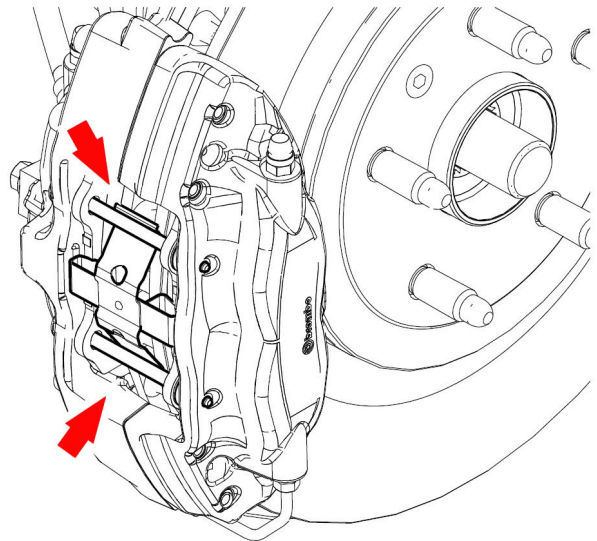
Follow the service manual for the removal of rims and brake calipers to access the pads if required (fig 2a,2b).

Inspect the brake pads and rotors for any type of unusual wear or embedded debris.

Verify that all retaining clips and pins are present and are not damaged or loose. Thoroughly clean the brake pads using a suitable cleaner and replace any missing or worn parts

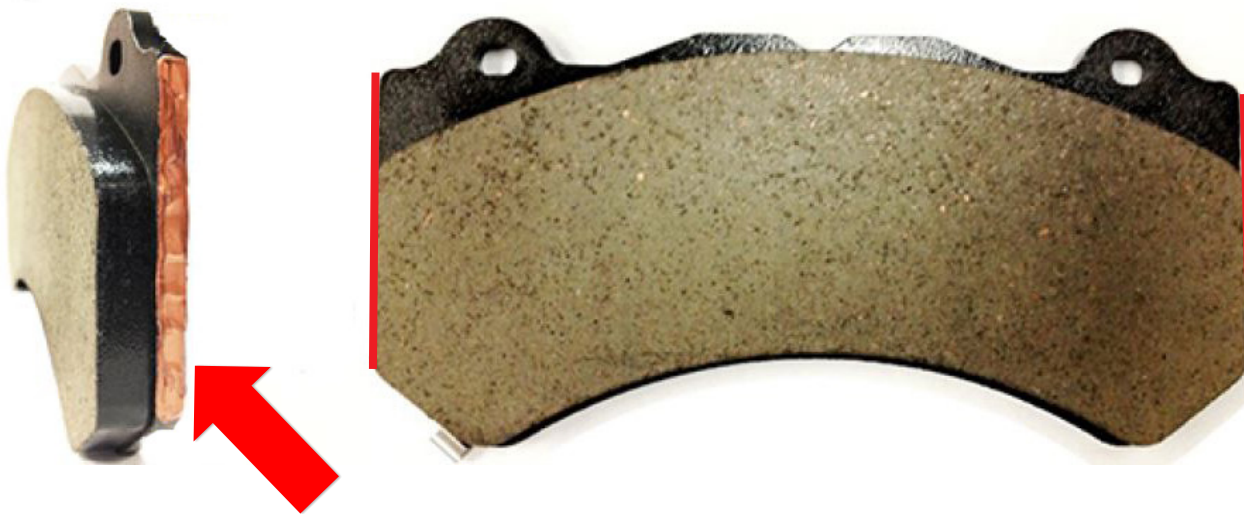
fig 3a

Aside from the standard service lubricant applied to shims on the backing plate of brake pads (front pads (fig 3a, rear pads fig. 3b).

Apply a small amount (approximately 1-2 mm thick) of Copper Brake Paste only to the leading and trailing edge of the steel backing plate of each brake pad.
