**MODEL:** Karma Revero**DATE:** July 2017**Revised:** February 2018**TITLE:** Wiper Arm Replacement**APPLICABILITY:** MY17 and MY18 Revero, On Complaint**MARKET REGION:** North America**PURPOSE:** Replacement of passenger side wiper arm

# Technical Service Bulletin

**TB-17-78-13**

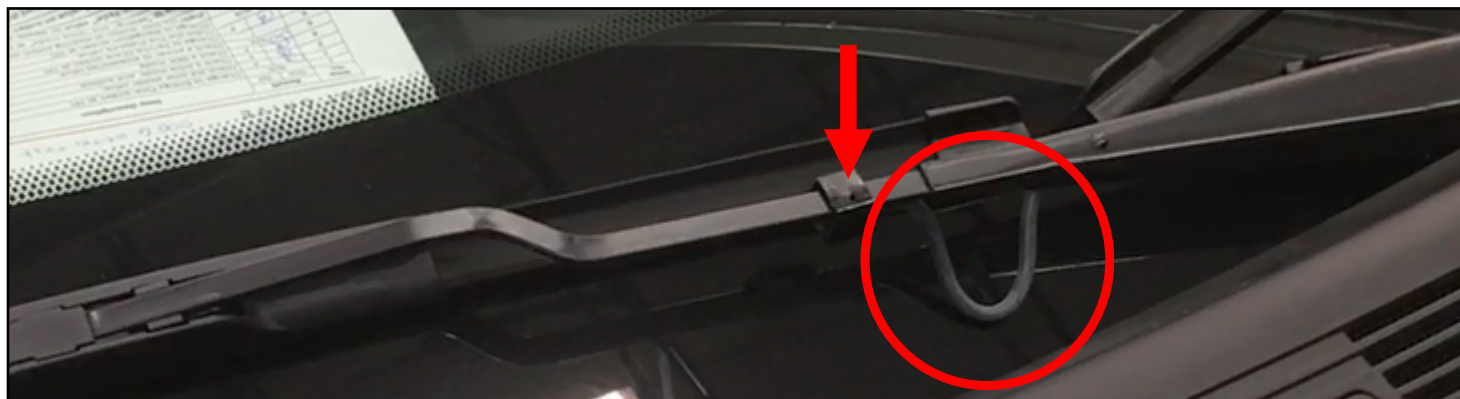
fig.1

The concern present is as illustrated in (fig 1). The nozzle slides out of position on wiper arm making the washer fluid hose visible

To remedy this concern install the new passenger side wiper arm C131178201205 on the vehicle.

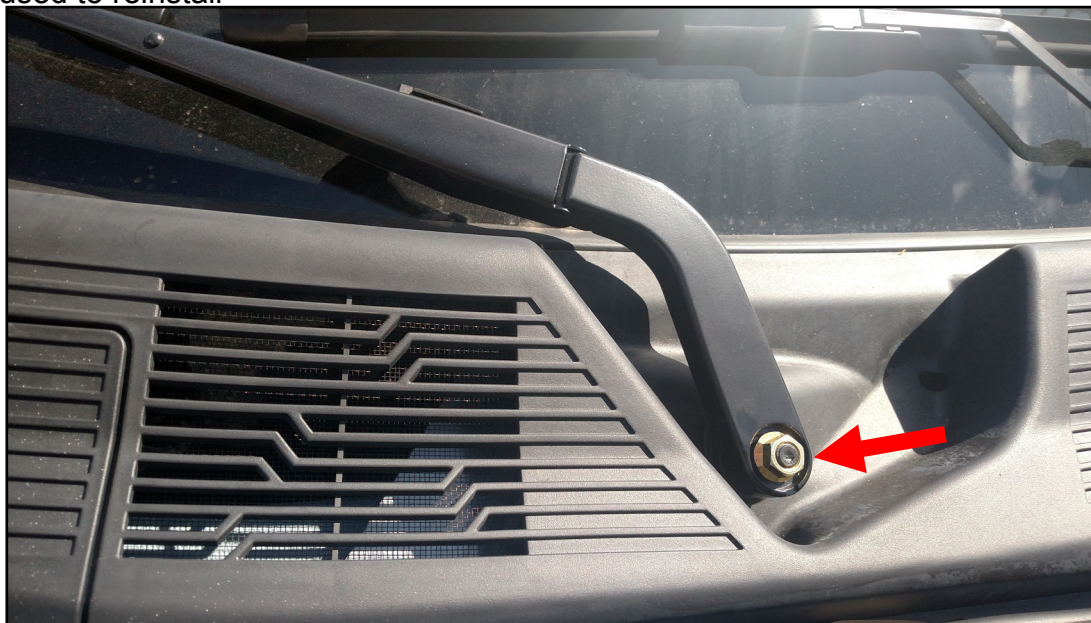
fig.2a

- b. Remove the cap and Remove the nut (install torque 25Nm) (fig. 2a, b) When removing the wiper, undo the hose from the "Y" fitting as shown in fig. 2c,d. The new arm will have nozzles and a hose used to reinstall

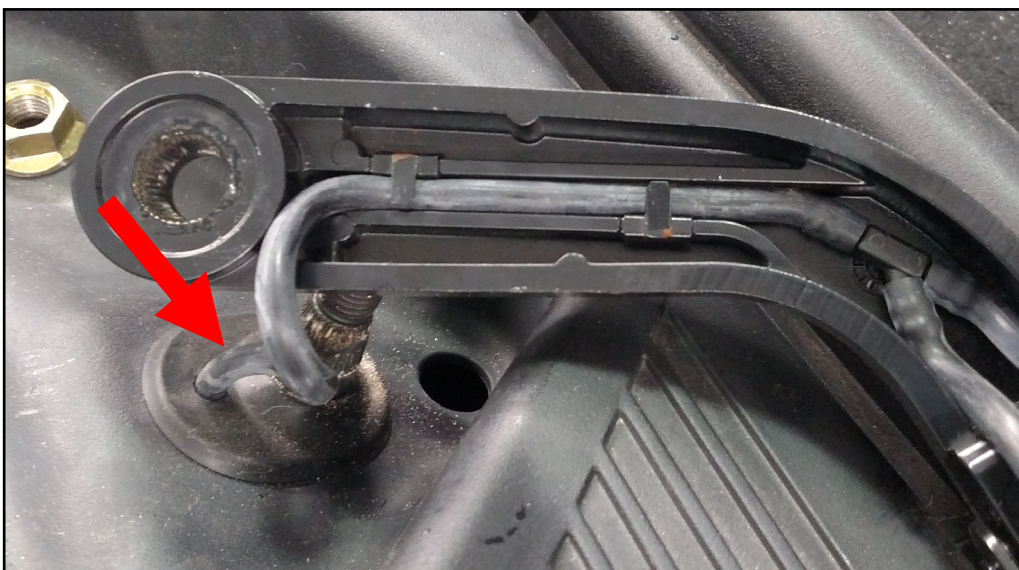
fig.3a

- c. The hose will not detach but may pull out some length from the grommet, (fig. 3a) when attaching to the new wiper arm, be sure to push the excess length back through the grommet.
