# Mirai Hydrogen Supply Regulator Noise

YEAR(S)	MODEL(S)	ADDITIONAL INFORMATION
2016 - 2017	Mirai

Some 2016 – 2017 model year Mirai vehicles may exhibit a chirp noise coming from the rear of the vehicle during the following conditions:

This chirp noise may come from the hydrogen supply regulator. Follow the Repair Procedure in this bulletin to address this condition.

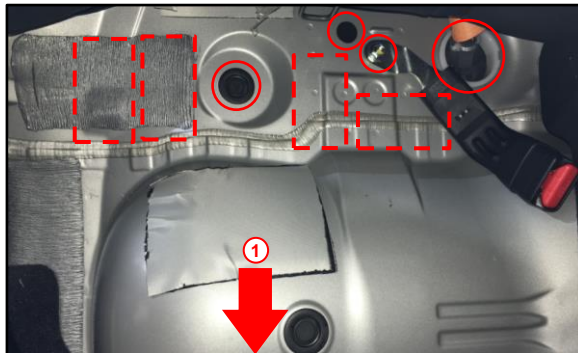
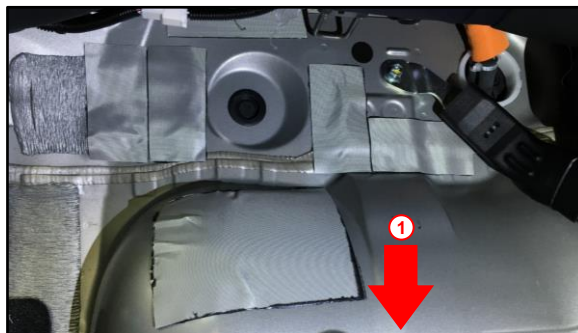
**Figure 1. Passenger Side**

- B. Wipe the seat area clean BEFORE installing the pads.
- C. Install the silence pads under the rear seats in the locations shown.

- Keep the silence pads AT LEAST 5 mm away from the edge of the seat belt mounting brackets.
- Keep the silence pads AT LEAST 5 mm away from the edge of the grommets.
- Do NOT overlap the silence pads.

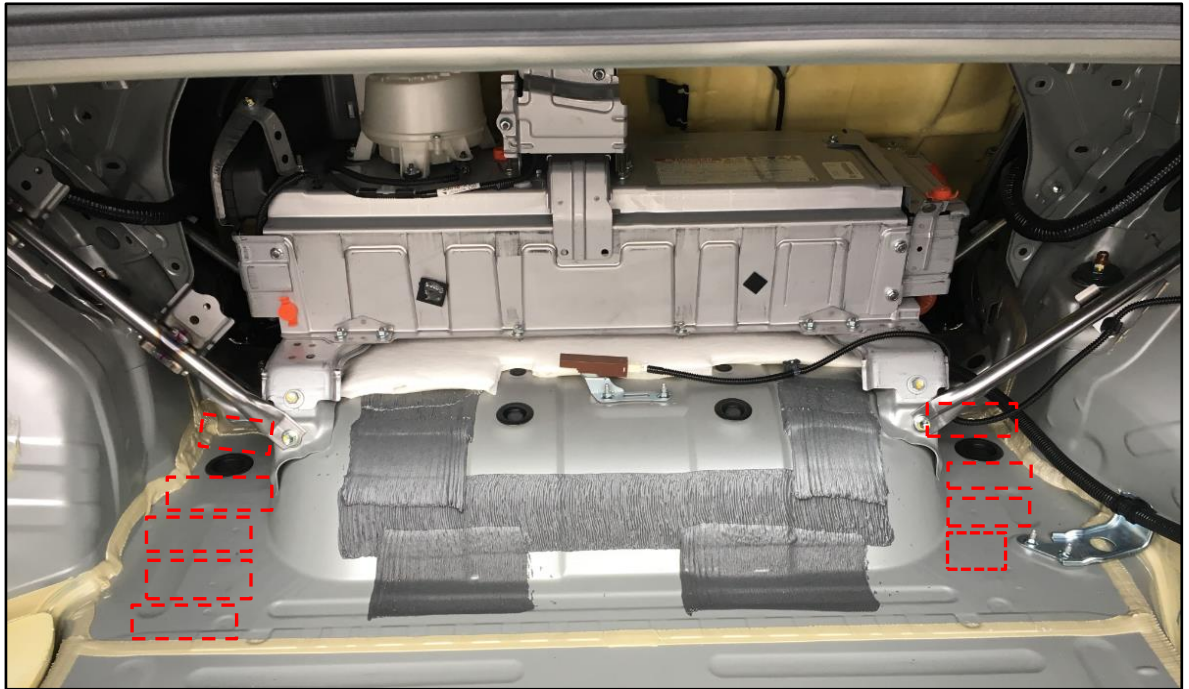
**Figure 3.**

C. Install the silence pads in the locations shown.

- Keep the silence pads AT LEAST 5 mm away from the edge of the grommets.
- Do NOT overlap the silence pads.
- Do NOT cover the mounting brackets.

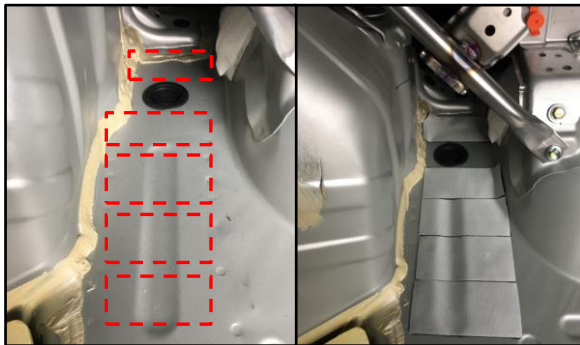
**Figure 4. Rear LH Luggage Compartment**

<b>1</b>	<b>Cut Silencer Pad to 60 mm X 60 mm</b>
----------	--

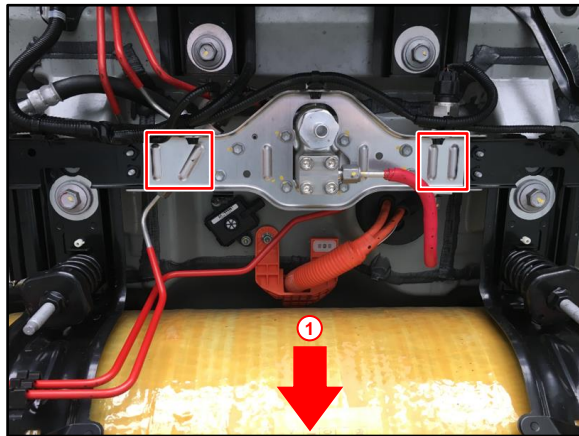
**Figure 6. Hydrogen Supply Regulator Frame Installation Locations**

- 6. Install the silence pads on the hydrogen supply regulator.
  - A. Remove the under-vehicle covers.  
Refer to TIS, applicable model and model year Repair Manual:
    - 2016 – 2017 Mirai:  
*Engine/Hybrid System – Intake/Exhaust – [“Intake / Exhaust: Exhaust Pipe: Removal”](#)*
  - B. Cut one silence pad into two 50 mm X 60 mm pieces.
  - C. Clean the hydrogen supply regulator frame BEFORE installing the pads.
  - D. Install the silence pads on the hydrogen supply regulator frame in the locations shown.

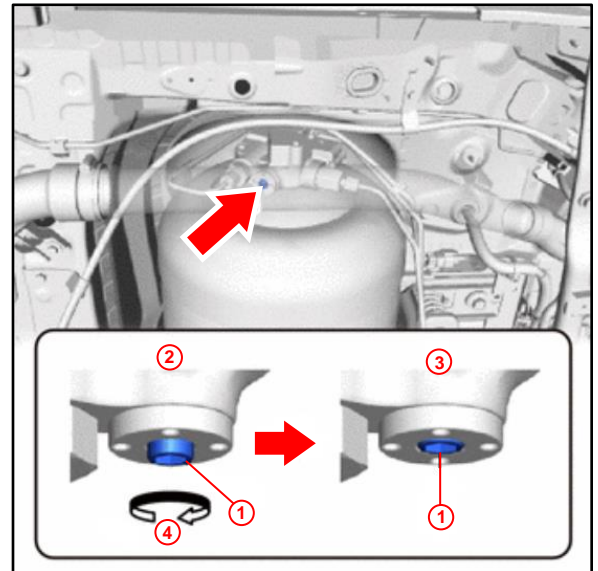
**Figure 8.**

- B. Close the manual valves for the No. 1 and No. 2 hydrogen tank assembly.
  - (1) Using an 8 mm socket hexagon wrench, rotate the adjustment bolt in a clockwise direction to close the manual valve of the No. 1 hydrogen tank assembly.

**Torque: 20 N\*m (204 kgf\*cm, 15 ft\*lbf)**

- The manual valve shuts OFF the pressure from the hydrogen tank assembly. Be careful not to damage the hexagonal portion.
- If the hexagonal portion has been damaged, the No. 1 hydrogen tank assembly **MUST** be replaced.

1	Adjustment Bolt
2	Manual Valve Open
3	Manual Valve Closed
4	Clockwise

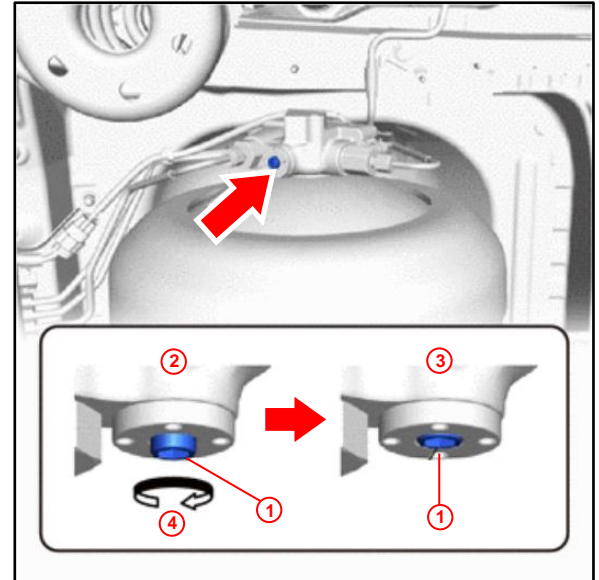
Figure 9.

- (2) Using an 8 mm socket hexagon wrench, rotate the adjustment bolt in a clockwise direction to close the manual valve of the No. 2 hydrogen tank assembly.

Torque: 20 N\*m (204 kgf\*cm, 15 ft\*lbf)

- The manual valve shuts OFF the pressure from the hydrogen tank assembly. Be careful not to damage the hexagonal portion.
- If the hexagonal portion has been damaged, the No. 2 hydrogen tank assembly MUST be replaced.

1	Adjustment Bolt
2	Manual Valve Open
3	Manual Valve Closed
4	Clockwise

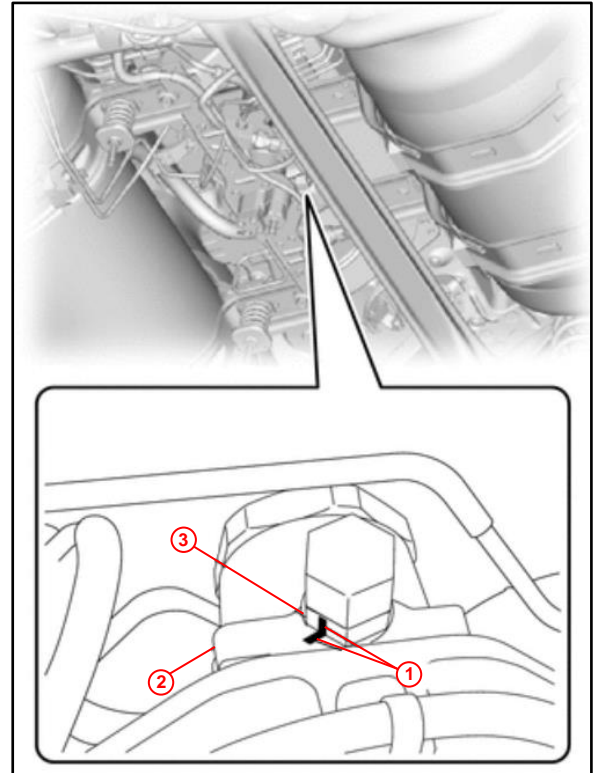
**Figure 10.**

- C. Perform depressurization.
  - (1) Apply paint marks to the hydrogen supply regulator union and the body of the hydrogen supply regulator assembly.

When loosening the No. 1 hydrogen supply regulator plug, there is a possibility that the hydrogen supply regulator union could turn together and be loosened, so applying paint marks will enable judgment of whether the hydrogen supply regulator union has been loosened.

<b>1</b>	<b>Paint Mark</b>
<b>2</b>	<b>Body</b>
<b>3</b>	<b>Hydrogen Supply Regulator Union</b>

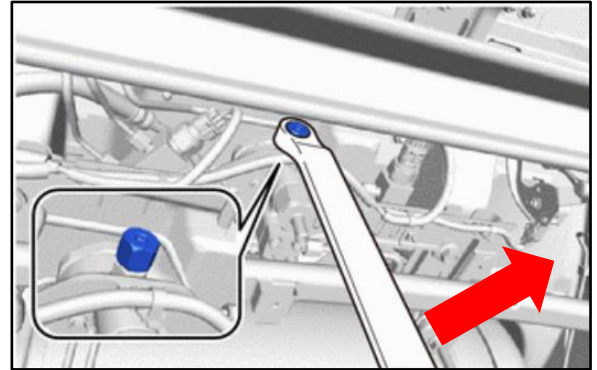
Figure 11.

- (2) To depressurize the compressed hydrogen gas from the medium pressure leak check port of the hydrogen supply regulator assembly, slowly loosen the No. 1 hydrogen supply regulator plug until the hissing sound of gas escaping can be heard, then stop loosening the No. 1 hydrogen supply regulator plug and wait for the sound to stop. Repeat this procedure until the sound stops occurring.

When performing depressurization, ONLY loosen the No. 1 hydrogen supply regulator plug. Do NOT remove it.

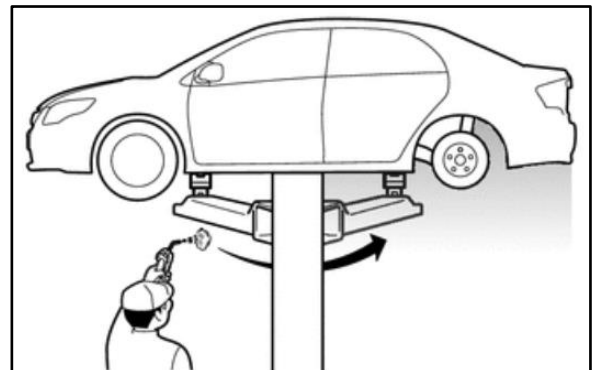
Figure 12.

- D. Blow compressed air at the underside of the vehicle to disperse ANY accumulated hydrogen gas.

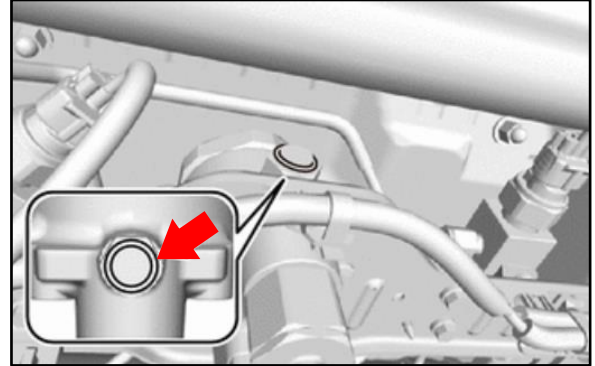
**Figure 13.**

- F. Remove the O-ring from the hydrogen supply regulator union.

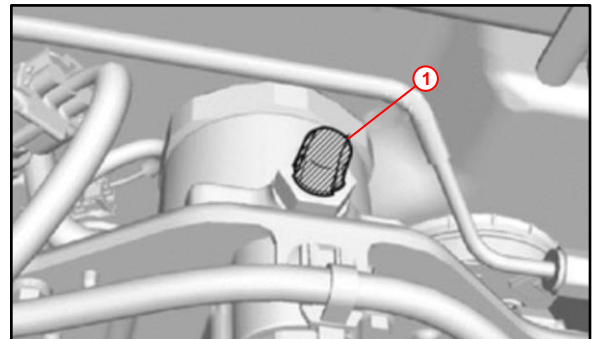
**Figure 14.**

To prevent damage to the seal portions and threaded portions, and to prevent foreign matter such as dust or metal fragments from entering the openings, cover the seal portions, threaded portions, and openings of the hydrogen supply regulator union with protective tape.

<b>1</b>	Protective Tape
----------	-----------------

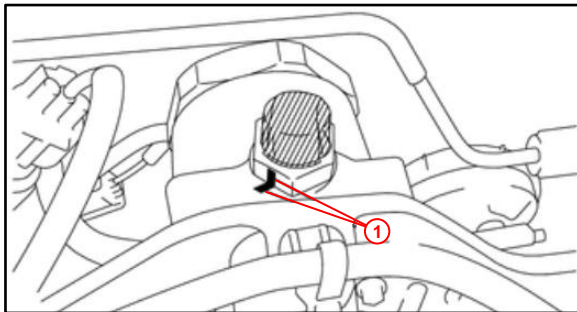
Figure 15. Correct

- G. Check that the hydrogen supply regulator union has NOT been loosened.

1	Paint Mark
---	------------

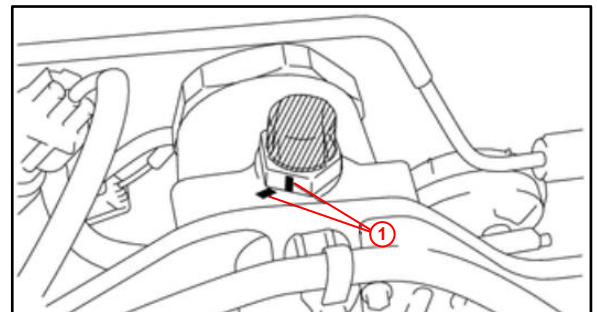
Figure 16. Incorrect

If the hydrogen supply regulator union has been loosened, there is the possibility of a compressed hydrogen gas leak, so it is necessary to remove the hydrogen supply regulator union and replace the O-ring with a NEW one.

1	Paint Mark
---	------------

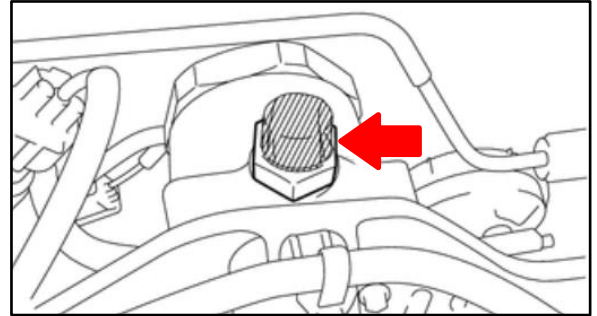
**Figure 17.**

- (1) Remove the hydrogen supply regulator union.

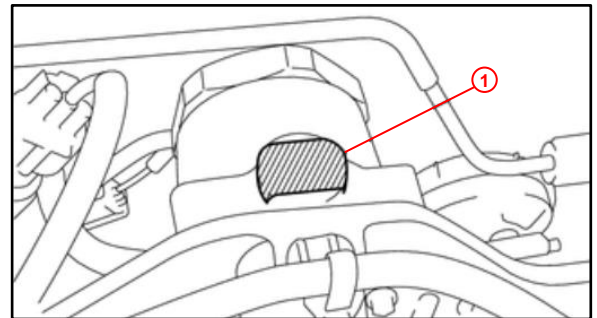
**Figure 18.**

To prevent foreign matter such as dust or metal fragments from entering the openings, cover the seal portions, threaded portions and, openings of the hydrogen supply regulator union installation portion with protective tape.

1	Protective Tape
---	-----------------

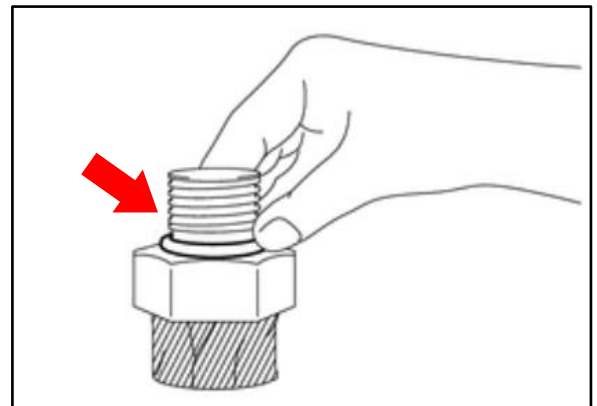
**Figure 19.**

- (2) Remove the O-ring from the hydrogen supply regulator union.

Perform this procedure by hand.  
Do NOT use ANY tools.

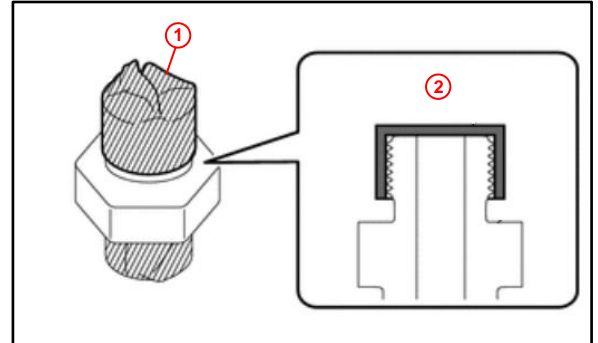
Figure 20.

To prevent the O-ring from being damaged during installation, apply protective tape.

Cover the hydrogen supply regulator union with protective tape so that the threaded portion and the hole CANNOT be seen.

1	Hydrogen Supply Regulator Union
2	Protective Tape

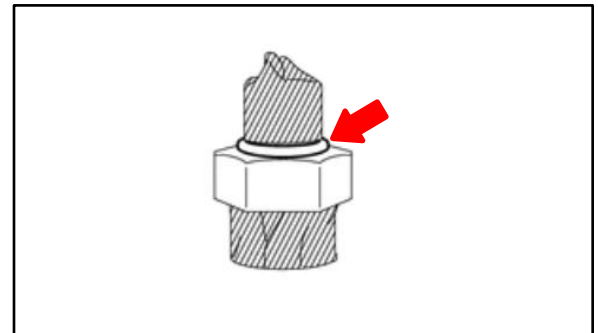
Figure 21.

- (4) Coat a NEW O-ring (P/N 90301-11036) with Toyota Genuine FC Grease.  
 (5) Install the O-ring to the hydrogen supply regulator union.

- Make sure not to damage the O-ring.
- Make sure the O-ring is NOT twisted.
- Make sure that the O-ring is NOT pinched.

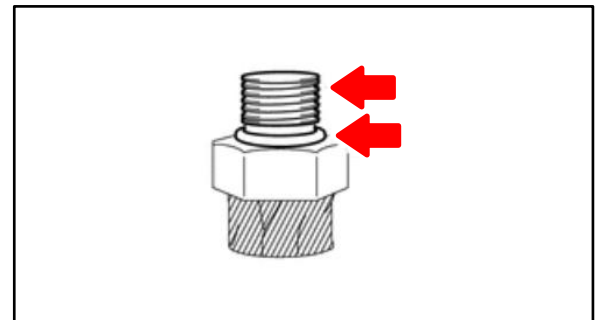
Figure 22.

- (6) Remove the protective tape from the hydrogen supply regulator union.  
 (7) Coat the O-ring and the threaded portion of the hydrogen supply regulator union with Toyota Genuine FC Grease.

To prevent the hydrogen supply regulator union installation portion from being contaminated by dust, metal fragments, etc., do NOT remove the protective tape from it until immediately BEFORE performing the work.

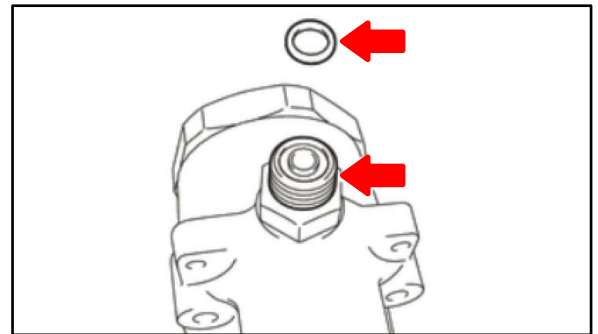
Figure 23.

- I. Apply Toyota Genuine FC Grease to a NEW O-ring (P/N 90301-09037) and to the threaded portion of the hydrogen supply regulator union.

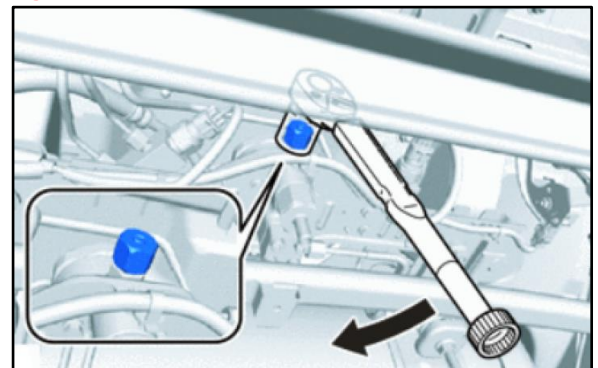
Figure 24.

- J. Install the O-ring to the hydrogen supply regulator union.

- K. Install the No. 1 hydrogen supply regulator plug to the hydrogen supply regulator union.  
 Torque: 25 N\*m (255 kgf\*cm, 18 ft\*lbf)

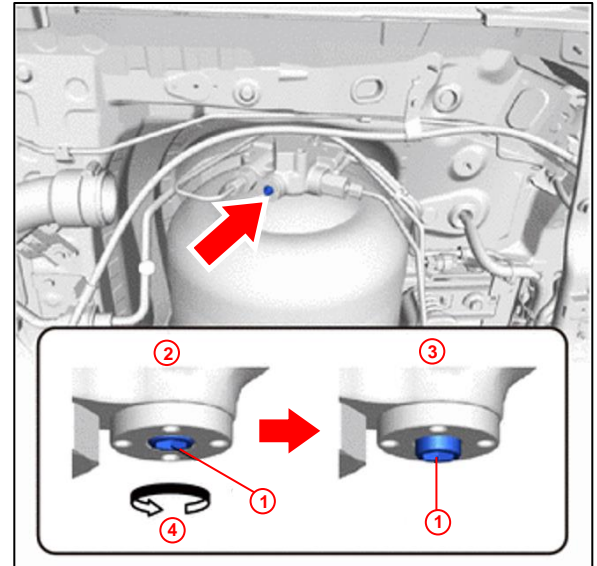
Figure 25.

- L. Using an 8 mm socket hexagon wrench, rotate the adjustment bolt counterclockwise, and open the No. 1 hydrogen tank assembly manual valve.

- The manual valve shuts OFF the pressure from the hydrogen tank assembly, so be careful not to damage the hexagonal portion.
- If the hexagonal portion is damaged, it will be impossible to operate the adjustment bolt.
- Do NOT rotate the adjustment bolt more than four rotations.
- Rotating the adjustment bolt more than four rotations could damage the manual valve.
- If the manual valve is damaged, it will be necessary to replace the No. 1 hydrogen tank assembly.

1	Adjustment Bolt
2	Manual Valve Closed
3	Manual Valve Open
4	Counterclockwise

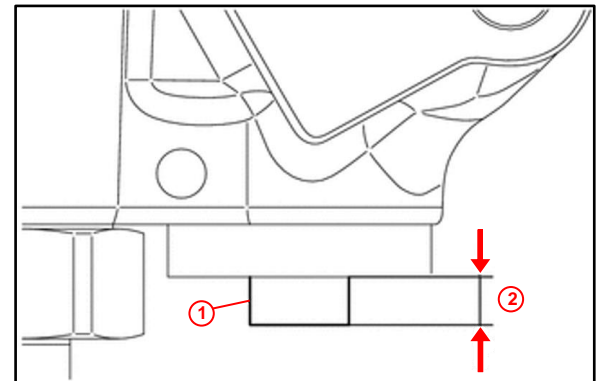
Figure 26.

When the manual valve is opened, the protrusion of the adjustment bolt is 3.5 mm (0.138 in.) or less.

1	Adjustment Bolt
2	Protrusion

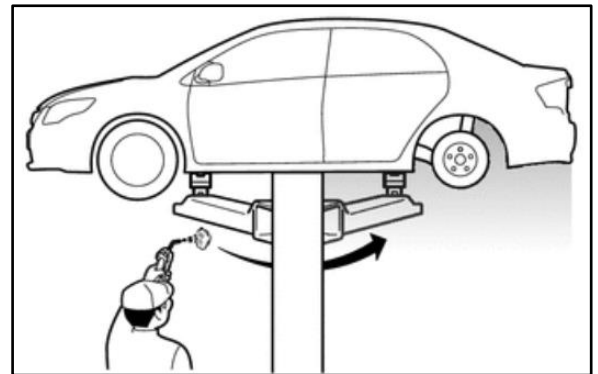
Figure 27.

- (1) Blow compressed air around the underside of the vehicle.

To enable accurate detection of hydrogen gas leaks from the piping, blow compressed air from the front of the vehicle toward the rear.

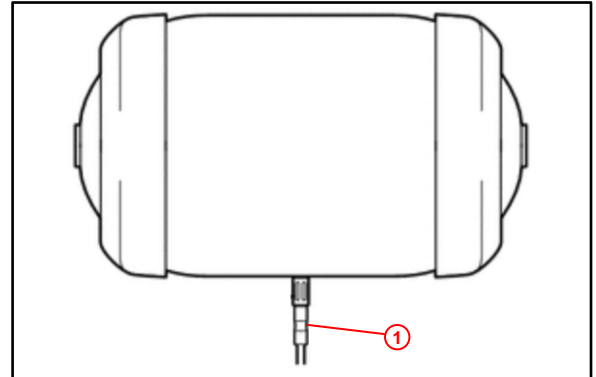
**Figure 28. Hydrogen Gas Contact Location**

- (2) Using the SST and a hydrogen gas detector, measure each of the measurement locations for approximately 10 continuous seconds per location.

- Hold the tip in light contact with the location so that the tip does not deform.
- Immediately AFTER the measurement starts, the measured value may be unstable.

<b>1</b>	<b>Hydrogen Gas Detector</b>
----------	------------------------------

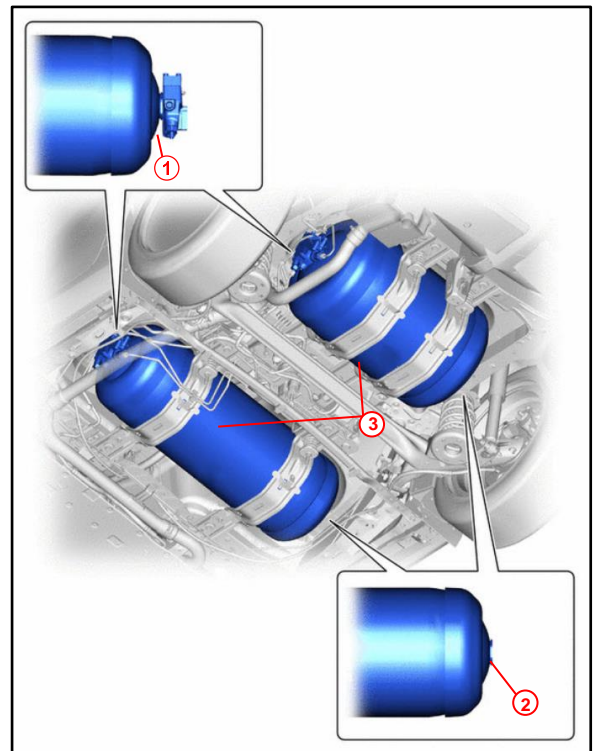
**Figure 29.**

Measure the area near the boss or center of the hydrogen tank assembly at 300 ppm or less.

<b>1</b>	<b>Boss Valve Side of Hydrogen Tank Assembly</b>
<b>2</b>	<b>Boss End Side of Hydrogen Tank Assembly</b>
<b>3</b>	<b>Center of Hydrogen Tank Assembly (one location in center of hydrogen tank assembly from underside of vehicle)</b>

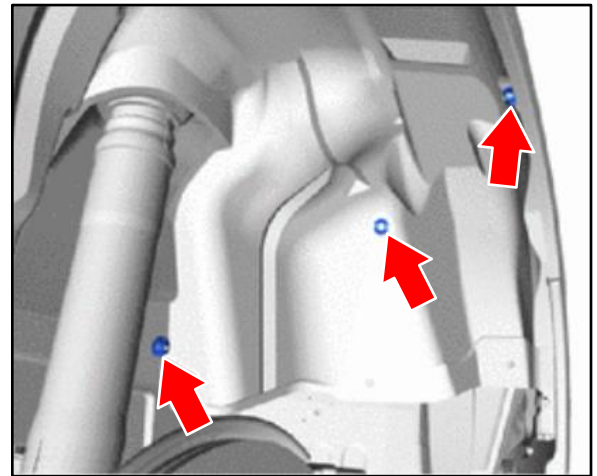
**Figure 30.**

1. Remove the three clips.

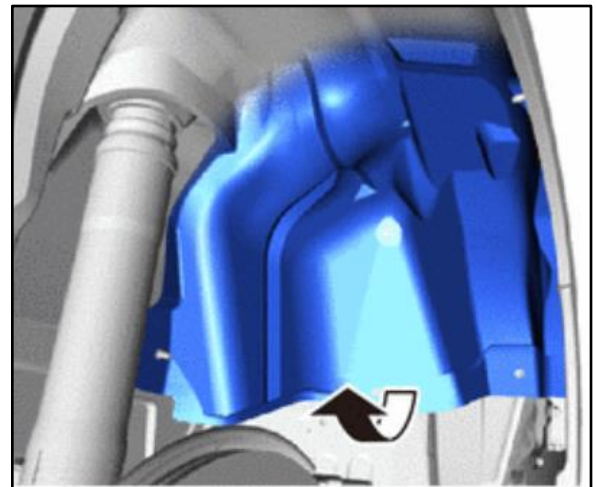
**Figure 31.**

2. Peel back the LH rear wheel house liner as shown.

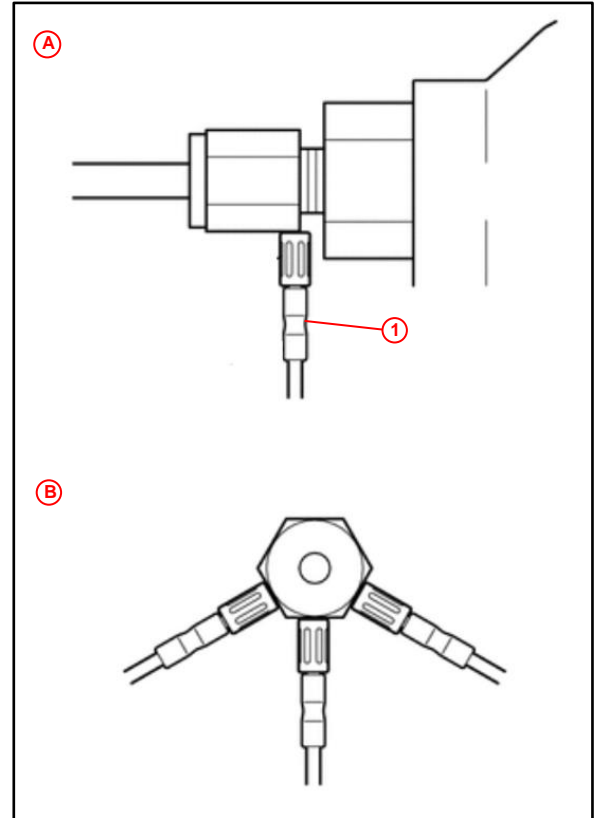
**Figure 32.**

- Immediately AFTER the measurement starts, the measured value may be unstable.
- Per the Repair Manual, if the specification is NOT met, replace the hydrogen tank assembly with a NEW one.

<b>1</b>	Hydrogen Gas Detector
<b>A</b>	Cutaway View
<b>B</b>	Side View

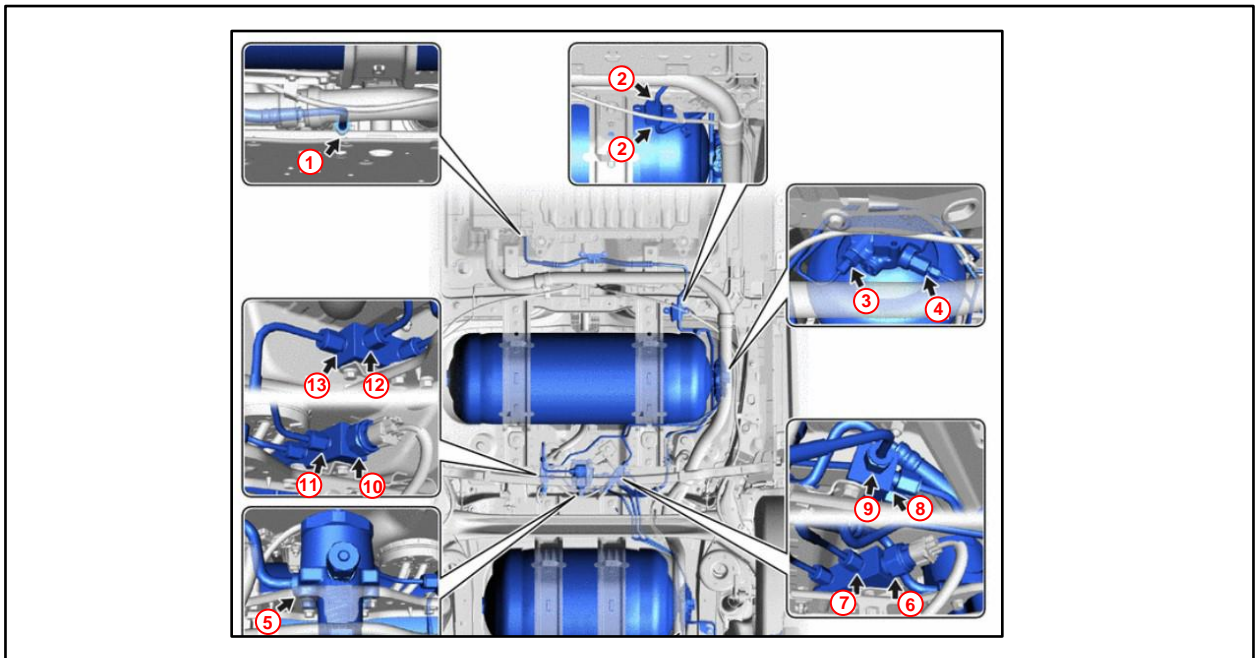
**Figure 33.**

For items 1 – 13, measure the area near the piping, connecting portion, or sensor connecting portion at 300 ppm or less.

<b>1</b>	<b>Connection Between FC Stack Assembly and No. 1 Hydrogen Supply Tube Sub-assembly</b>
<b>2</b>	<b>Connection Between No. 1 Hydrogen Supply Tube Sub-assembly and No. 2 Hydrogen Supply Tube Sub-assembly</b>
<b>3</b>	<b>Connection Between No. 1 Hydrogen Tank Assembly and No. 4 Hydrogen Tank Tube</b>
<b>4</b>	<b>Connection Between No. 1 Hydrogen Tank Assembly and No. 2 Hydrogen Tank Tube</b>
<b>5</b>	<b>Connection Between Hydrogen Supply Regulator Assembly and No. 2 Hydrogen Supply Tube Sub-assembly</b>
<b>6</b>	<b>Hydrogen Tank Tube Joint (for Inlet Side), Installation Location of Hydrogen Tank Pressure Sensor</b>
<b>7</b>	<b>Connection Between Hydrogen Tank Tube Joint (for Inlet Side) and No. 3 Hydrogen Tank Tube</b>
<b>8</b>	<b>Connection Between Hydrogen Tank Tube Joint (for Inlet Side) and Hydrogen Tank Tube Assembly</b>
<b>9</b>	<b>Connection Between Hydrogen Tank Tube Joint (for Inlet Side) and No. 2 Hydrogen Tank Tube</b>

<b>10</b>	<b>Hydrogen Tank Tube Joint (for Outlet Side), Installation Location of Hydrogen Tank Pressure Sensor</b>
<b>11</b>	<b>Connection Between Hydrogen Tank Tube Joint (for Outlet Side) and No. 5 Hydrogen Tank Tube</b>
<b>12</b>	<b>Connection Between Hydrogen Tank Tube Joint (for Outlet Side) and No. 4 Hydrogen Tank Tube</b>
<b>13</b>	<b>Connection Between Hydrogen Tank Tube Joint (for Outlet Side) and No. 6 Hydrogen Tank Tube</b>

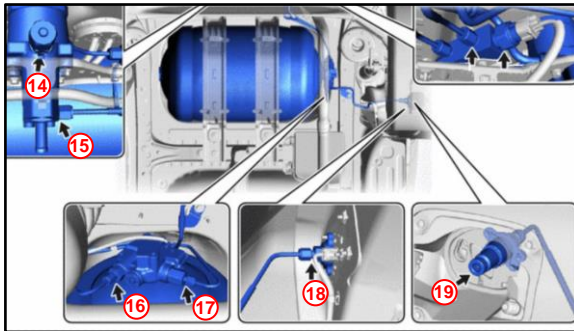
**Figure 34.**

- For items 14 – 18, measure the area near the piping, connecting portion, or sensor connecting portion at 300 ppm or less.
- For item 19, measure with the tip of the hydrogen leak detector in direct contact with the filling port at 1,000 ppm or less.<sup>\*4, \*5</sup>

<b>14</b>	<b>Medium Pressure Port of Hydrogen Supply Regulator Assembly<sup>*1</sup></b>
<b>15</b>	<b>Connection Between Hydrogen Supply Regulator Assembly and No. 6 Hydrogen Tank Tube</b>
<b>16</b>	<b>Connection Between No. 2 Hydrogen Tank Assembly and No. 5 Hydrogen Tank Tube</b>
<b>17</b>	<b>Connection Between No. 2 Hydrogen Tank Assembly and No. 3 Hydrogen Tank Tube</b>
<b>18</b>	<b>Connection Between Hydrogen Inlet Receptacle Assembly and Hydrogen Tank Tube Assembly<sup>*2</sup></b>
<b>19</b>	<b>Filling Port of Hydrogen Inlet Receptacle Assembly<sup>*3</sup></b>

- \*1: If the value is NOT as specified, replace the O-ring of the medium pressure port.
- \*2: Measure from underneath the vehicle, with the LH rear wheel house liner peeled back.
- \*3: Because there is a possibility of erroneously detecting hydrogen that has accumulated near the filling port, open the hydrogen inlet receptacle cap and wait for AT LEAST 3 minutes before performing the measurement.
- \*4: When performing leak inspection of the hydrogen inlet receptacle assembly, hold the tip of the hydrogen leak detector in light contact with the area shown in the illustration (Figure 35).
- \*5: To prevent damage to the O-ring, do NOT insert the tip of the hydrogen leak detector into the filling port of the hydrogen inlet receptacle assembly.

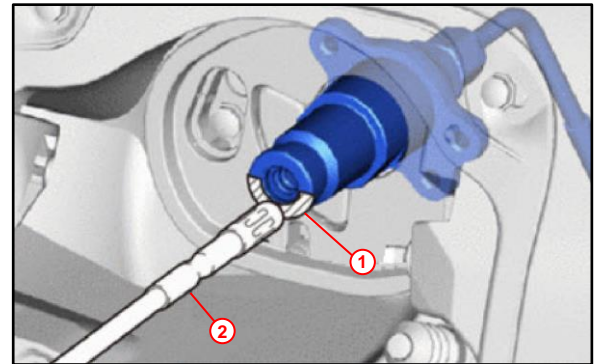
**Figure 35.**

<b>1</b>	<b>Contact Area for Hydrogen Leak Detector</b>
<b>2</b>	<b>Hydrogen Leak Detector</b>
