Tight Clearance or Contact of TRD Pro LH Rear Shock Reservoir to Body

Service Category Suspension

Section Rear Suspension

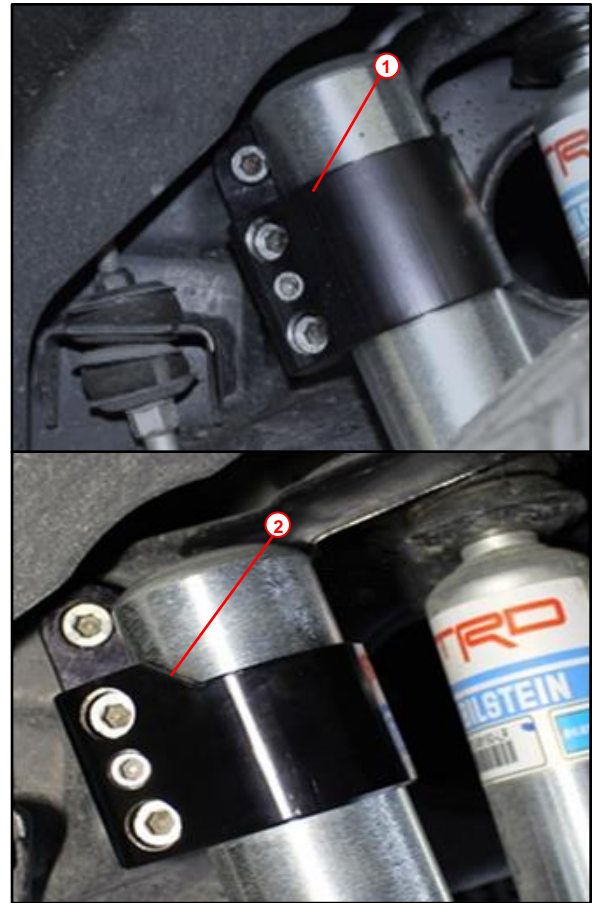
Figure 1.

1. Check the shape of the reservoir bracket. Does the bracket have an angled step as shown?
 - **YES** — This bulletin does **NOT** apply. Continue diagnosis using the applicable Repair Manual.
 - **NO** — Continue to step 2.

1	No Angled Step
2	Angled Step

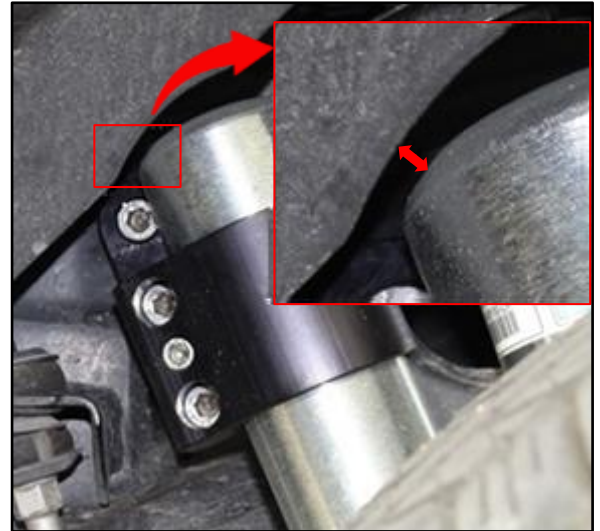
2. Measure the smallest distance between the LH rear shock reservoir end and the inner wheelhouse panel edge.

Is the clearance less than 5 mm?

Figure 2. Reservoir Clearance Measurement

- **YES** — Continue to step 3.
- **NO** — This bulletin does NOT apply. Continue diagnosis using the applicable Repair Manual.

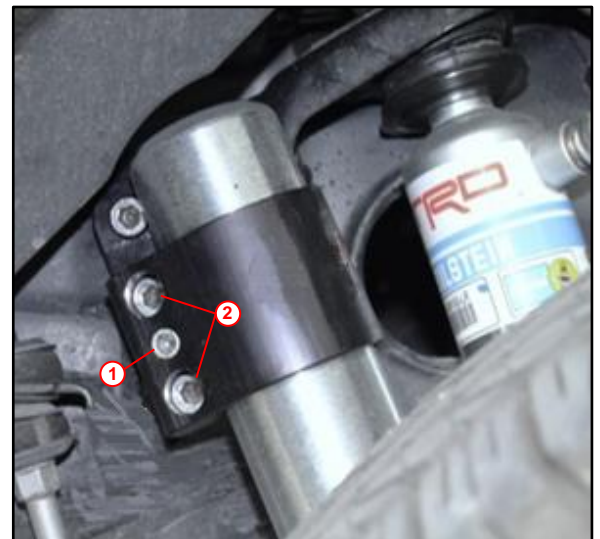
Figure 3. Reservoir Bracket Bolts

1	No. 1 Bolt
2	No. 2 Bolt

4. Using a 5 mm Allen socket, remove the No. 1 bolt. Then, using a 6 mm Allen socket, remove both No. 2 bolts. The reservoir and bracket are now free.

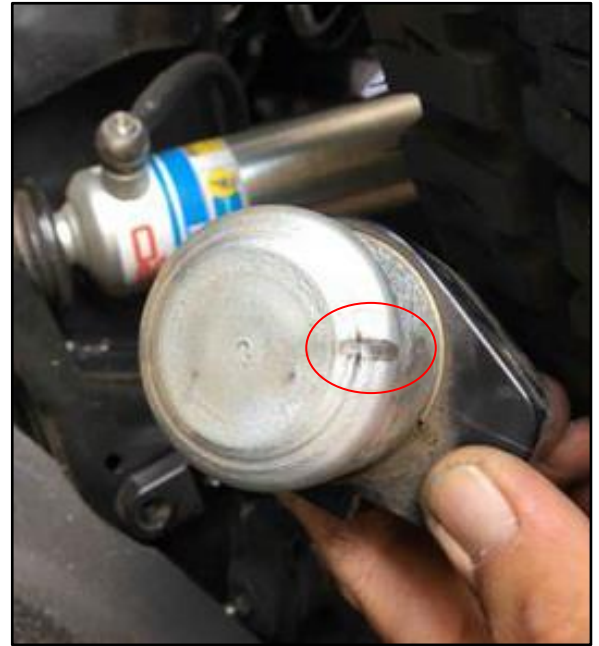
Figure 4. Plating Damage Example

If the reservoir plating is damaged by contact with the body flange, remove and replace the left rear shock absorber per the TRD suspension kit accessory installation instructions. Refer to ["2015-2018 4Runner TRD Suspension Kit PTR13-89150, PTR13-89160 Rev. E,"](#) located at *TIS – Library – Service Information – Accy – Accessory Diagnostic Guide*.

If the plating is undamaged, the original shock absorber may remain in place.

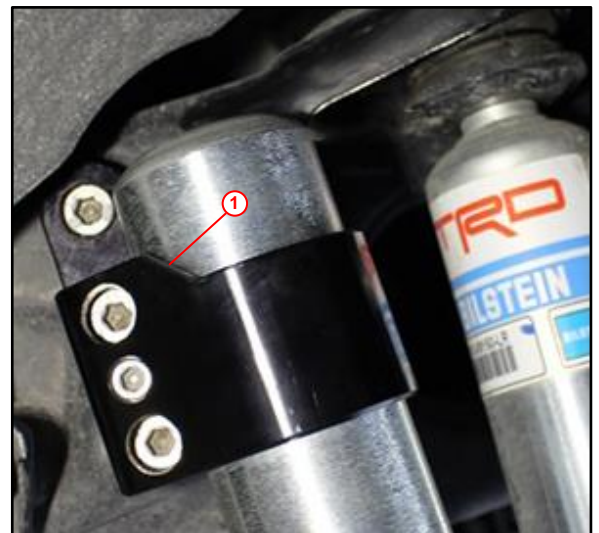
Figure 5. Countermeasure Bracket

1	Angled Step
---	-------------

8. Inspect the inner body panel for contact damage. If damage is present, clean any bare metal with wax and grease remover and recoat with the Dupli-Color® Scratch Fix All-in-1™ Exact-Match Automotive Touch-up Paint.
9. Install a countermeasure bracket with the angled step toward the free end of the reservoir as shown.
