# ***Airstream Service Bulletin***

Bulletin Number: 174

Product Line: Airstream Atlas

Subject: Battery Fuse Replacement

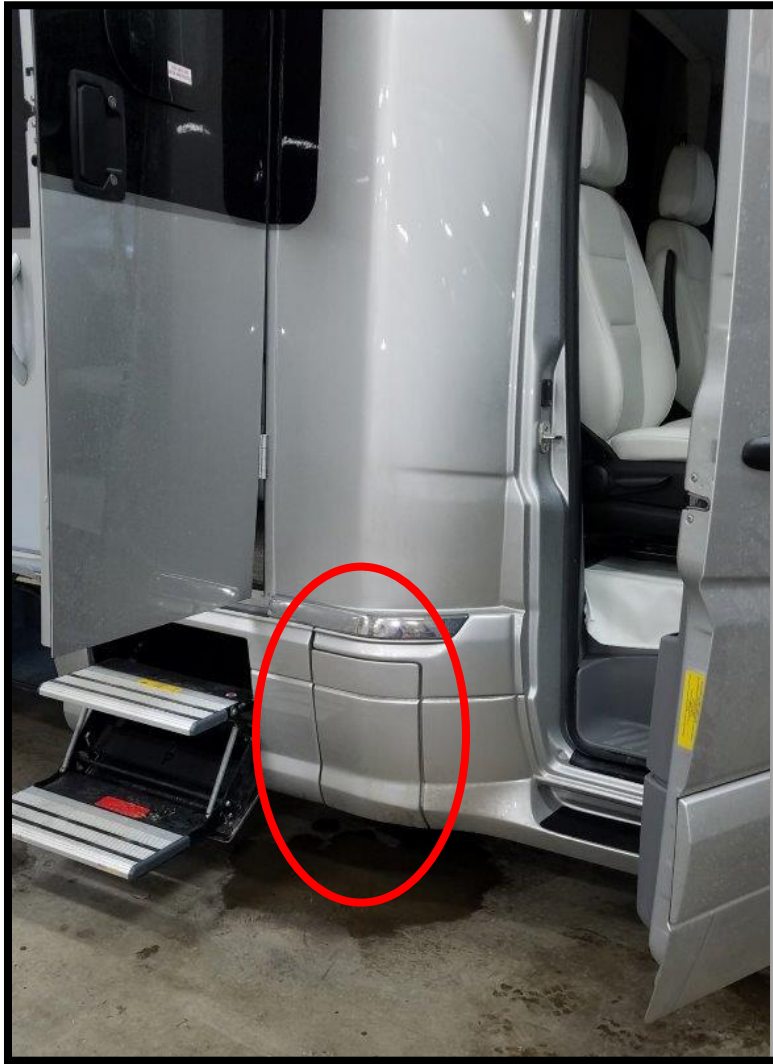
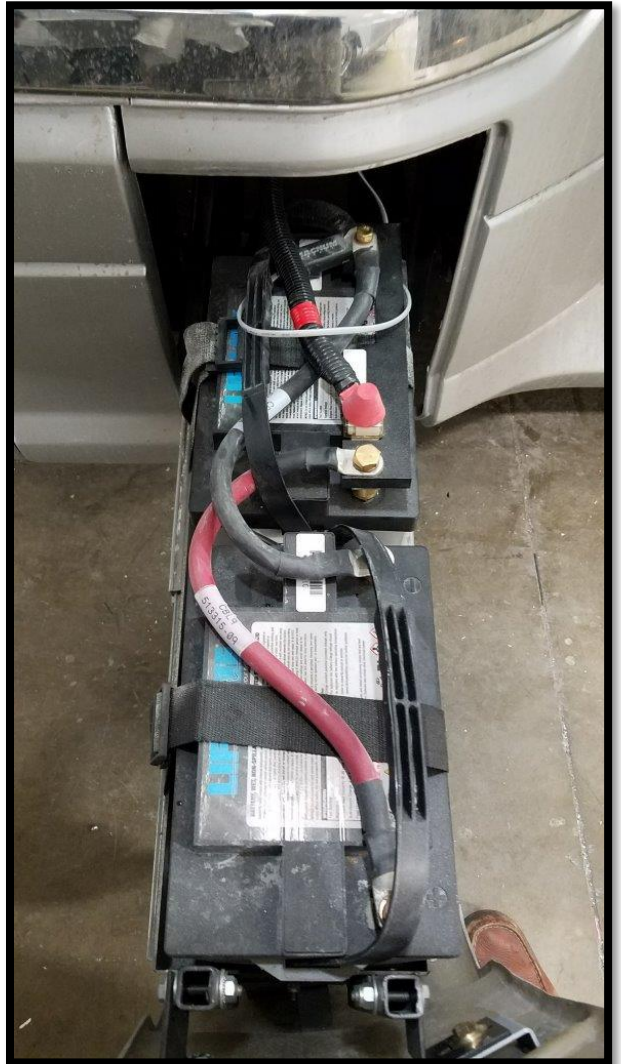
**Step 1:** Start by accessing the batteries. The compartment is located on the curbside behind the passenger side door. You will need to remove the pin under the compartment and slide the compartment out.

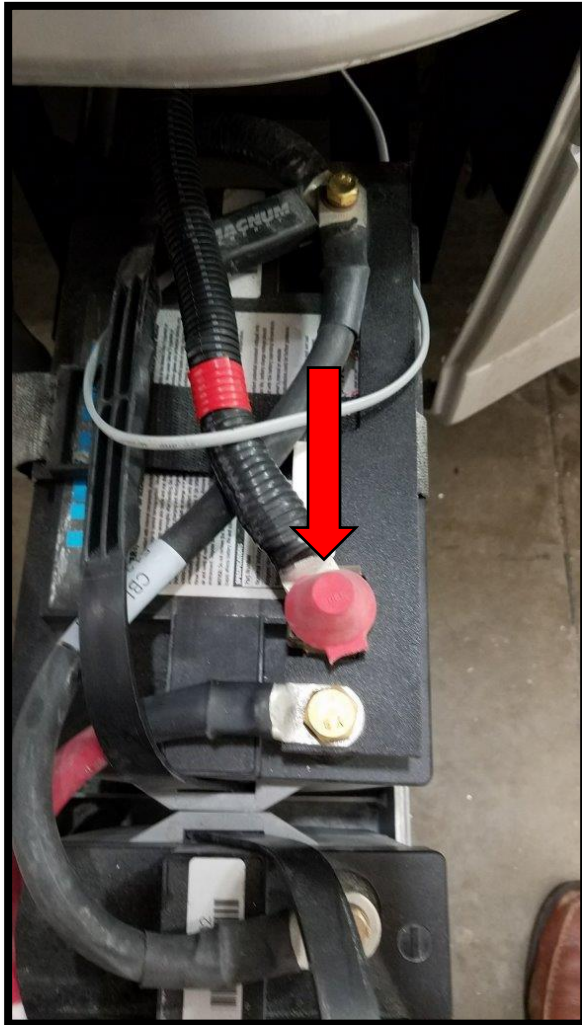
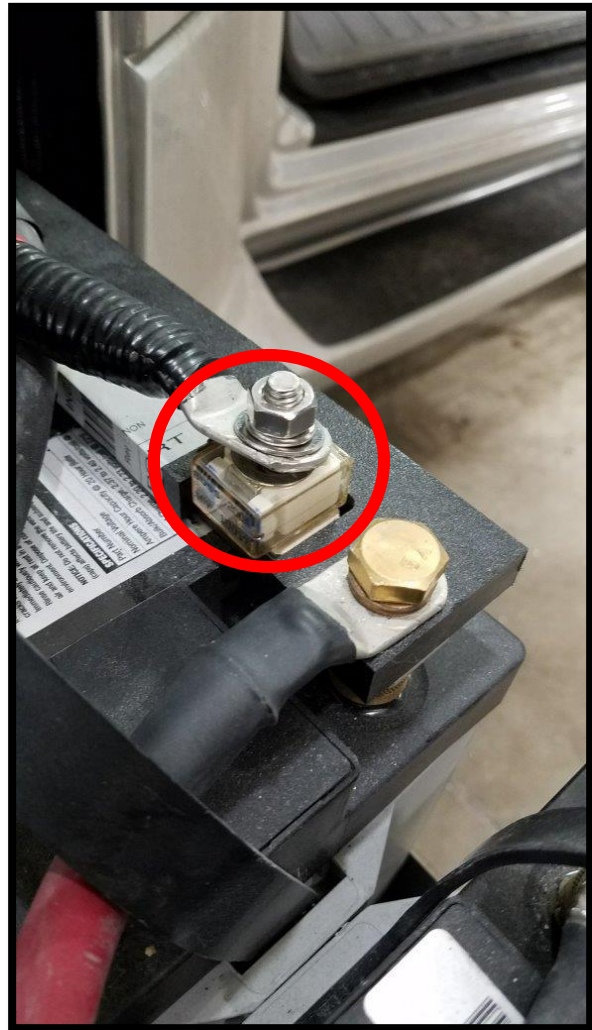
**Step 2:** Remove the rubber cap on the positive terminal of the rear battery to expose the lug.

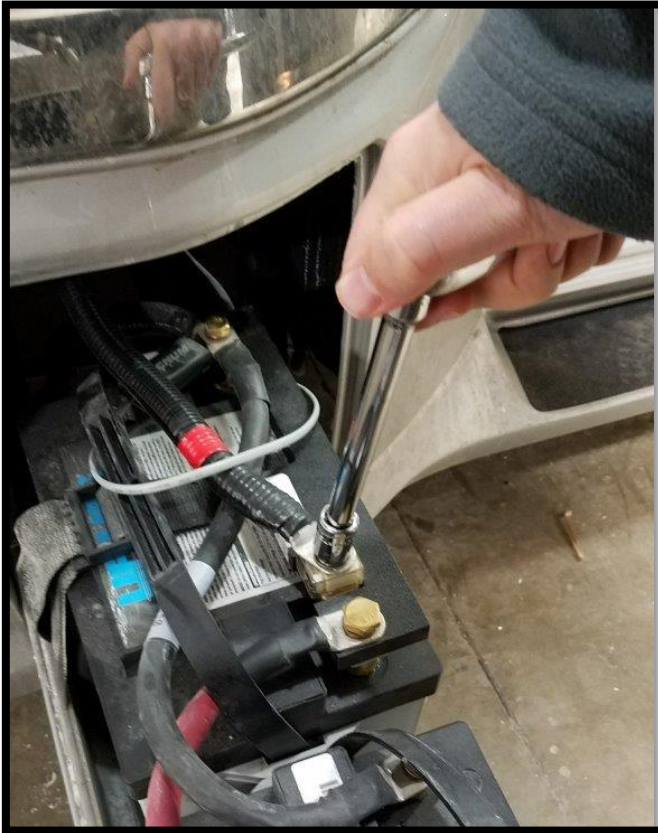
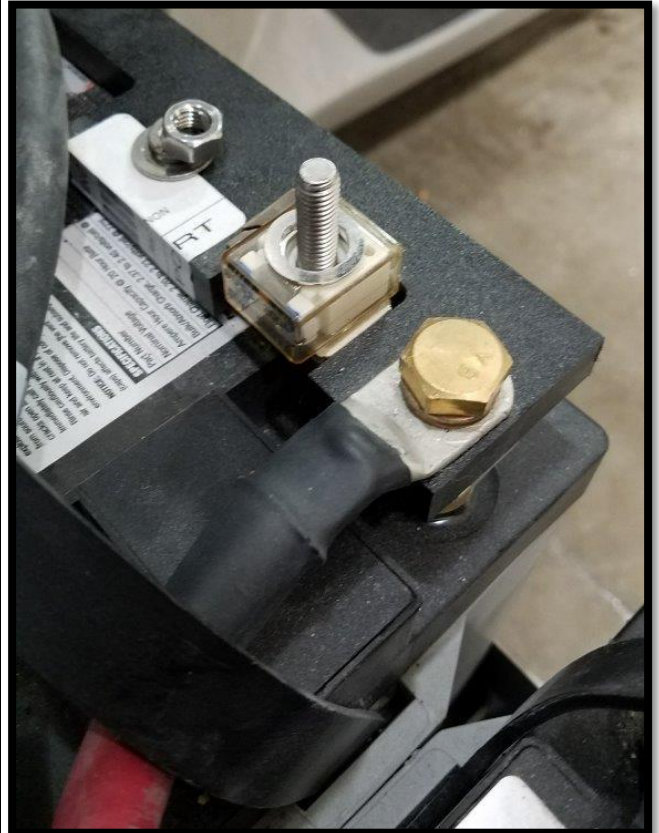
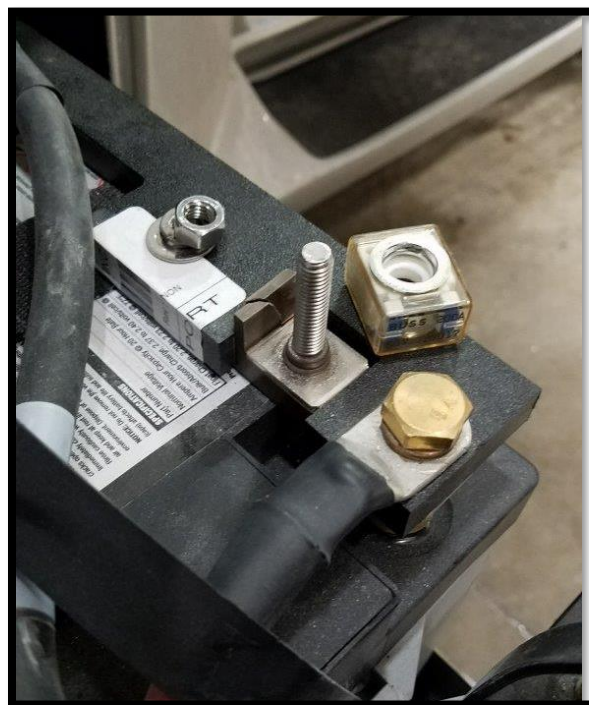
**Step 3:** Using a 13mm wrench or socket, remove the nut holding the positive battery cable, remove the cable and the 150 amp fuse located on the lug.

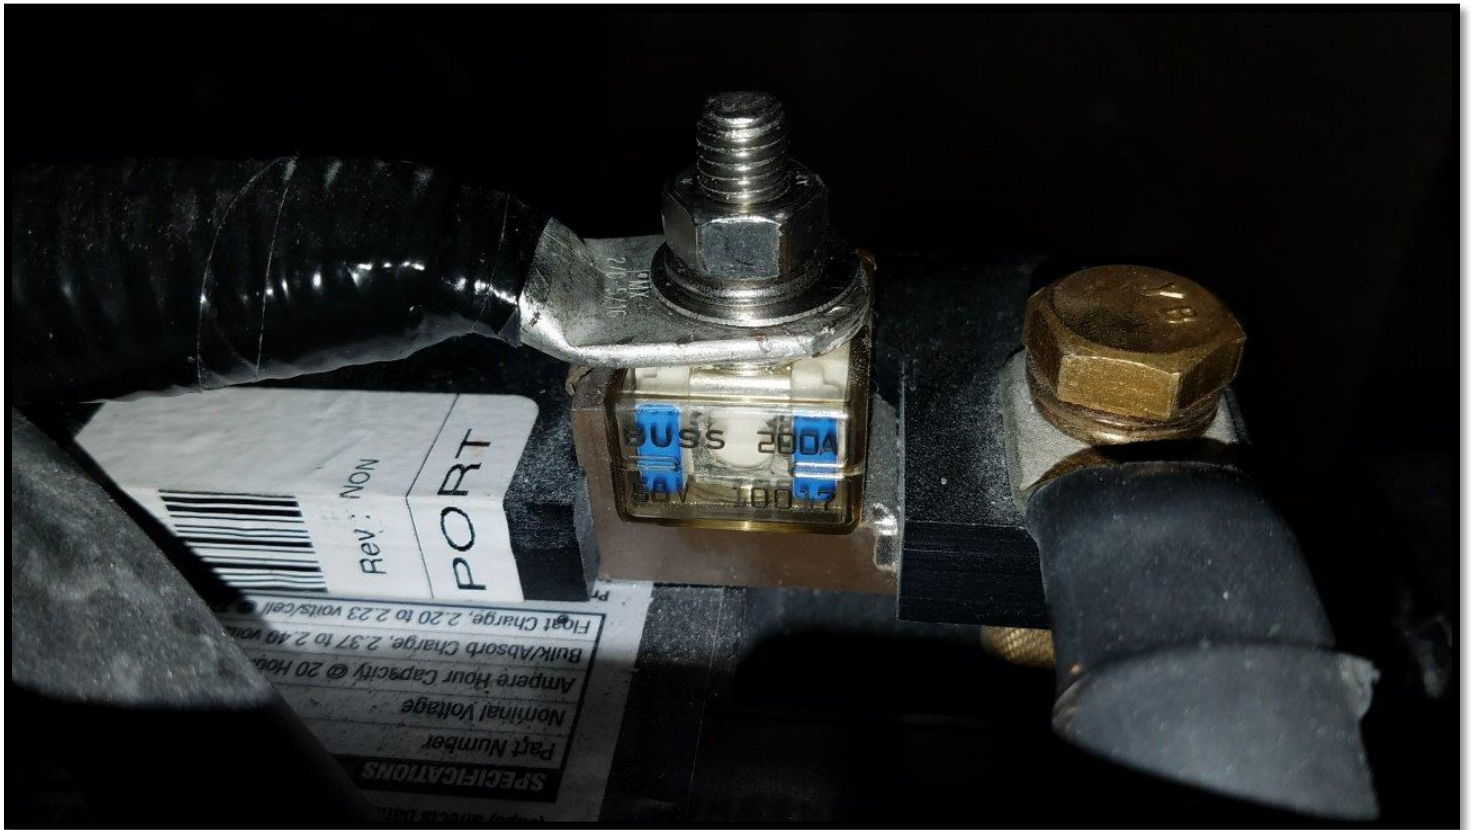
**Step 4:** Replace the 150 amp fuse with the 200 amp fuse (**Part # 512660-200**) and re-attach the battery cable and nut. The torque rating for this nut is 75 inch lbs.
