## Low Tire Pressure/TPMS Indicator On After Recent Tire Replacement?

### AFFECTED VEHICLES

2014–16 CR-V

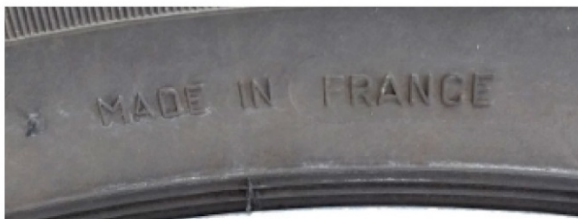
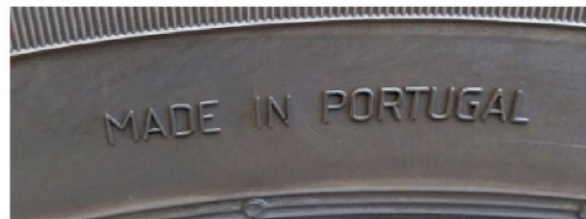
#### Manufacturing Location:

If you get a vehicle coming in because the Low Tire Pressure/TPMS indicator is on after a recent tire replacement, the issue could be a mismatched tire. One of the original equipment tires (DOT ID **CN5L**) are the Continental CrossContact™ LX, size 225/65R17. Made in France, they have a **1-ply** sidewall construction.

Those tires have been discontinued and are now made in Portugal. The Portuguese-made tires (DOT ID **AF5L**) have a **2-ply** sidewall construction.

France

Portugal

The online owner's manual recommends replacing all four tires at the same time. But if that's not practical, the tires should be replaced as a pair (right and left front tires, right and left rear tires).

If the mismatched tire happens to be a Portuguese-made tire, your customer will have to replace the opposite side of the set with another Portuguese-made tire since the French-made tires are no longer available.

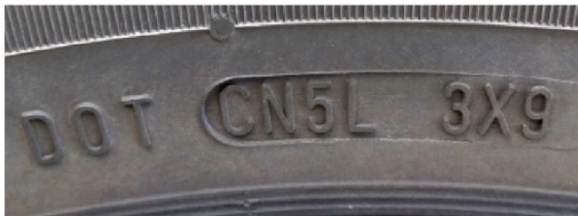
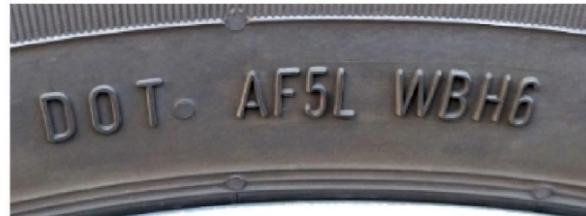
#### DOT ID:

"CN5L"

"AF5L"

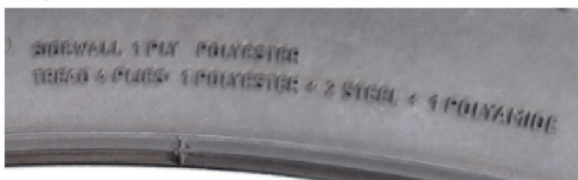
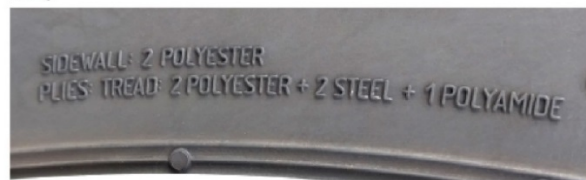
#### Ply Information

1 Ply

2 Ply

This difference in sidewall construction means the Portuguese-made tire has different rolling characteristics than the French-made tire. Because of the way indirect TPMS works, that difference will cause the Low Tire Pressure/TPMS indicator to come on.
