SUBJECT:

HEAD UNIT MISMATCH WITH MICROPHONE

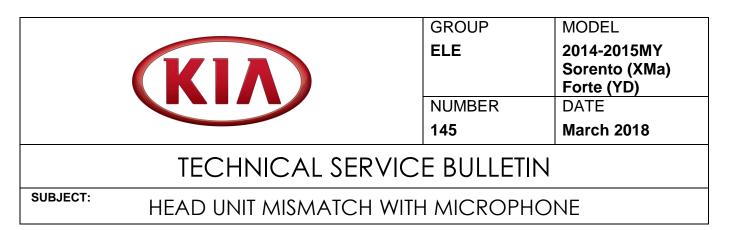
The difference in the microphone's operating voltage can be identified by the outer appearance of the microphone. (Note: Both 3.3 Volt and 8 Volt head units may have an identical appearance.) <u>Identify the microphone type to order the proper head unit</u> through Direct Exchange when this concern occurs, using the information below.

The Hands Free Microphone (MIC) is located on the front driver side of the roof headliner. NOTE: The 3.3V MIC has a <u>linear or dotted</u> style screen and the 8V MIC has a <u>mesh</u> style screen. Determine the vehicle equipped MIC and reference the table on the following page for head unit exchange part number needed.
