Technical Service Bulletin

17 Leaking rear muffler

17 18 90 2050501/1 February 22, 2018.

Model(s)	Year	VIN Range	Vehicle-Specific Equipment
A3	2016 - 2018	All	1.4 L TFSI

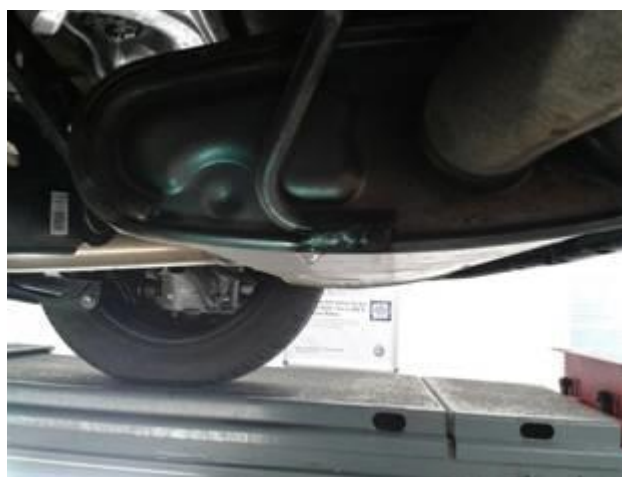
Condensed water leaks near rear axle (Figure 1). On the fold of the rear muffler condensed water leaks or there are soot marks or minor exhaust gas discharge (Figure 2).

Figure 1. Condensed water.

1. Drill a 3 mm hole (Figure 3, A) on the rear muffler on the left. This prevents condensed water from accumulating.

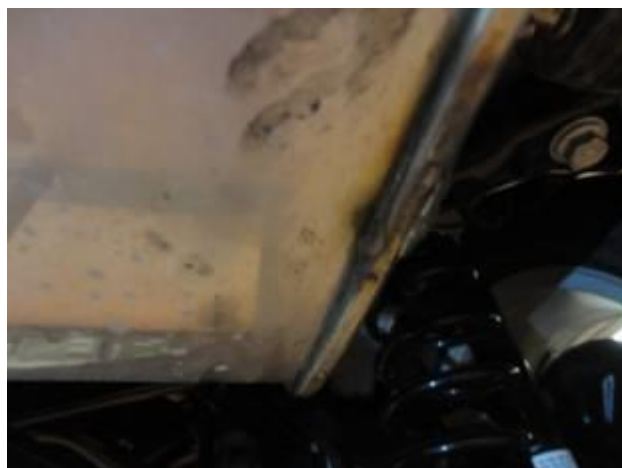
Figure 2. Soot marks.

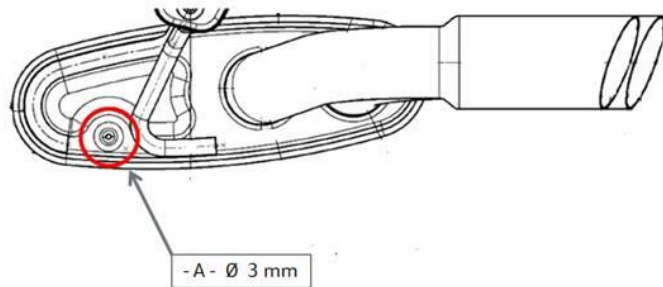
Figure 3. 3mm hole on the rear silencer.
