Technical Service Bulletin

34 Oil loss via breather line on gearbox

34 18 28 2049944/1 February 7, 2018.

Model(s)	Year	VIN Range	Vehicle-Specific Equipment
R8	2017 - 2018	All	Not Applicable

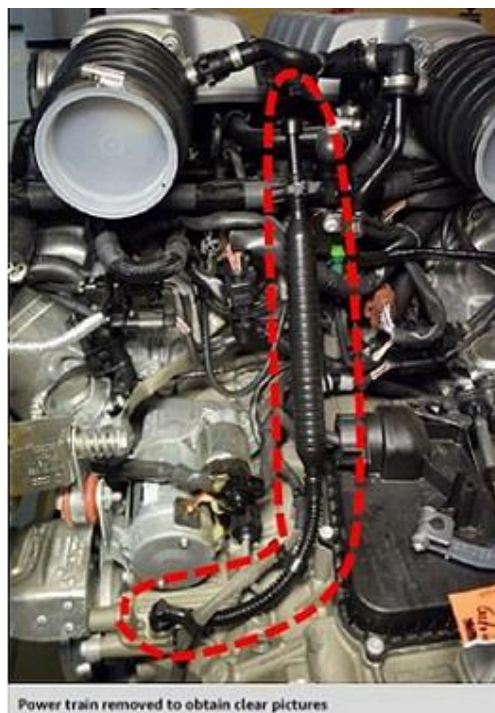
Figure 1. Original transmission vent tube.

The original transmission vent tube is routed from the drivers' side of the transmission behind the starter to the back of the engine ending in-between the throttle bodies (Figure 1).

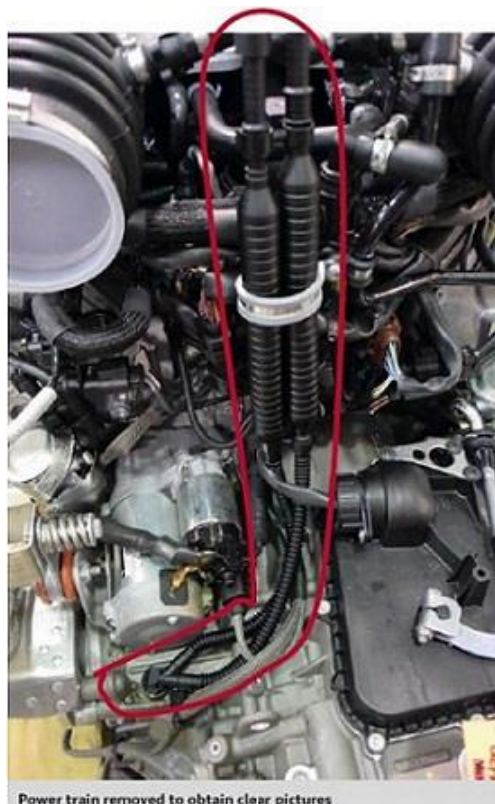
Figure 2. New transmission vent tube.

The new twin tube design will be installed in the same location but it is secured slightly different (Figure 2).

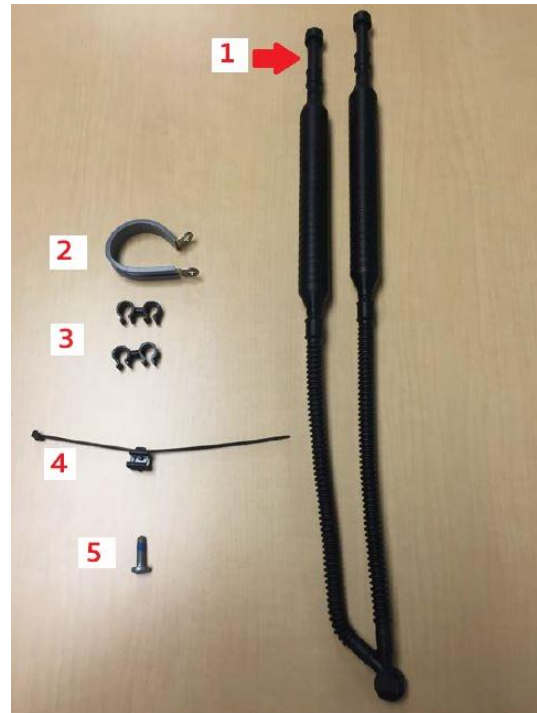
Figure 3. Required parts.

Parts required for this update (Figure 3):

1. Updated Double Vent Tube 0BZ 301 469 A
2. Clamp N 101 029 03
3. 2x Hose holder N 103 150 02
4. WHT 001 999
5. Bolt N 910 696 01

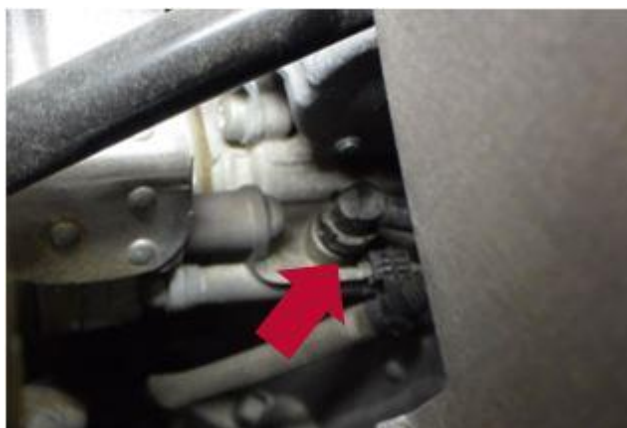
Figure 7. Transmission vent hose connection.

3. The vent hose connection at the gearbox is just underneath the front of the engine oil tank behind the starter (Figure 7).
