Title (customer effect) REQUEST REGEN Button Missing From EATS Status and DPF Status Screens In Instrument Cluster (IC) - Chassis Equipped With New (Updated) Cluster Design - **Model Year 2018 And Newer**

Cause Model year 2018 (Generation 2) Chassis may not display the REQUEST REGEN button on the EATS Status and DPF Status screens in the instrument cluster. This may occur following a software update.

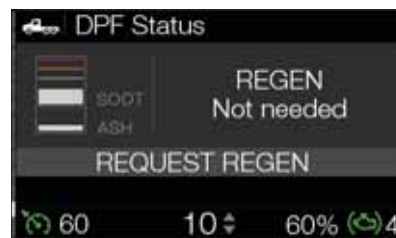
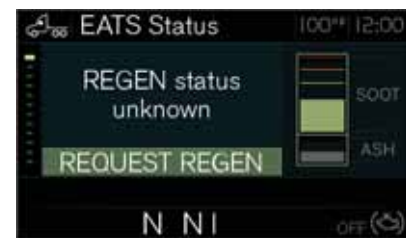
Previously, the REQUEST REGEN button was located at the bottom of the screen on both the EATS Status and DPF Status menus as shown below:

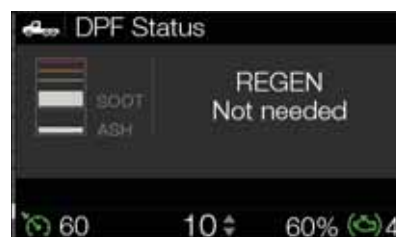
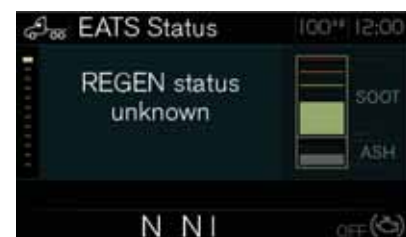
Following the update, the option to request a Parked Regen is no longer present directly on the Status screens:

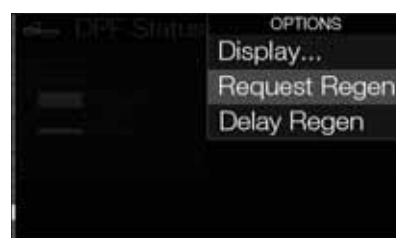
Inactive. Vehicle in motion or regen not needed

Request Regen is now included in the OPTIONS menu off of each of these screens as seen below. The function can only be selected if a parked regeneration is required, and is locked out if the unit is not stationary.

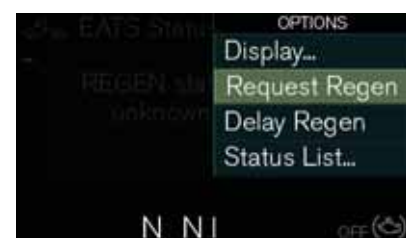
Active. Button can be pressed
