DOC #	PROCESS NAME	PAGE	REVISION	STATION	BY	DATE
AR855	SOF Brake Hose Routing	1 OF 1		SER-E	C. Ward	3/20/2018

Complaint: Park brake hose rubbing against jounce bumper bracket located on rear axle

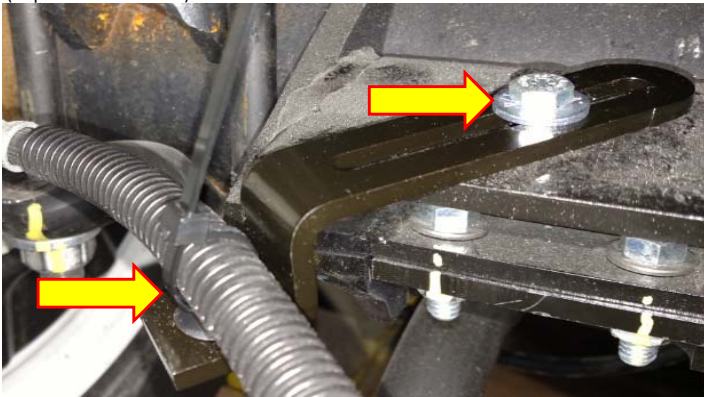
Cause: Unknown OEM design changes

Step 3: Secure bracket into existing hole in top side of jounce bumper bracket and use cable tie strap to secure brake hose for adequate routing clearance.

(Repeat on both sides)
