SI M24 01 18
Automatic Transmission

AISIN AUTOMATIC TRANSMISSION: RIGHT SIDE OUTPUT SHAFT SEAL REPLACEMENT

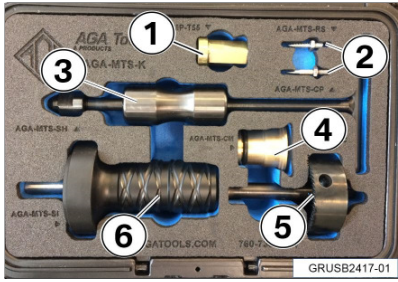
The attached updated repair procedure incorporates the use of the newly available Repair kit (seal removal and installation tool), part number **83 30 2 452 307**, that is shown below.

<p>Repair (tool) kit contents:</p> <ol style="list-style-type: none"> 1. Plug socket for topping up the transmission fluid 2. Pierce pin and screw tip 3. T-Handle Side Hammer for pulling the seal 4. Cutter Guide Bushing 5. Milling tool/cutter with arbor 6. Seal installer/seal driver <p>Refer to tool bulletin M04 01 18 or more information.</p>
---	---

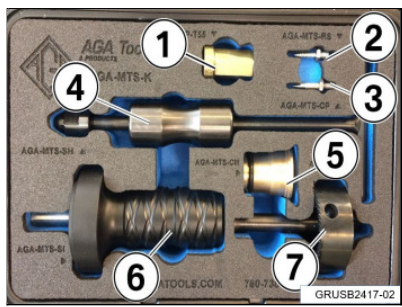
<table><tr> <td>1</td> <td>AGA-MTS-TX55</td> <td>Plug Socket</td> </tr><tr> <td>2</td> <td>AGA-MTS-CP</td> <td>Pierce Pin</td> </tr><tr> <td>3</td> <td>AGA-MTS-RS</td> <td>Pulling Pin</td> </tr><tr> <td>4</td> <td>AGA-MTS-SH</td> <td>T-Handle Side Hammer</td> </tr><tr> <td>5</td> <td>AGA-MTS-CM</td> <td>Cutter Guide Bushing</td> </tr><tr> <td>6</td> <td>AGA-MTS-SI</td> <td>Seal Driver</td> </tr><tr> <td>7</td> <td>AGA-MTS-BC</td> <td>Cutter with Arbor</td> </tr></table>

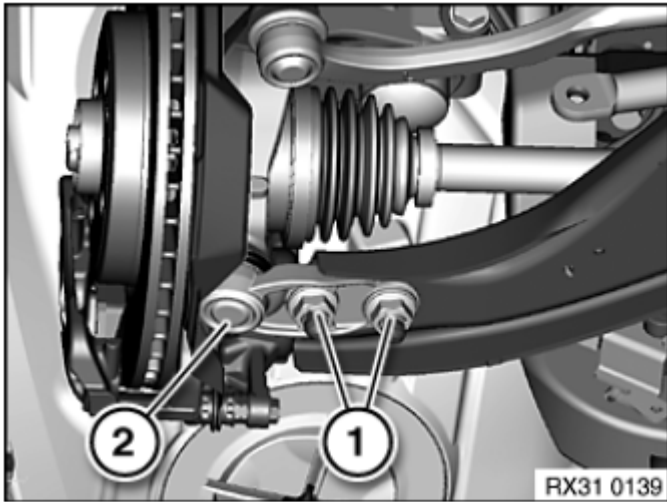
Unscrew the nuts (1) on the right front wheel guide joint (2).

Replace the nuts (1)

Tightening torque:

Replace the nuts.

Joining torque: 50 Nm

Angle of rotation: 90°

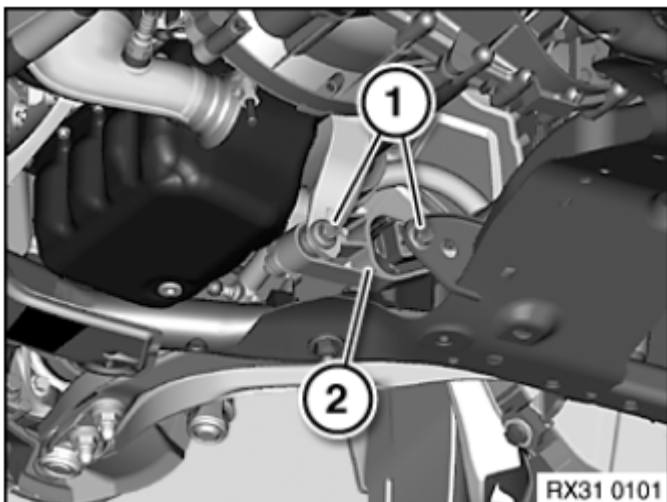
Release the screws (1) and remove the anti-roll bar link (2).

Tightening torque:

Torque: 108 Nm

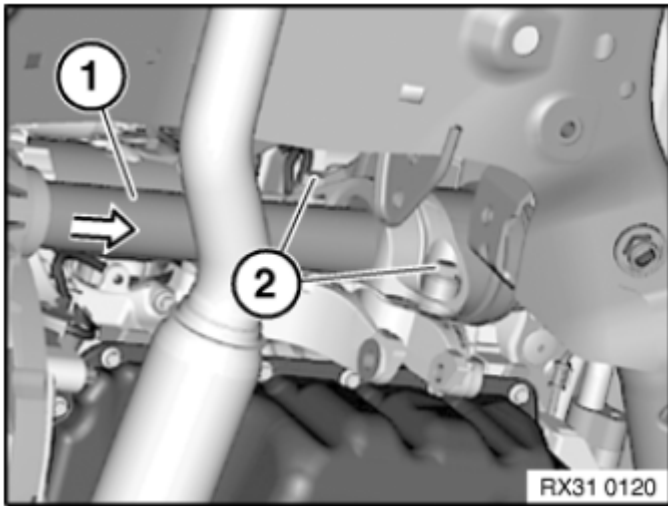
Loosen the screws for the bearing support (2).

Tightening torque:

Torque: 38 Nm

Lever the output shaft (1) out of the transmission and hang it to the side.

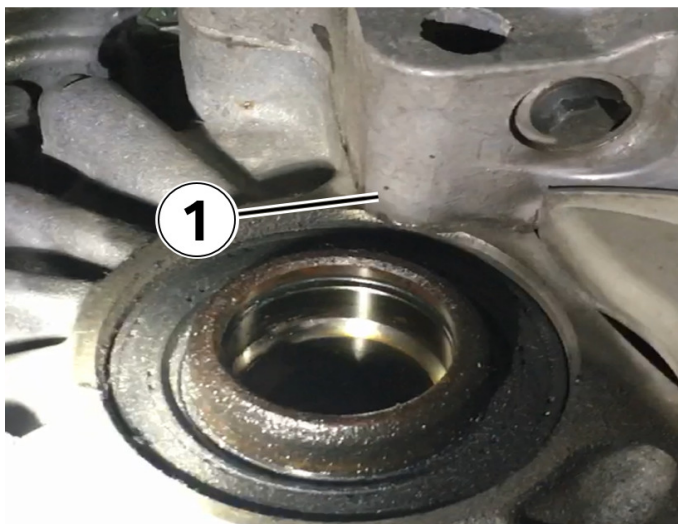
The engine crankcase material overlaps (1) with the output shaft seal.

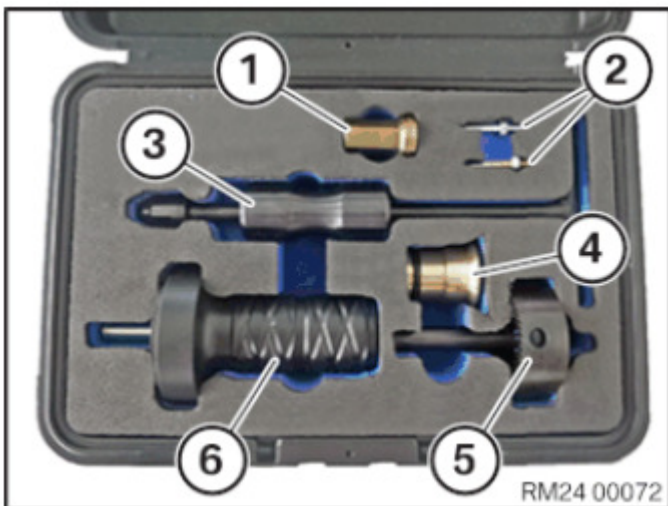
To replace the radial shaft seal, special tool 2 452 307 (shaft seal repair kit) will be needed to remove the overlapping material of the engine crankcase.

Tool kit contents:

- (1) Plug socket for topping up the transmission fluid
- (2) Centre punch and screw tip
- (3) Seal puller
- (4) Guide sleeve
- (5) Milling tool
- (6) Seal installer

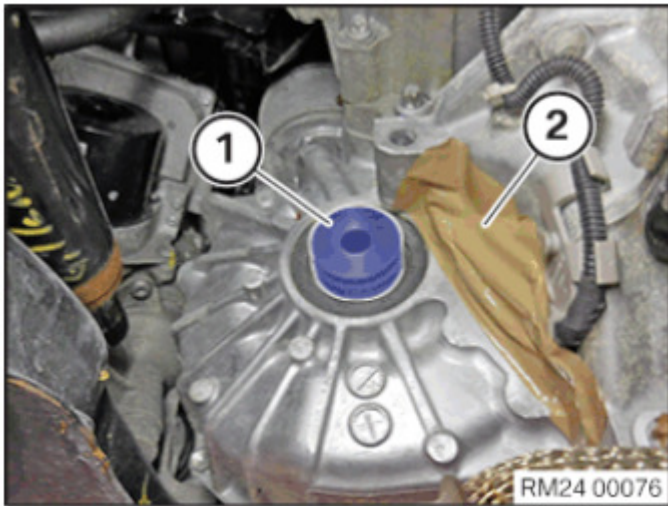
Mask off the opening to the transmission bell housing with adhesive tape (2).

Install the guide sleeve (1) for the milling tool.

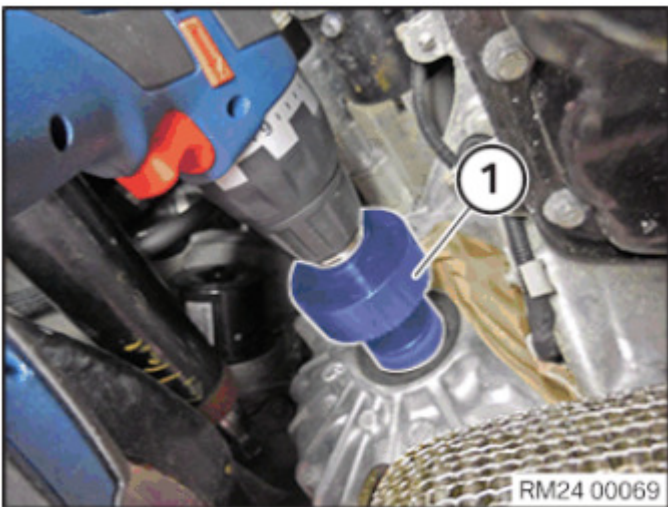
Install the milling tool into a cordless drill with an adjustable clutch.

Adjust the clutch for safety.

Cut the overlapping crankcase material with the milling tool (1).

When complete remove the chips and clean the area surrounding the transmission.

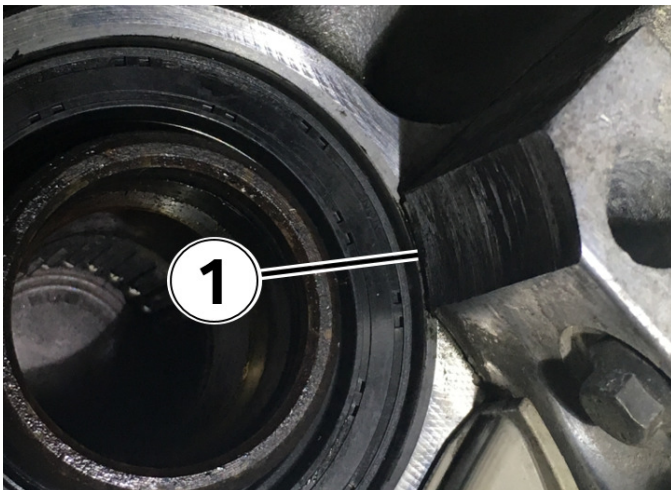
When complete the crankcase material (1) will have been milled away by approximately 3.5 mm.

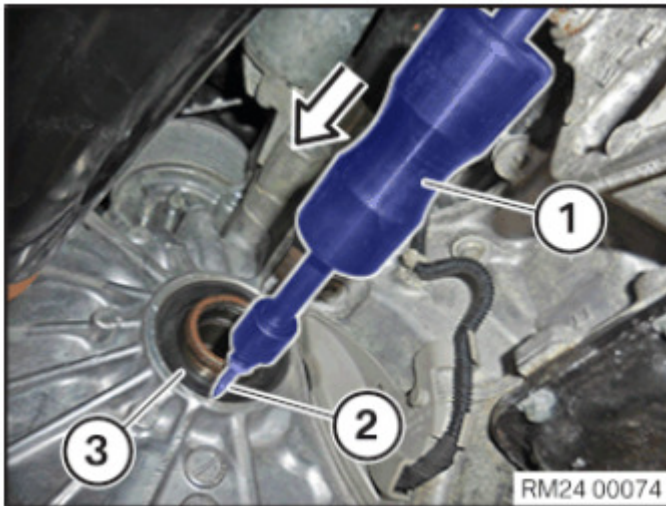
Use the screw-in center punch (2) and the seal puller (1).

Use the weight of the seal puller (1) to create a hole in the radial shaft seal (3).

Do not use a drill, debris lost in the transmission may result in a transmission malfunction.

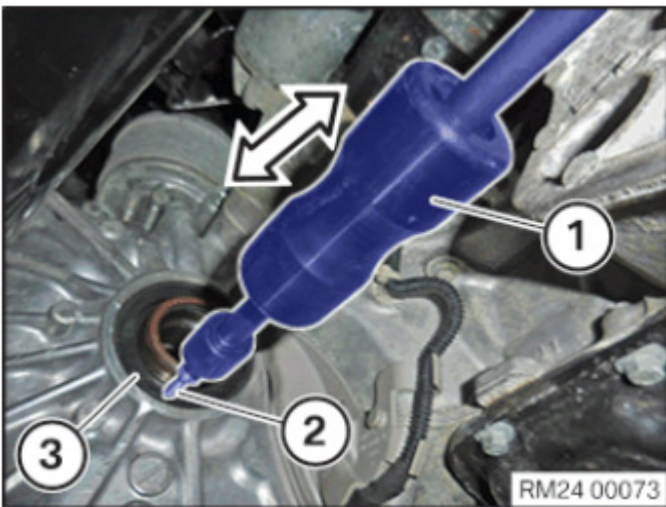
Use the seal puller (1) with the screw-in tip (2)

Rotate the tool tip clockwise into the radial shaft seal hole (3).

Pull the radial shaft seal (2) out with the impact weight of the puller (1).

Clean the sealing surface once removed.

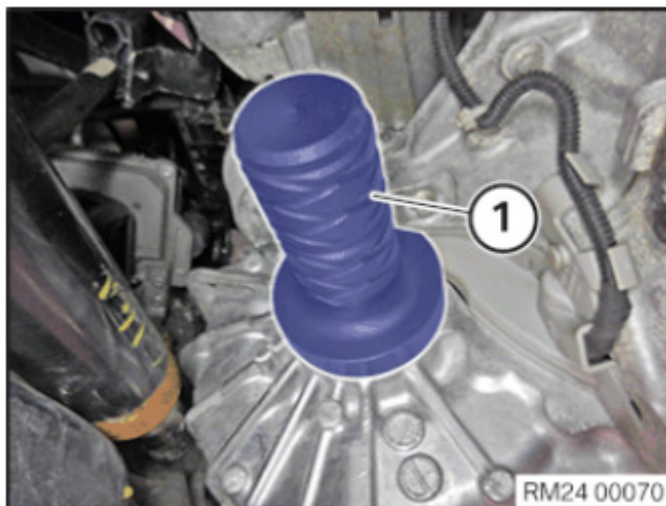
Coat sealing lips of new radial shaft seal with clean transmission oil.

Drive the radial shaft seal into the transmission with the seal installer (1) and a suitable hammer.
