**April 16, 2018**

Version 1

## Clicking from the Driver's Power Seat While Using the Height or Tilt Adjustment

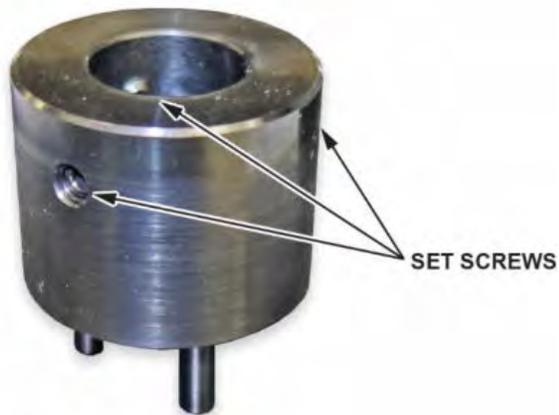
1. Make sure the set screws are installed on the meshing tool. If they are not installed, install them without passing through the inner cutout of the tool.

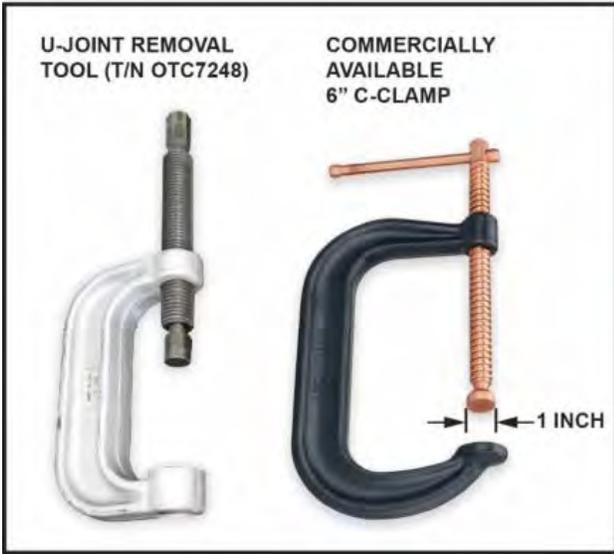
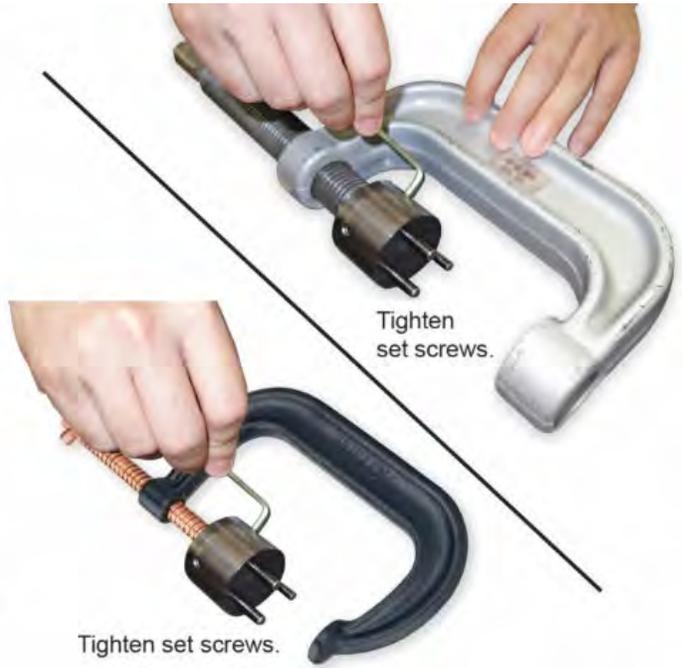
2. Install the meshing tool onto the U-Joint Removal Tool (T/N OTC7248) or universal 6-inch C-clamp. Hand tighten the set screws with a hex tool.

If you are using a 6-inch C-clamp, the foot of the C-Clamp must be 1-inch in diameter for the meshing tool to fit correctly.

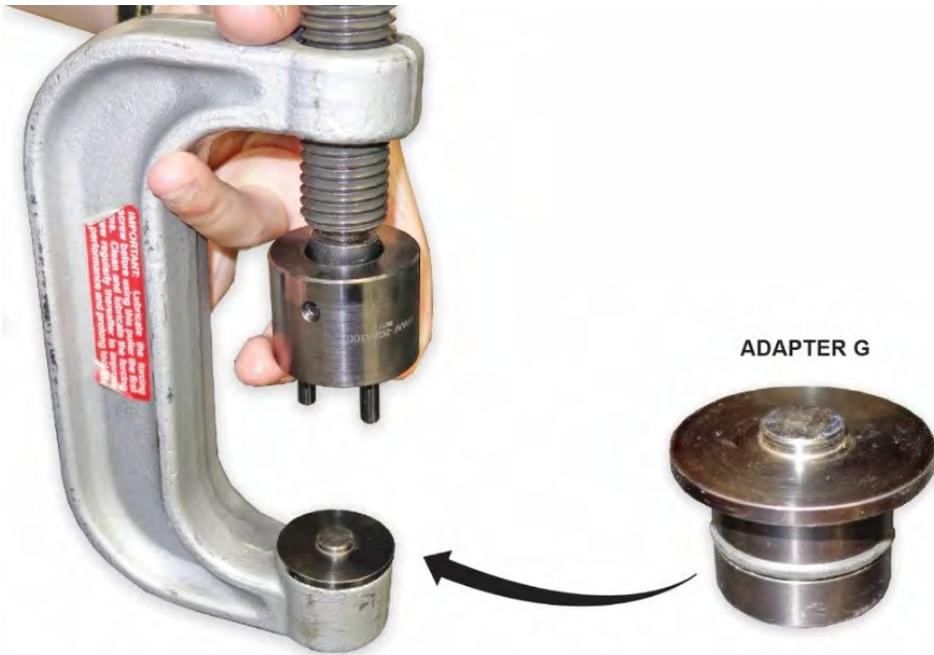
3. If you are using the U-Joint Removal Tool (T/N OTC7248), install Adaptor G (T/N 07XAF-001050B).

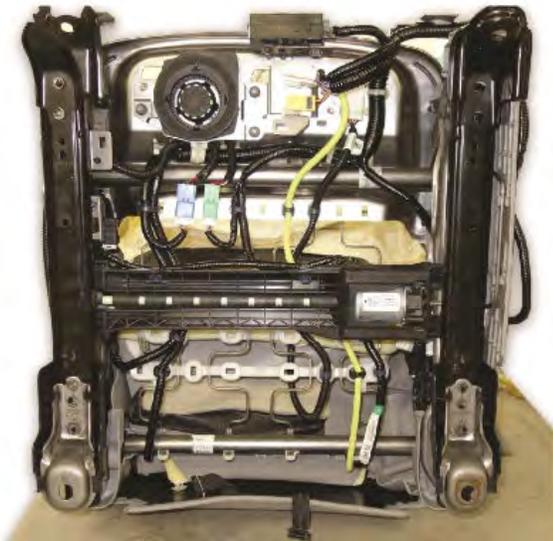
*Bottom of seat:*

- Do not remove the cushion cover from the foam pad. Remove both parts as an assembly.
- For reference during assembly, take a photo of the harness routing and clip location layout as shown.
- Ventilated seat is shown. It may differ slightly from the seat you are repairing.

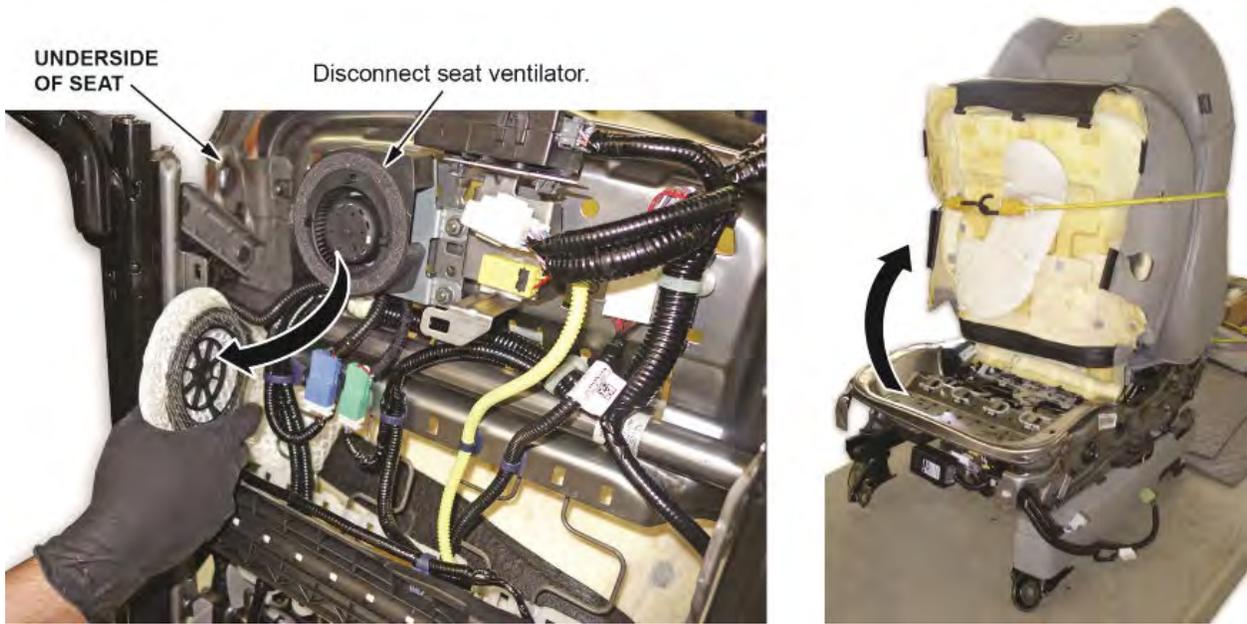
5. Remove the seat ventilator from seat bottom (if equipped).

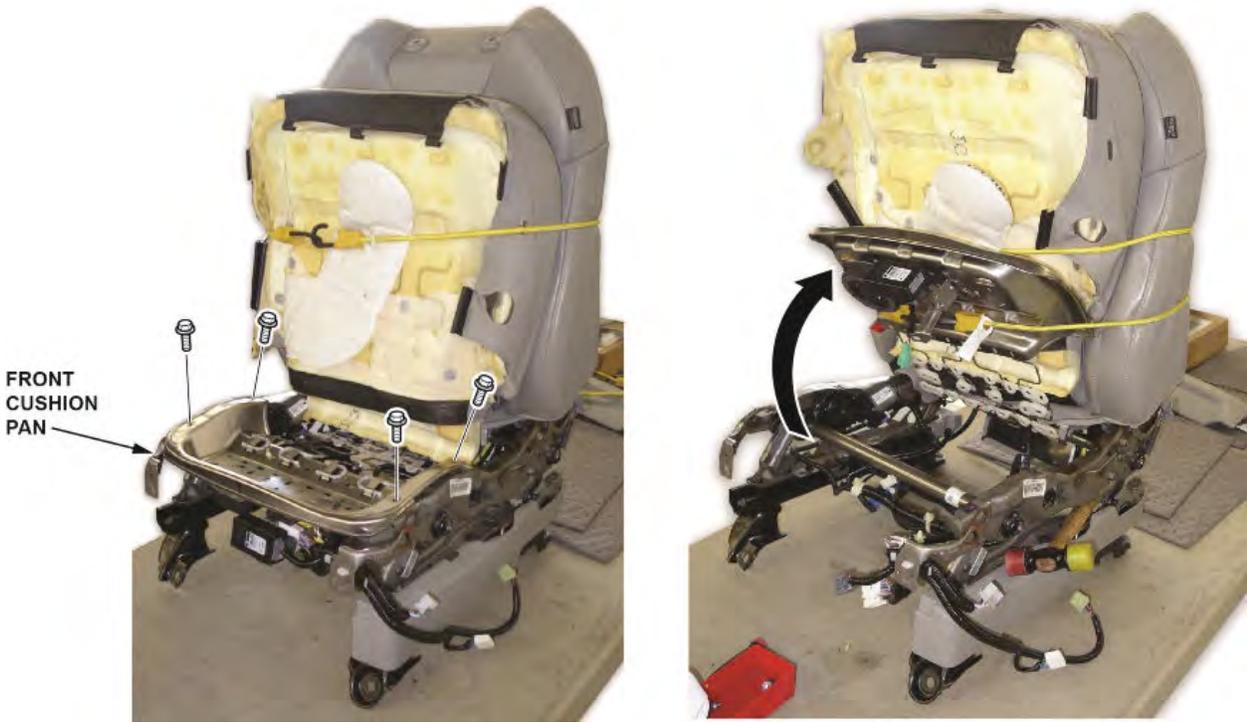
7. Remove the four 10 mm bolts from the front cushion pan.

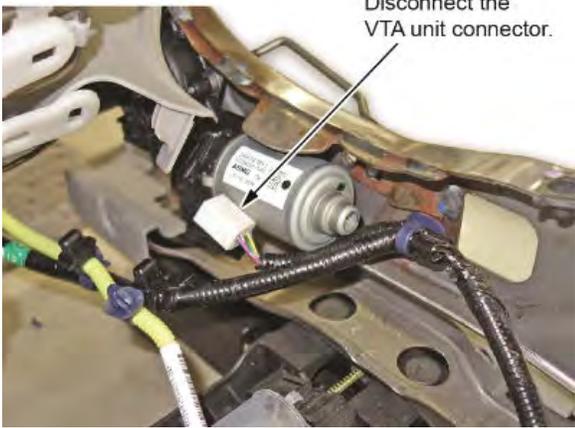
- Lift the cushion pan, and hold it up with a bungee cord or set the seat on its back on a clean surface to keep the cushion pan out of the way.
- Disconnect the VTA unit connector.

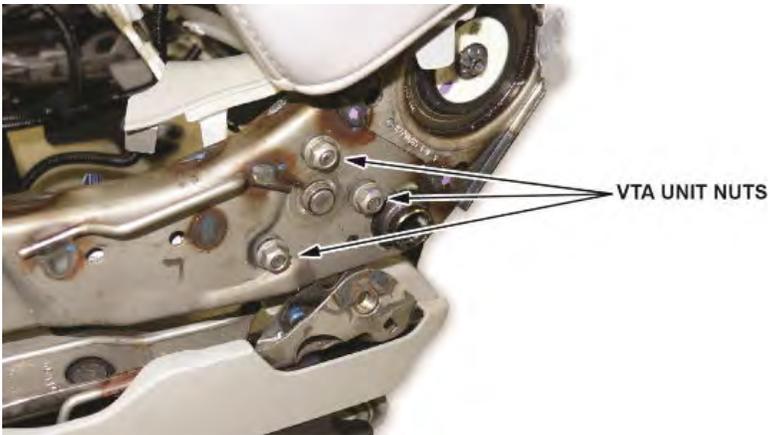
- Remove the VTA unit nuts, then remove the VTA unit.

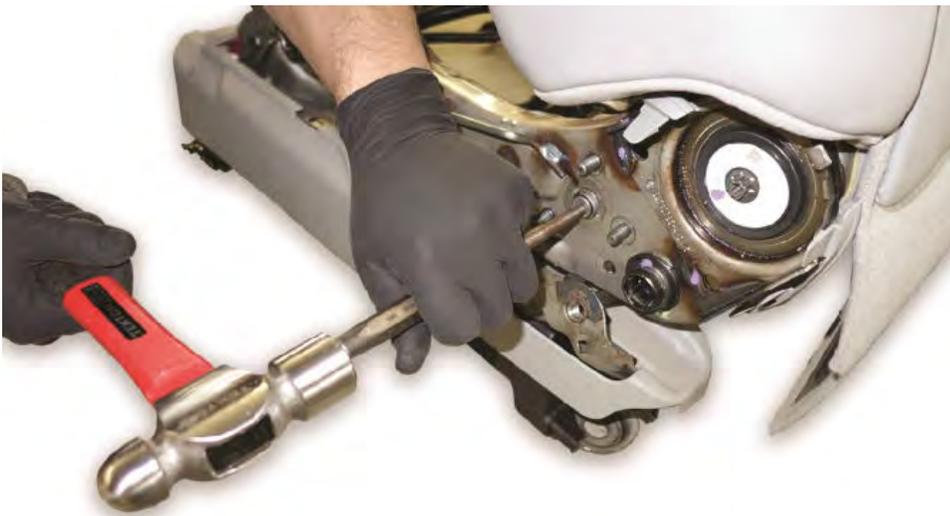
11. Raise the seat as much as possible by pulling the seat frame as shown. This allows easier meshing of the gear teeth when installing the new VTA motor.

- If the seat frame is too low and you cannot access the VTA unit nut, use an open end wrench.
- If it is difficult to remove the VTA unit after removing the nuts, hit the center shaft of the VTA unit with a punch tool and hammer to remove it.

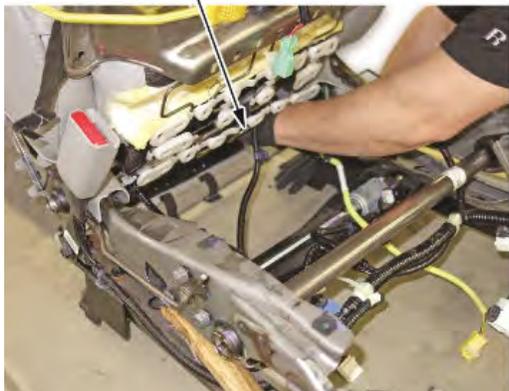
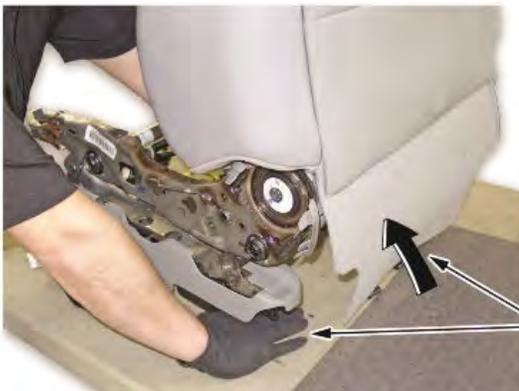
The photo below shows how the seat should look after it is raised.

Grasp the seat frame.

Pull upward while holding the base down.

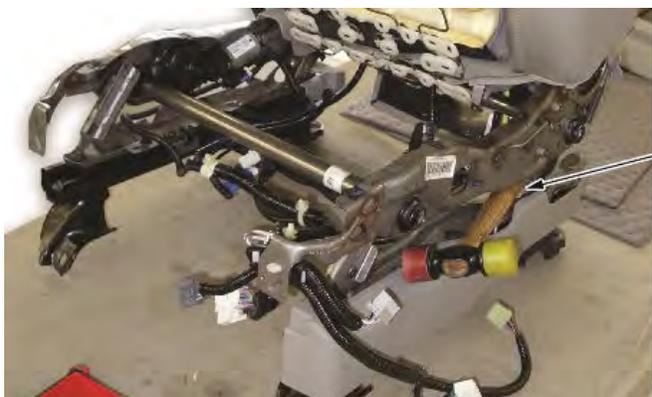
Place a hammer handle (or similar tool) between the upper and lower sections of the seat frame to prevent the rear of the frame from collapsing and pinching fingers. Remove the blocking hammer **ONLY** when you have installed and aligned the new VTA motor.

Prop open the gap between the upper and lower frame sections.

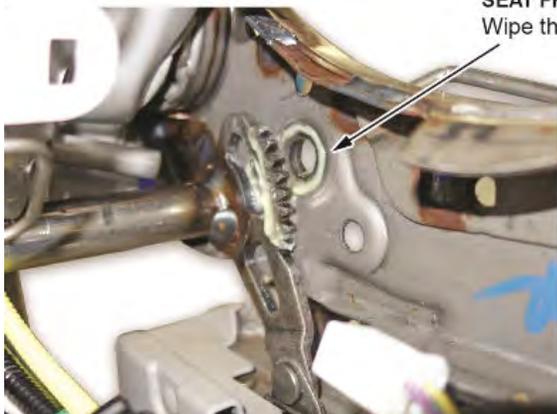
**SEAT FRAME GEAR**  
Wipe this area.

12. Wipe off any excess grease from the seat frame gear teeth with a paper towel or clean rag.

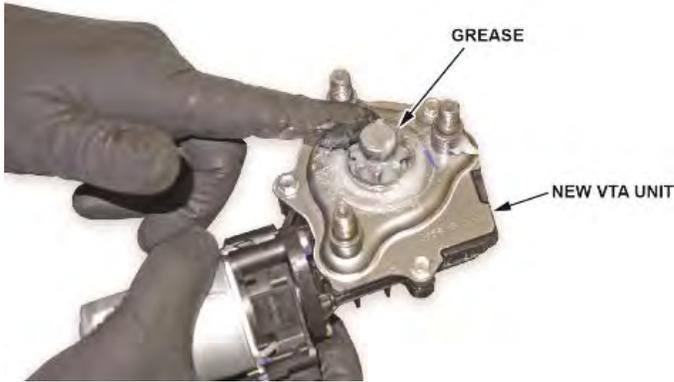
13. Apply the provided grease to the new VTA unit motor splines.

Only 1/8<sup>th</sup> of the grease packet is needed. Do not use the whole packet.

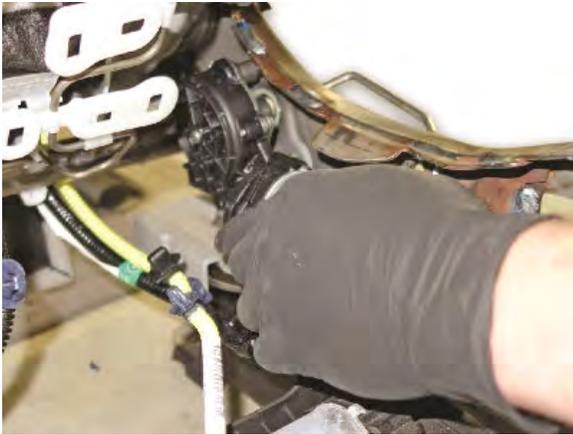
14. Mount the new VTA unit onto the seat frame.

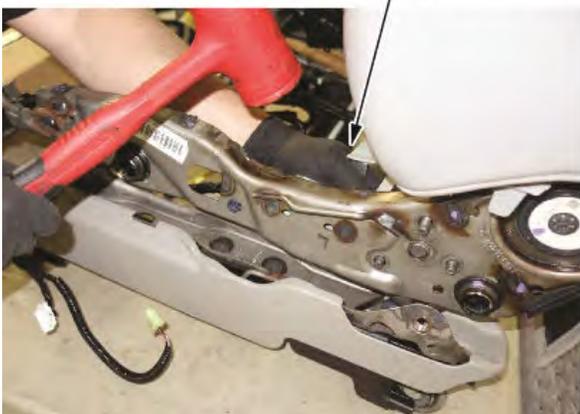
15. While applying pressure to keep the VTA unit against the seat frame, use a rubber mallet or plastic hammer to hit the frame downwards. This will allow the VTA unit splines to align and engage with the frame gear.

Press the VTA unit against the frame.

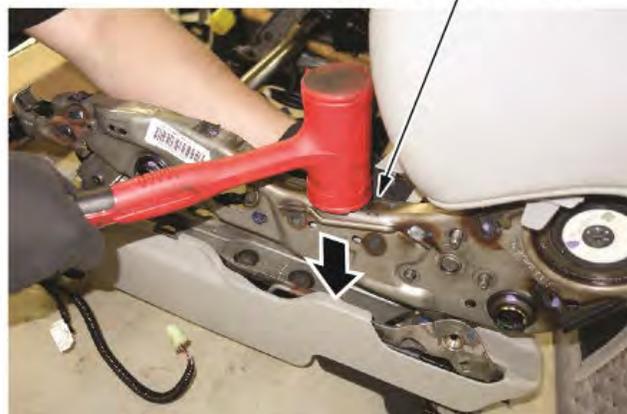
Hit the frame downward.

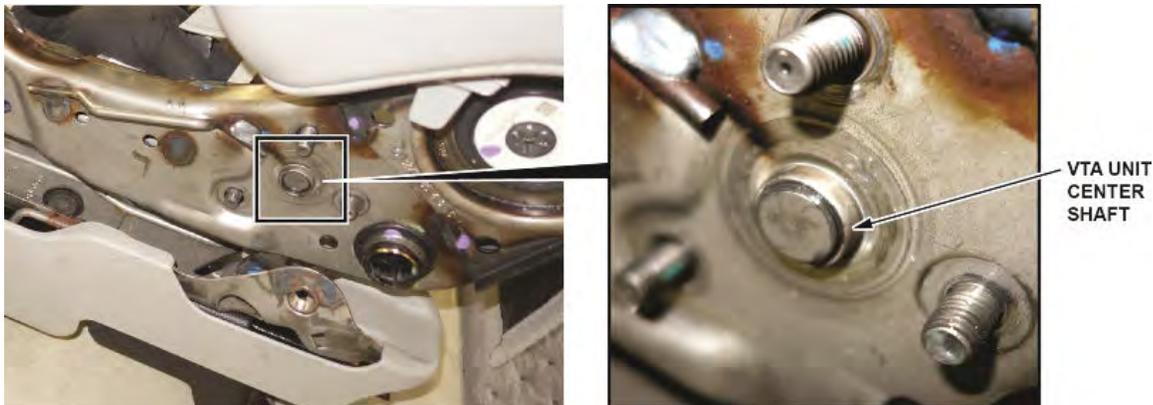
16. Make sure the VTA unit splines and seat frame gear are properly engaged. The VTA unit center shaft should be protruding from the frame.

- You may need to adjust or remove the blocking hammer handle if it is preventing proper gear engagement.
- Use caution as the seat will **NOT** be fully supported and may collapse or pinch fingers until the new VTA unit is secured to the seat frame.

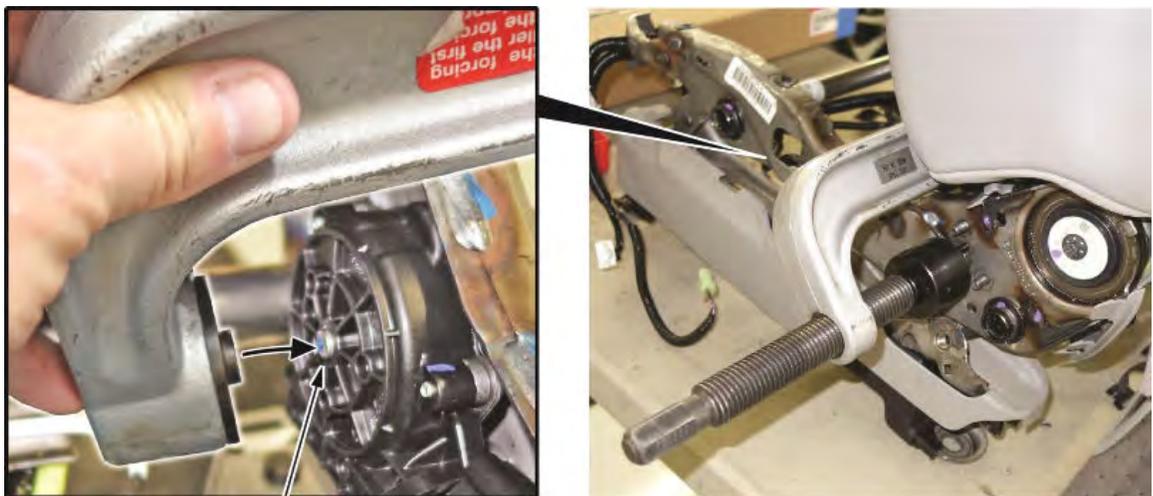
17. Place the meshing tool as shown. Center the tool on the pinion shaft protruding from the VTA unit.

- **DO NOT** over tighten the C-clamp.
- **DO NOT** attempt to install the VTA unit without using the meshing tool. Seating the VTA unit by tightening the nuts will damage the VTA unit.

Place the tool on the pinion shaft of the VTA unit.

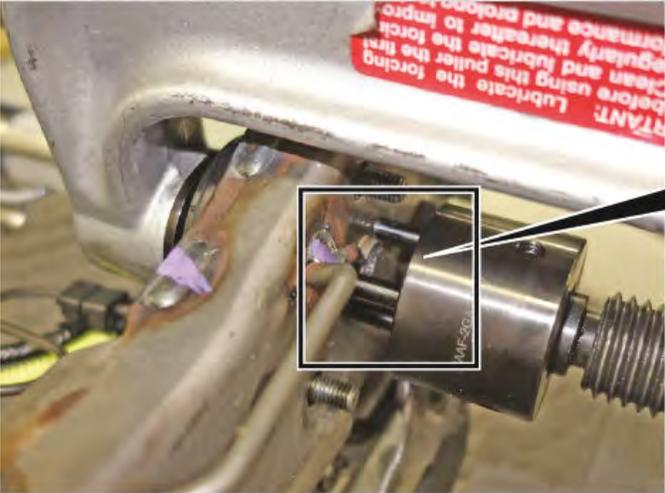
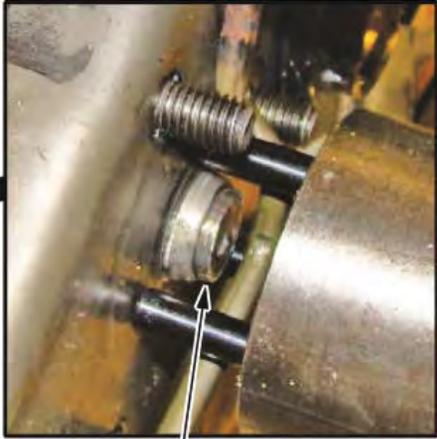
18. Gradually tighten the C-clamp until the VTA unit shaft is protruding out of the frame. Once the VTA unit shaft is protruding, go to the next step.

Tighten the tool until the VTA unit shaft protrudes.

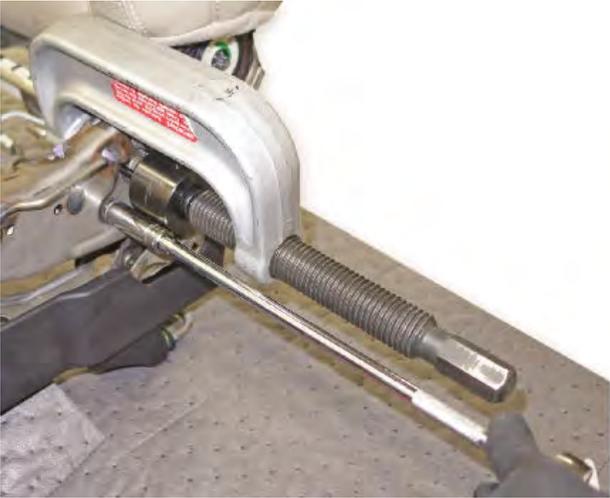
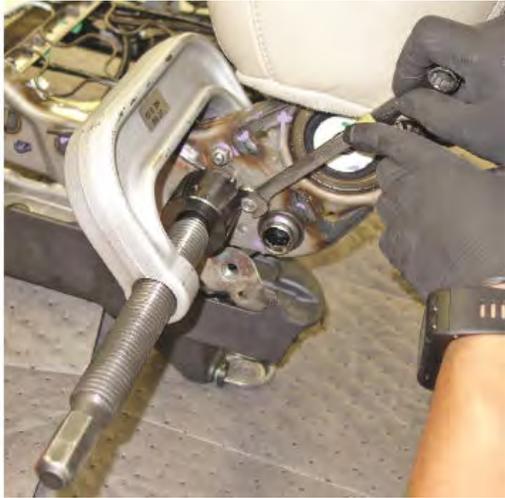
19. With the C-clamp still in place, install the new VTA unit nuts and snug them with a wrench.

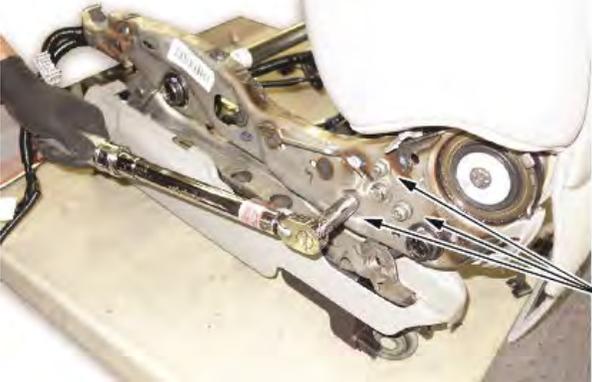
**VTA UNIT NUTS**  
25 N•m (18 lb-ft)

20. Remove the C-clamp, and torque the nuts to **25 N•m (18 lb-ft)**.

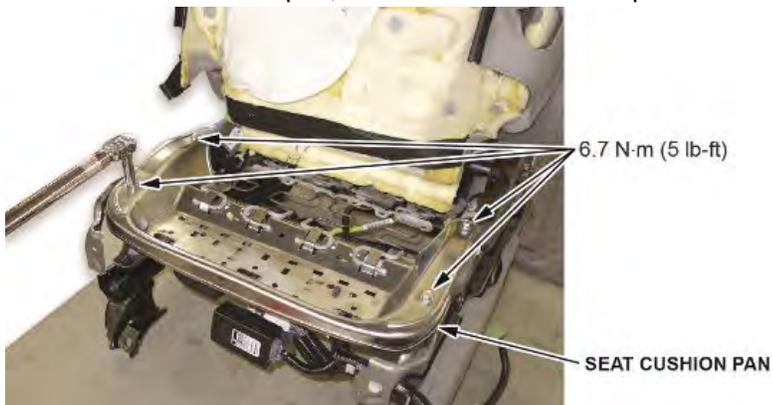
21. Make sure the VTA unit is supporting the seat's weight, then remove the blocking hammer or tool.
22. Connect the VTA unit connector.
23. Lower the seat cushion pan, and install the bolts. Torque the bolts to **6.7 N•m (5 lb-ft)**.

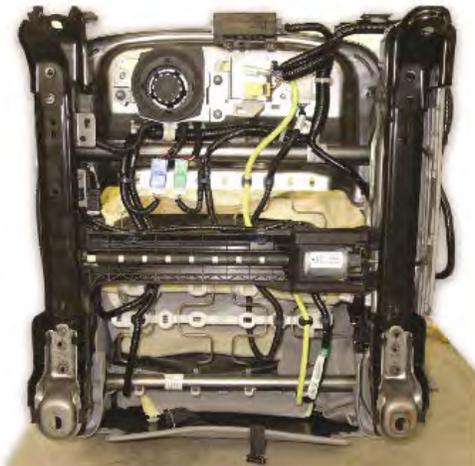
*Bottom of seat:*

- Do not remove the cushion cover from the foam pad. Remove both parts as an assembly.
- For reference during assembly, take a photo of the harness routing and clip location layout as shown.
- Ventilated seat is shown. It may differ slightly from the seat you are repairing.

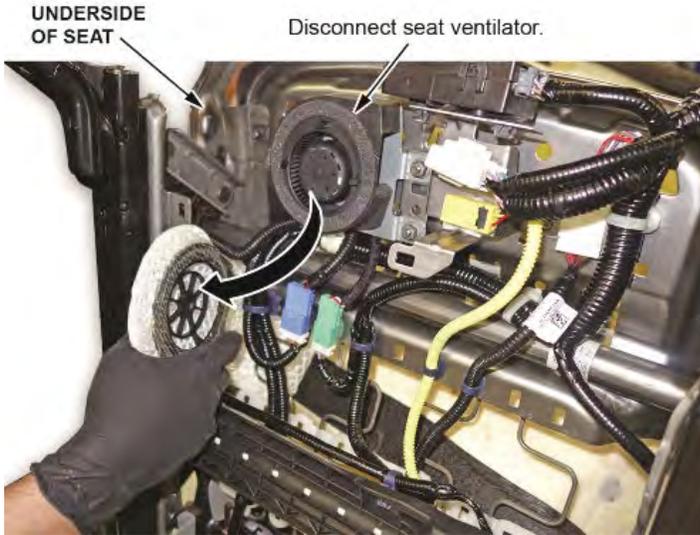
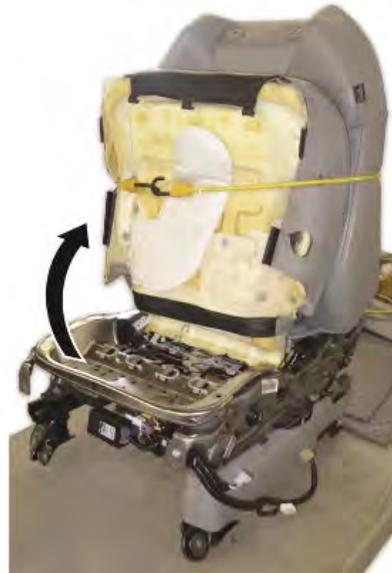
5. Remove the seat ventilator from the seat bottom (if equipped).

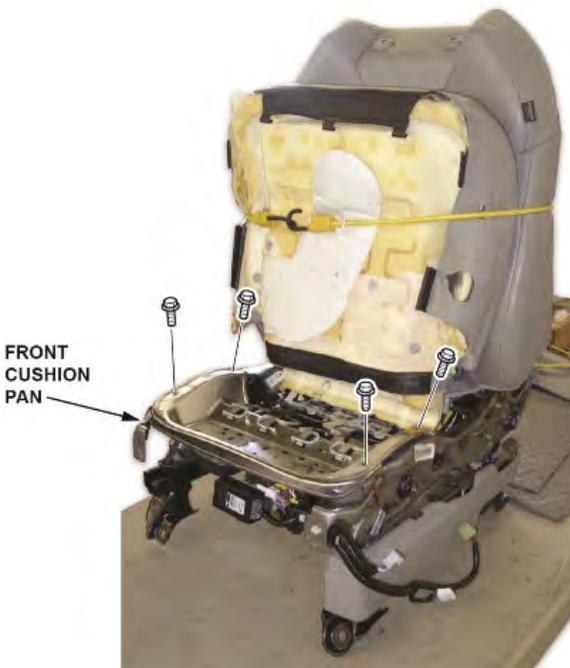
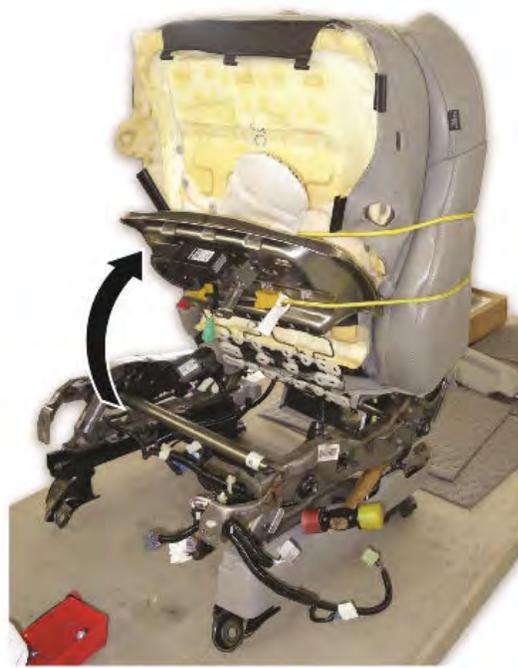
6. Remove any harnesses or harness clips that will prevent the removal of the cushion pan.
7. Remove the four 10 mm bolts from the front cushion pan.

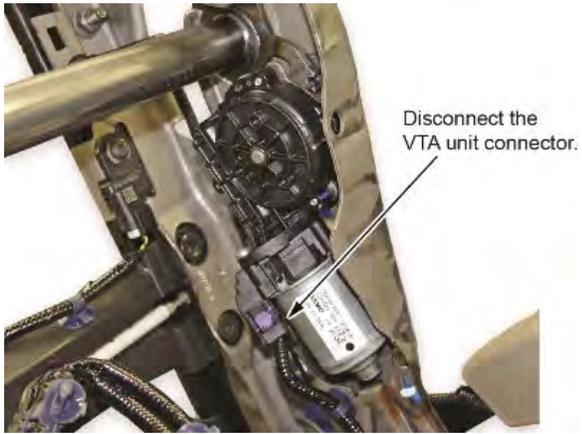
9. Disconnect the VTA unit connector.

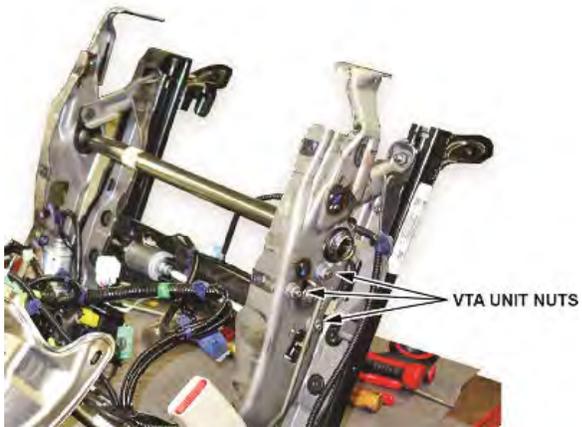
10. Remove the VTA unit nuts.

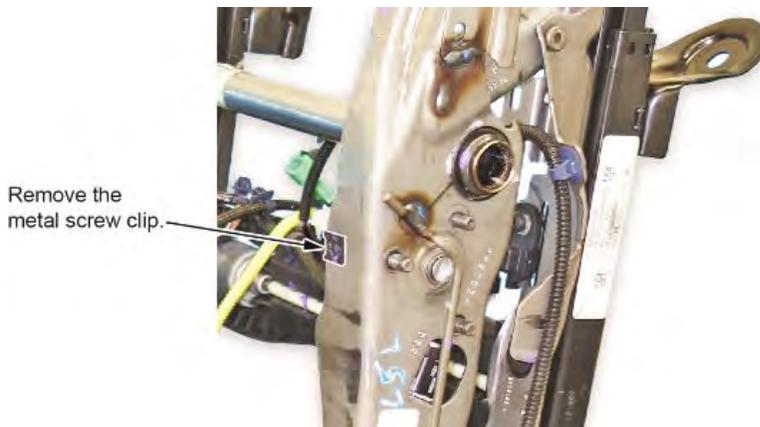
11. Remove the metal screw clip on top of the VTA unit with a clip removal tool.

Make sure you do not damage or lose the metal screw clip.

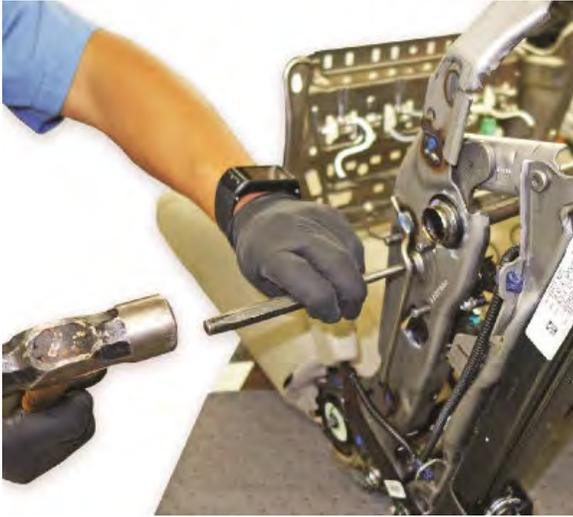
12. Remove the VTA unit.

If it is difficult to remove the VTA unit after removing the nuts, hit the center shaft of the VTA unit with a punch tool and hammer to remove it.

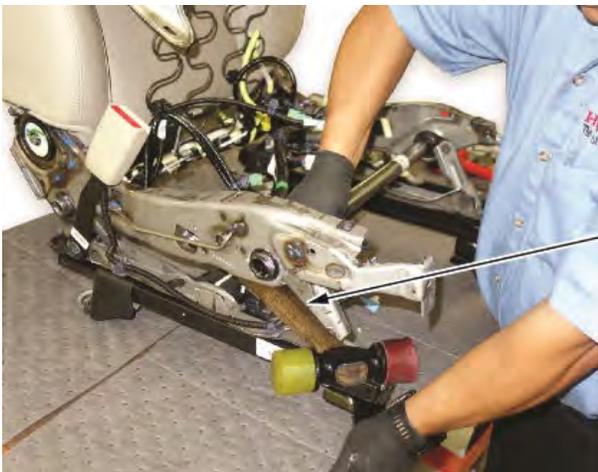
Place a hammer handle (or similar tool) between the upper and lower sections of the seat frame to prevent the rear of the frame from collapsing and pinching fingers. Remove the blocking hammer **ONLY** when you have installed and aligned the new VTA motor.

Prop open the gap between the upper and lower frame sections.

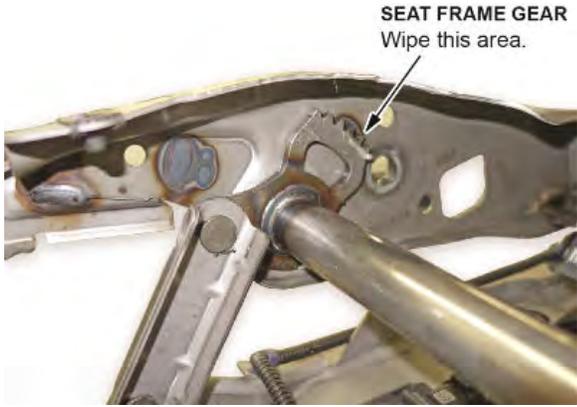
14. Wipe off any excess grease from the seat frame gear teeth with a paper towel or clean rag.

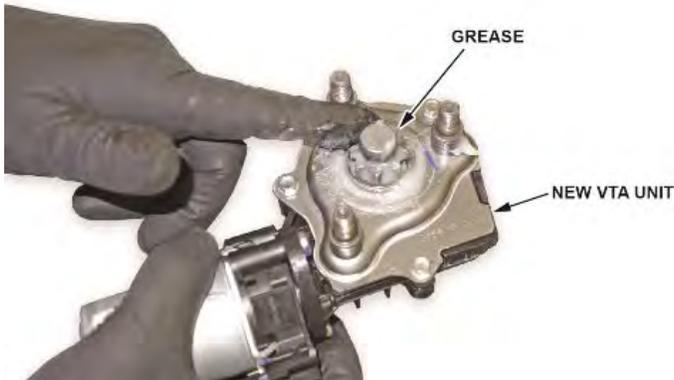
15. Apply the grease provided in the kit to the new VTA unit splines.

Only 1/8<sup>th</sup> of the grease packet is needed. Do not use the whole packet.

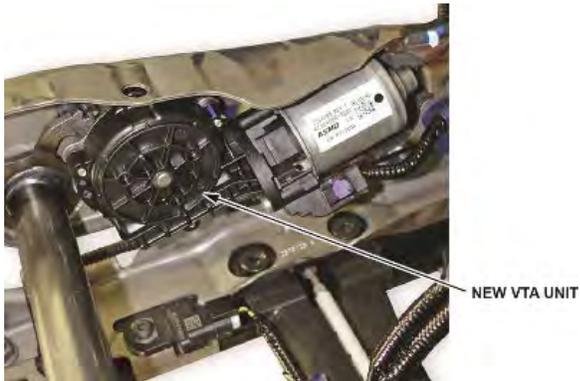
16. Mount the new VTA unit to the seat frame.

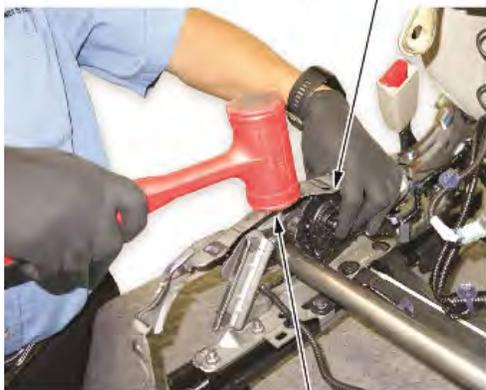
17. While applying pressure to keep the VTA unit against the seat frame, use a rubber mallet or plastic hammer to hit the frame downwards. This will allow the VTA unit splines to align and engage with the frame gear.

Press the VTA unit against the frame.

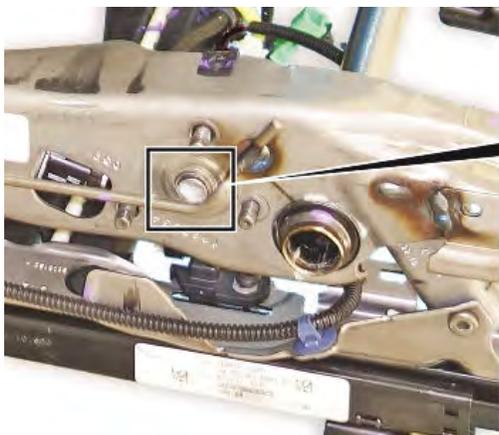
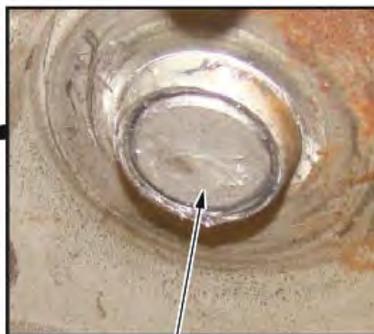
VTA UNIT  
CENTER SHAFT

18. Make sure the VTA unit splines and seat frame gear are properly engaged. The VTA unit center shaft should be protruding from the frame.

- You may need to adjust or remove the blocking hammer handle if it is preventing proper gear engagement.
- Use caution as the seat will **NOT** be fully supported and may collapse or pinch fingers until the new VTA unit is secured to the seat frame.

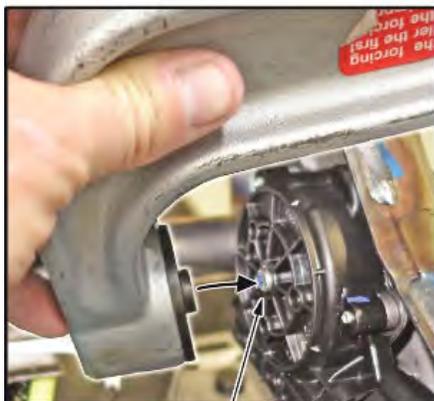
19. Place the meshing tool as shown. Center the tool on the pinion shaft protruding from the VTA unit.

Place the tool on the pinion shaft of the VTA unit.

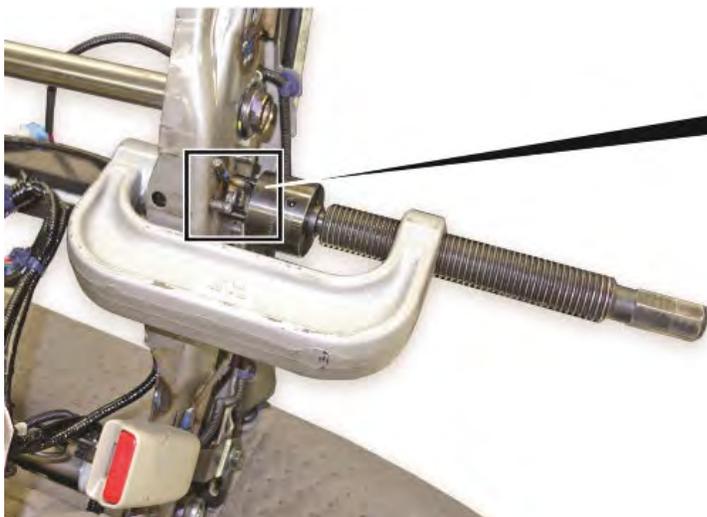
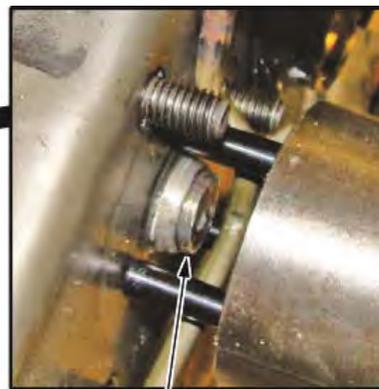
20. Gradually tighten the C-clamp until the VTA unit shaft is protruding from the frame. Once the VTA unit shaft is protruding, go to the next step.

Tighten the tool until the VTA unit shaft protrudes.

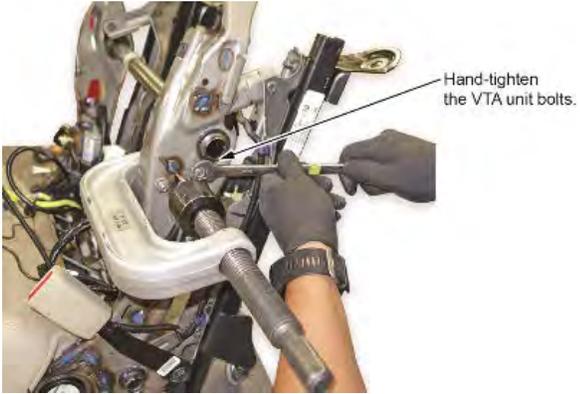
21. With the C-clamp still in place, install the new VTA unit nuts and snug them with a wrench.

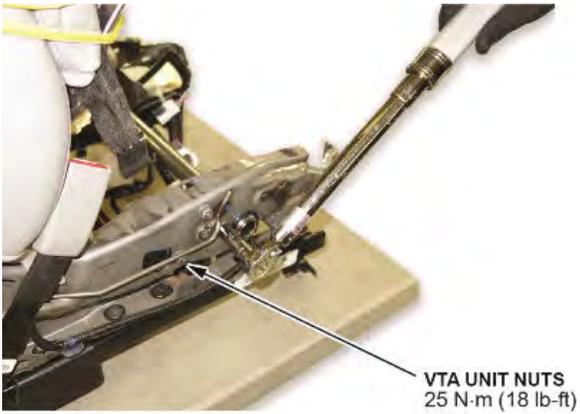
22. Remove the C-clamp, and torque the nuts to **25 N•m (18 lb-ft)**.

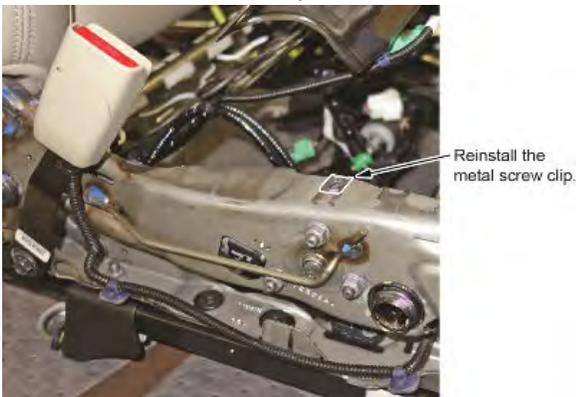
23. Install the metal screw clip.

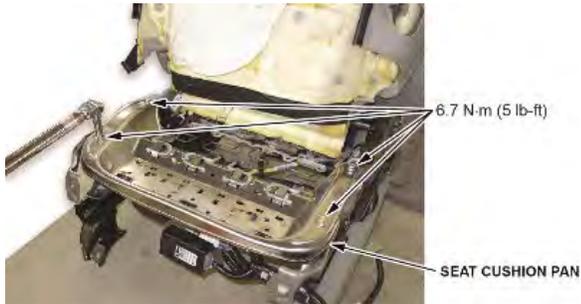
26. Lower the seat cushion pan, and install the bolts. Torque the bolts to **6.7 N•m (5 lb-ft)**.
