April 16, 2018

Clicking from the Power Seat While Using the Height or Tilt Adjustment

AFFECTED VEHICLES

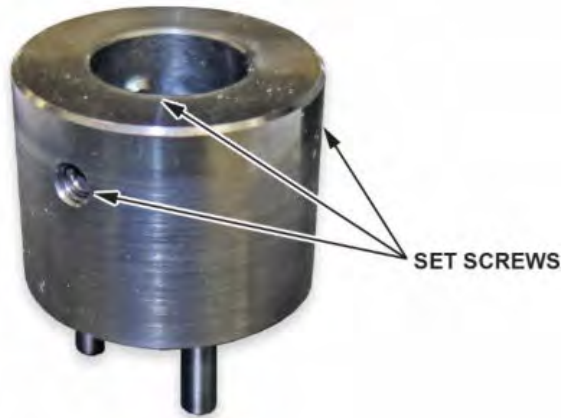
1. Make sure the set screws are installed on the meshing tool. If they are not installed, install them without passing through the inner cutout of the tool.

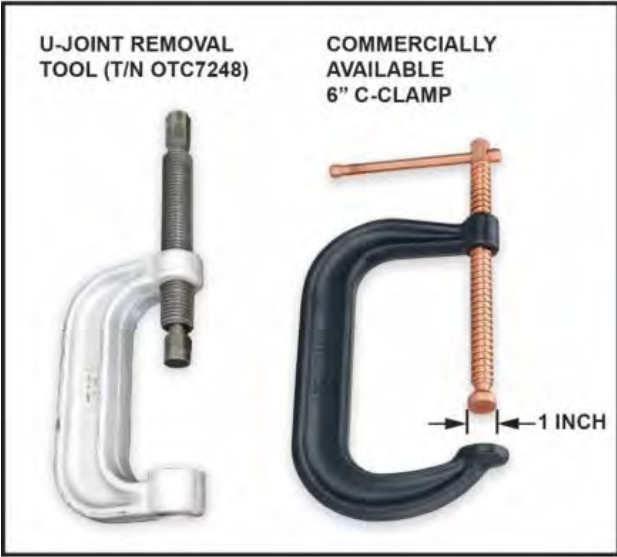
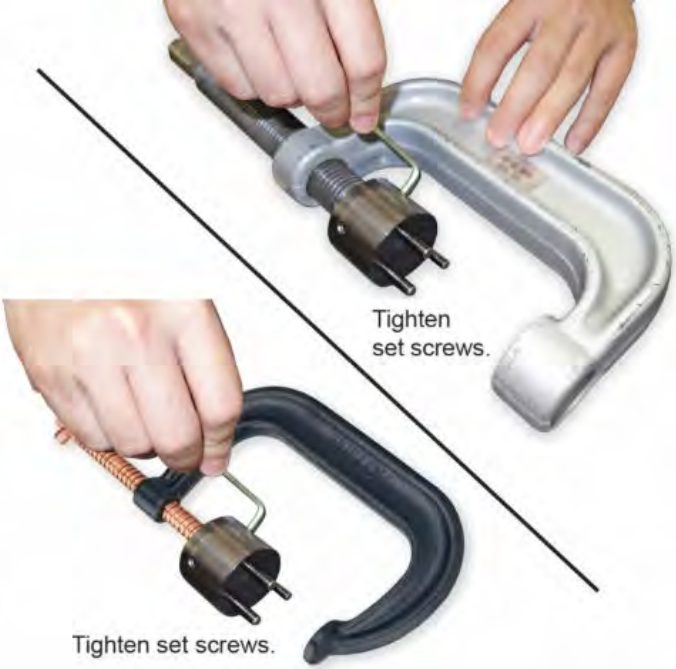
2. Install the meshing tool onto the U-Joint Removal Tool (T/N OTC7248) or universal 6-inch C-clamp. Hand tighten the set screws with a hex tool.

If you are using a 6-inch C-clamp, the foot of the C-Clamp must be 1-inch in diameter for the meshing tool to fit correctly.

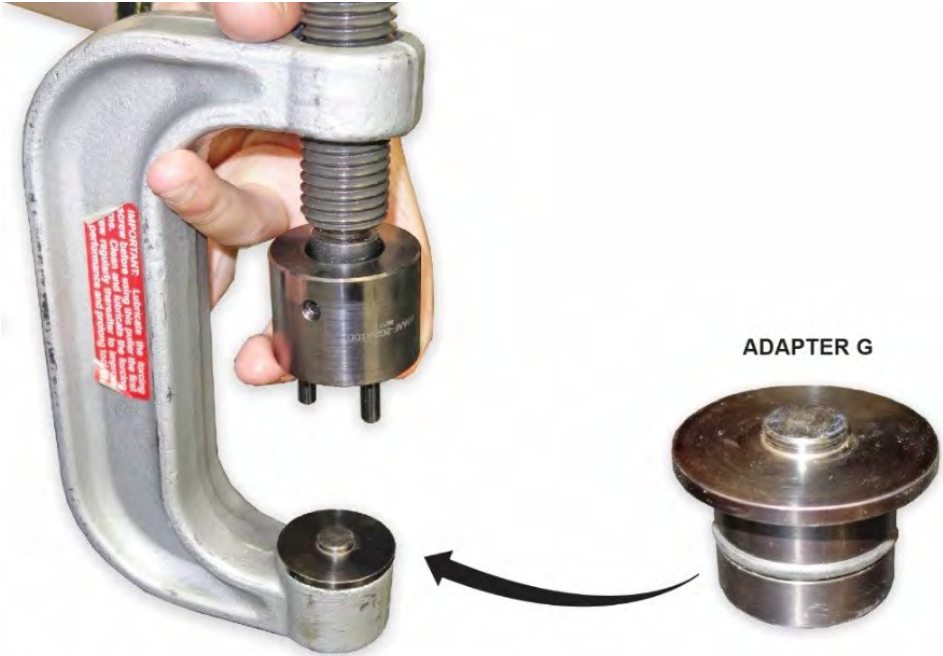
3. If you are using the U-Joint Removal Tool (T/N OTC7248), install Adaptor G (T/N 07XAF-001050B).

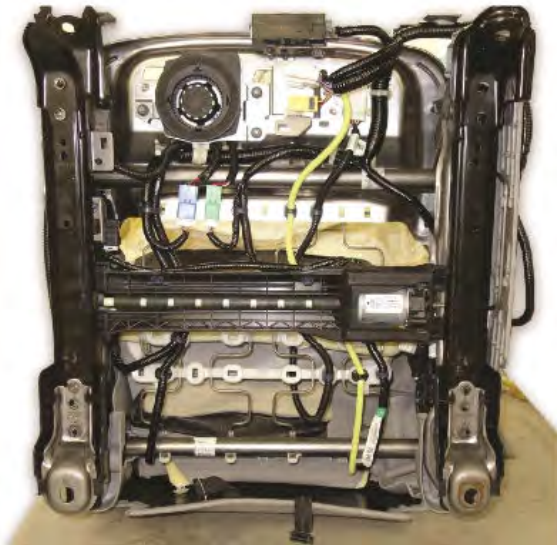
Bottom of seat:

- Do not remove the cushion cover from the foam pad. Remove both parts as an assembly.
- For reference during assembly, take a photo of the harness routing and clip location layout as shown.
- MDX Ventilated Driver's Seat is shown. It may differ slightly from the seat you are repairing.

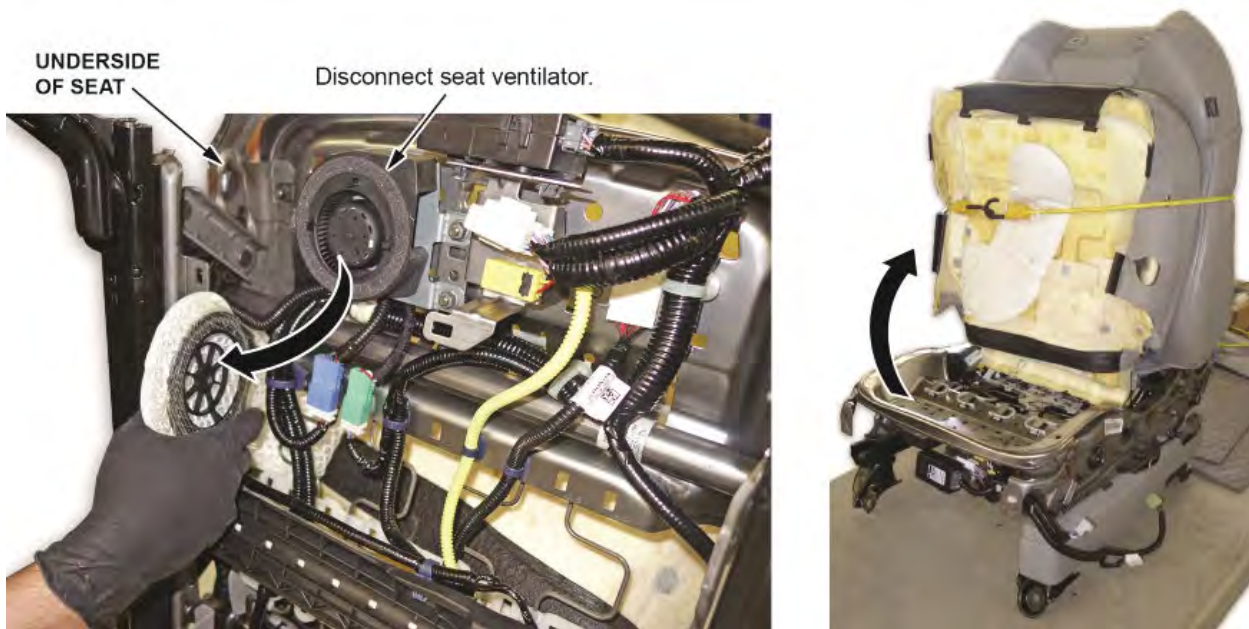
5. Remove the seat ventilator from seat bottom (if equipped).

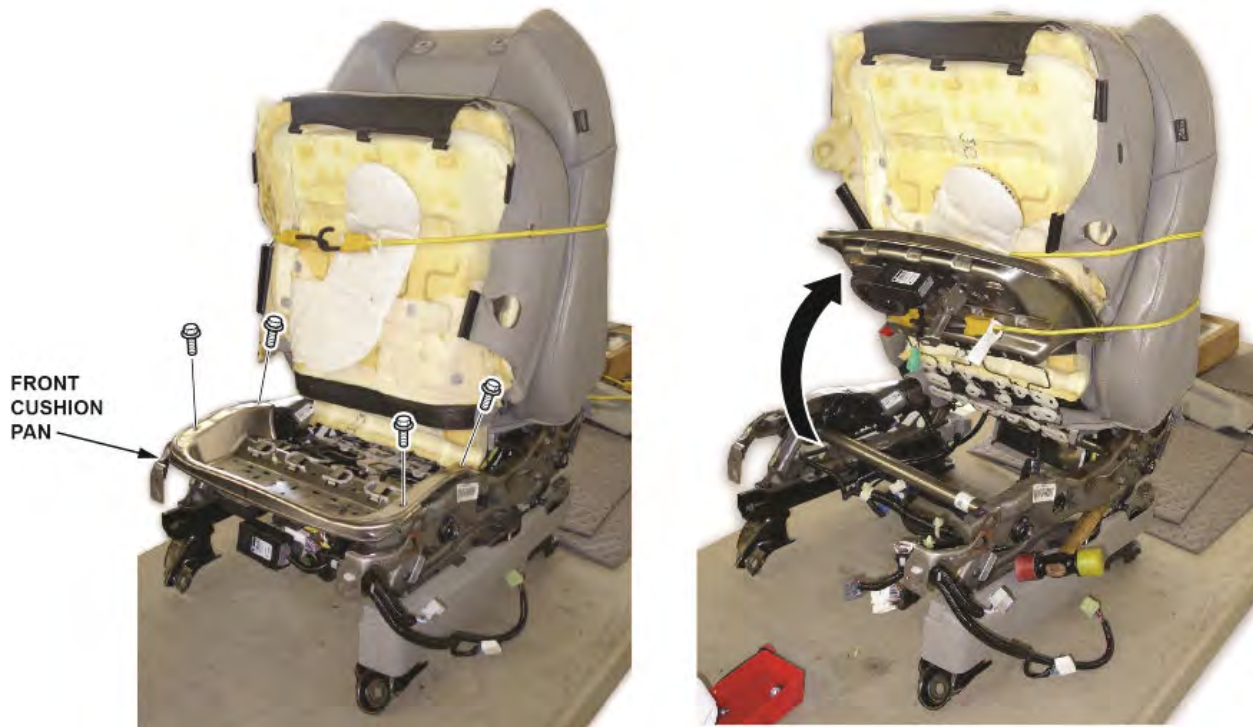
6. Remove any harnesses or harness clips that will prevent removal of the cushion pan.
7. Remove the four 10 mm bolts from the front cushion pan.

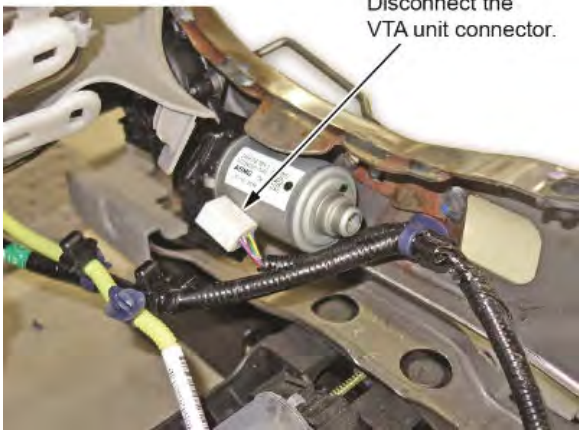
- Lift the cushion pan, and hold it up with a bungee cord or set the seat on its back on a clean surface to keep the cushion pan out of the way.
- Disconnect the VTA unit connector.

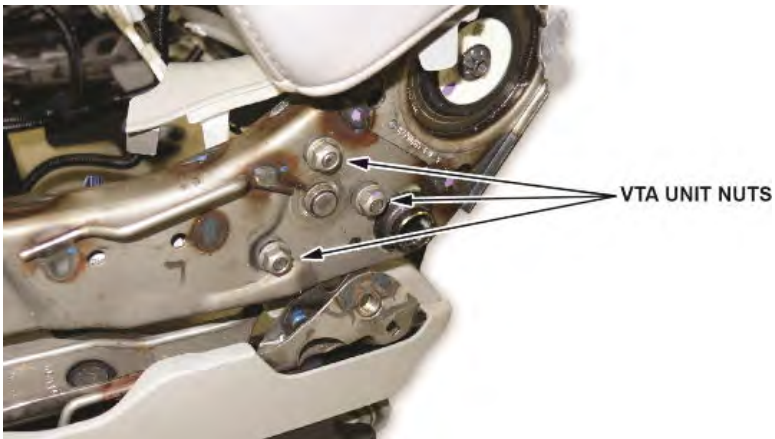
- Remove the VTA unit nuts, then remove the VTA unit.

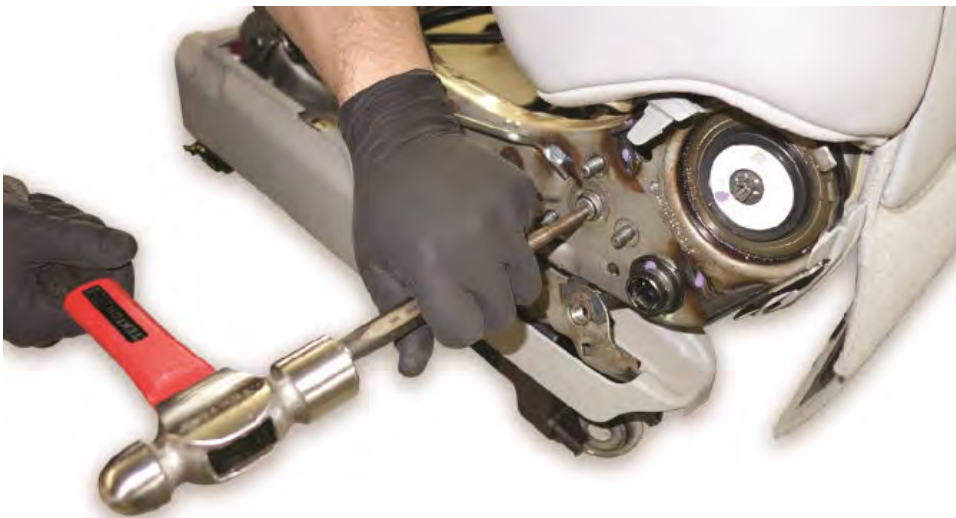
- If the seat frame is too low and you cannot access the VTA unit nut, use an open end wrench.
- If it is difficult to remove the VTA unit after removing the nuts, hit the center shaft of the VTA unit with a punch tool and hammer to remove it.

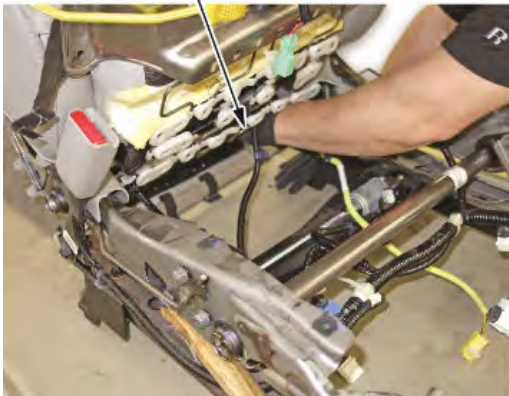
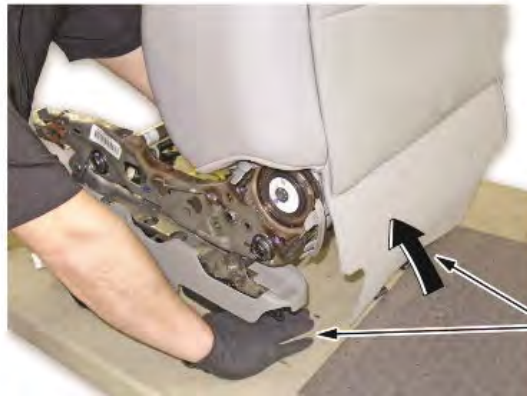
11. Raise the seat as much as possible by pulling the seat frame as shown. This allows easier meshing of the gear teeth when installing the new VTA motor.

Grasp the seat frame.

Pull upward while holding the base down.

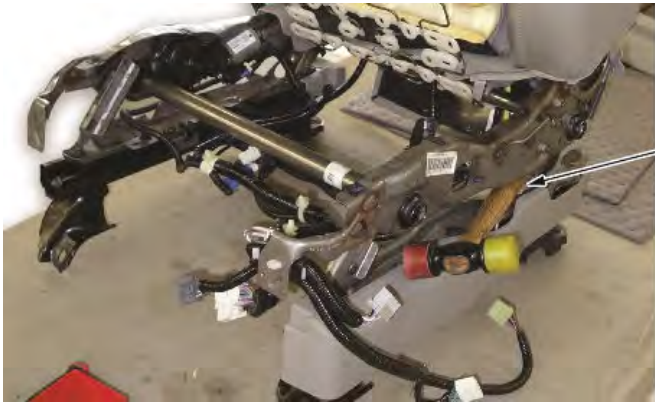
Place a hammer handle (or similar tool) between the upper and lower sections of the seat frame to prevent the rear of the frame from collapsing and pinching fingers. Remove the blocking hammer **ONLY** when you have installed and aligned the new VTA motor.

Prop open the gap between the upper and lower frame sections.

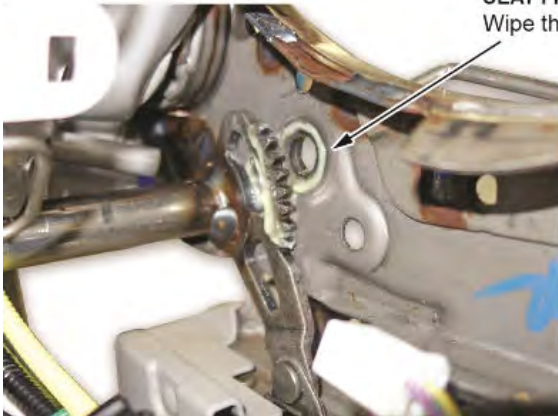
12. Wipe off any excess grease from the seat frame gear teeth with a paper towel or clean rag.

SEAT FRAME GEAR
Wipe this area.

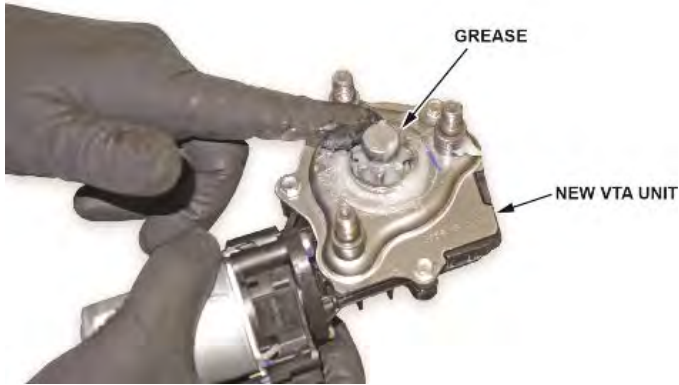
13. Apply the provided grease to the new VTA unit motor splines.

Only 1/8th of the grease packet is needed. Do not use the whole packet.

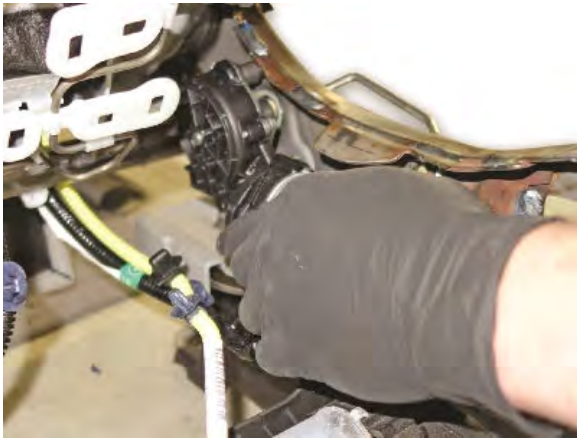
14. Mount the new VTA unit onto the seat frame.

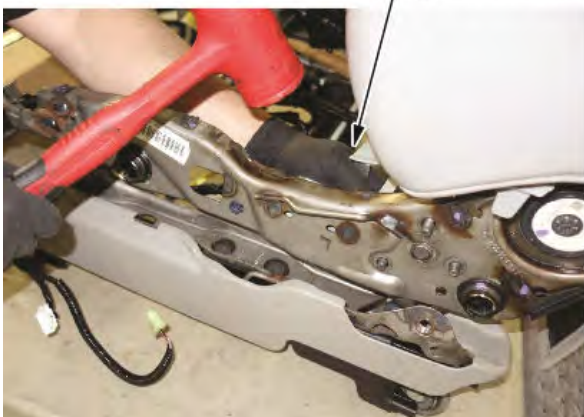
15. While applying pressure to keep the VTA unit against the seat frame, use a rubber mallet or plastic hammer to hit the frame downwards. This will allow the VTA unit splines to align and engage with the frame gear.

Press the VTA unit against the frame.

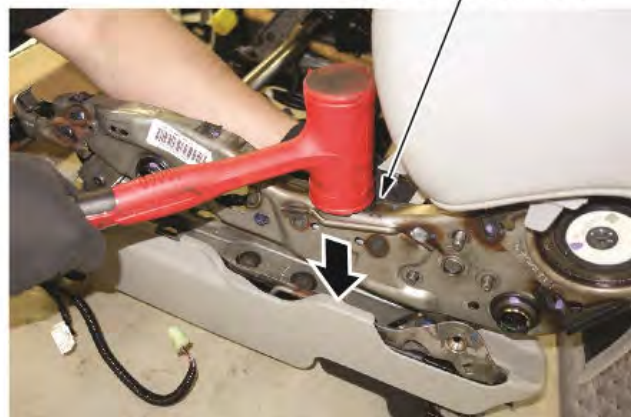
Hit the frame downward.

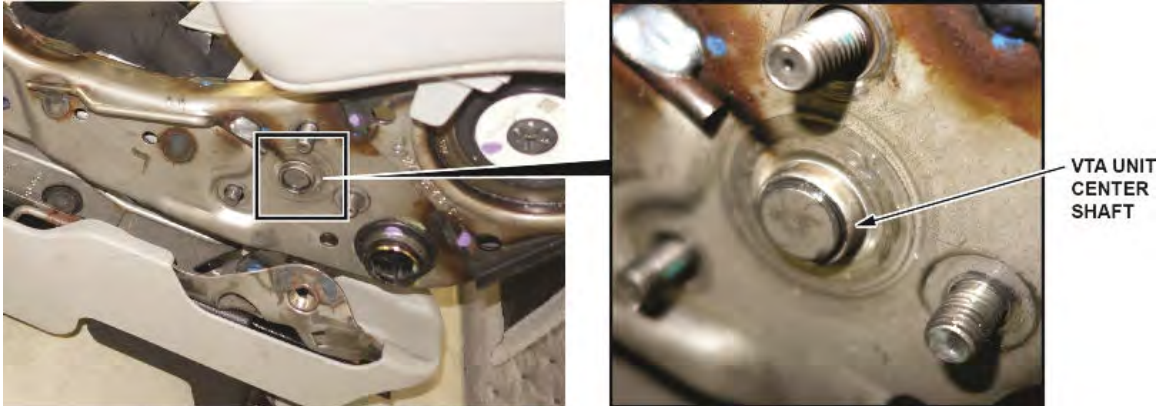
16. Make sure the VTA unit splines and seat frame gear are properly engaged. The VTA unit center shaft should be protruding from the frame.

- You may need to adjust or remove the blocking hammer handle if it is preventing proper gear engagement.
- Use caution as the seat will **NOT** be fully supported and may collapse or pinch fingers until the new VTA unit is secured to the seat frame.

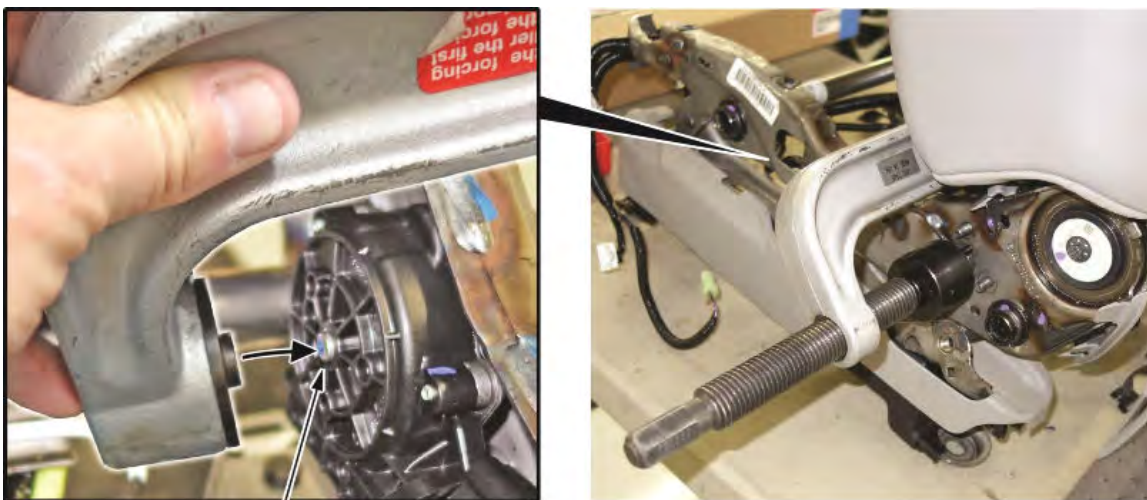
17. Place the meshing tool as shown. Center the tool on the pinion shaft protruding from the VTA unit.

Place the tool on the pinion shaft of the VTA unit.

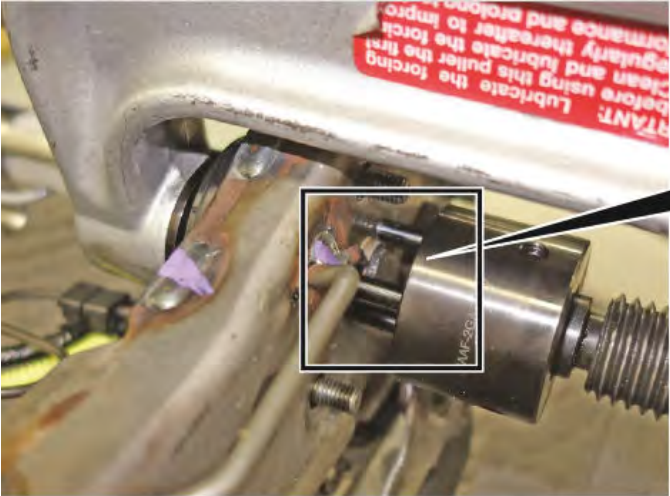
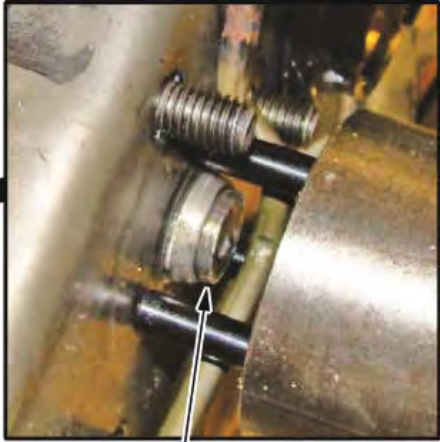
18. Gradually tighten the C-clamp until the VTA unit shaft is protruding out of the frame. Once the VTA unit shaft is protruding, go to the next step.

Tighten the tool until the VTA unit shaft protrudes.

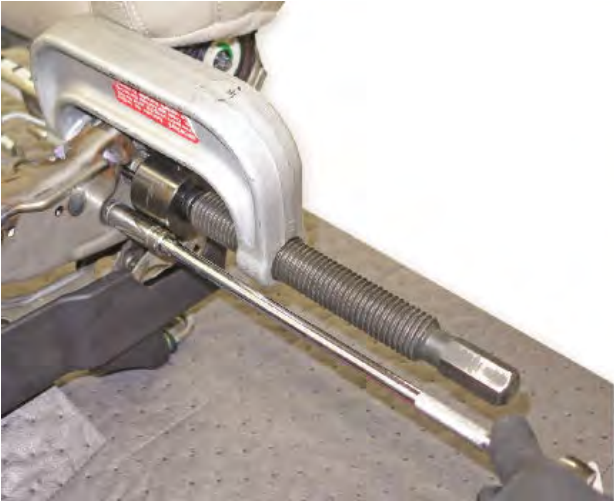
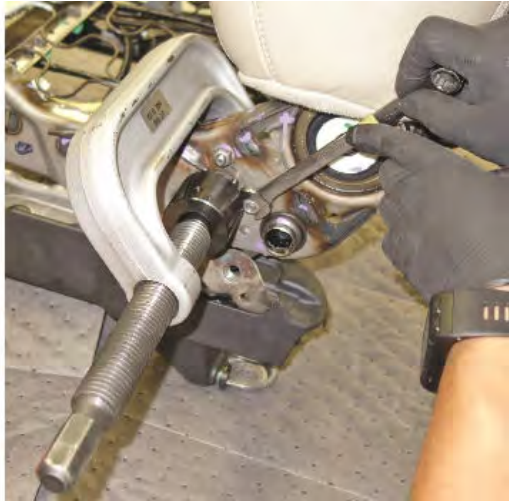
19. With the C-clamp still in place, install the new VTA unit nuts and snug them with a wrench.

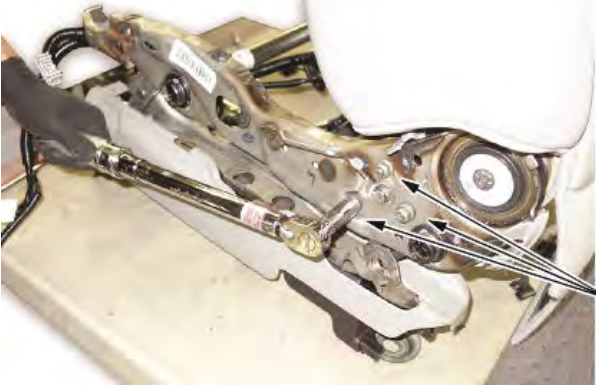
20. Remove the C-clamp, and torque the nuts to **25 N•m (18 lb-ft)**.

VTA UNIT NUTS
25 N•m (18 lb-ft)

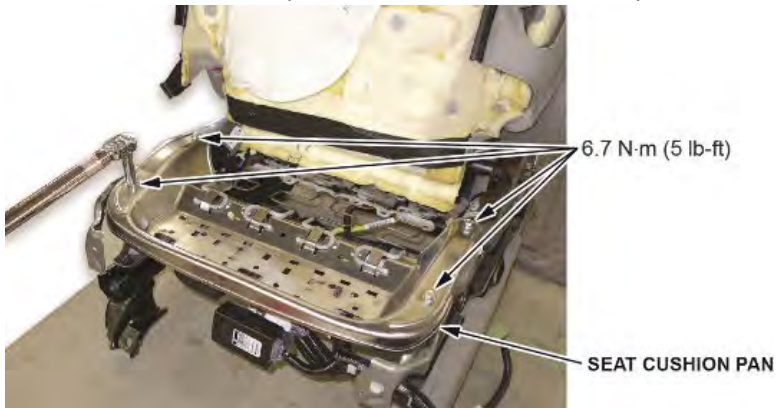
21. Make sure the VTA unit is supporting the seat's weight, then remove the blocking hammer or tool.
22. Connect the VTA unit connector.
23. Lower the seat cushion pan, and install the bolts. Torque the bolts to **6.7 N•m (5 lb-ft)**.

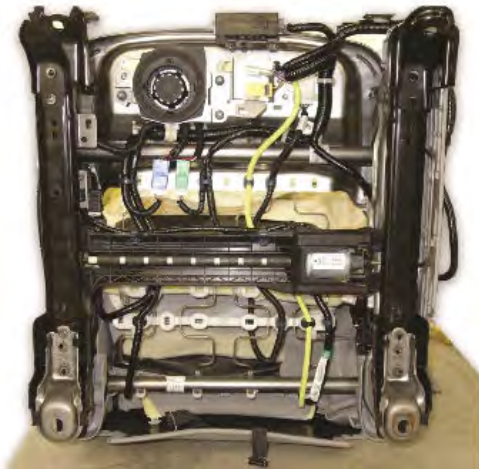
Bottom of seat:

- Do not remove the cushion cover from the foam pad. Remove both parts as an assembly.
- For reference during assembly, take a photo of the harness routing and clip location layout as shown.
- MDX Ventilated Driver's Seat is shown. It may differ slightly from the seat you are repairing.

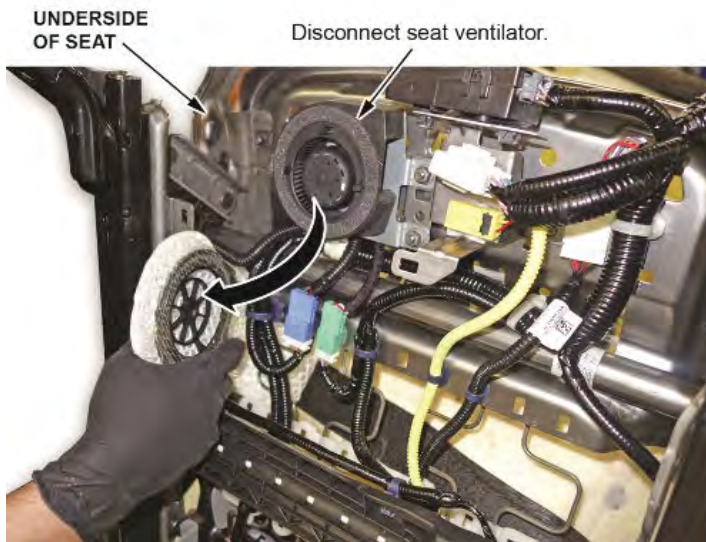
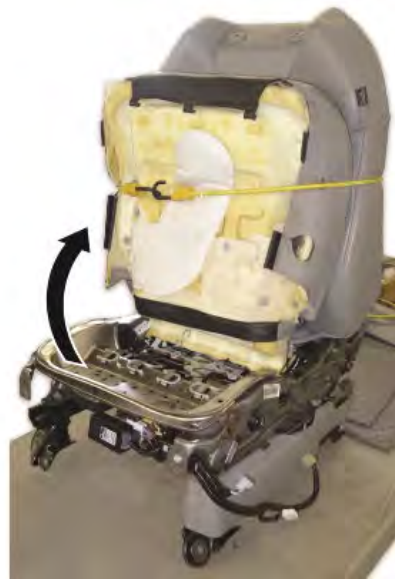
5. Remove the seat ventilator from the seat bottom (if equipped).

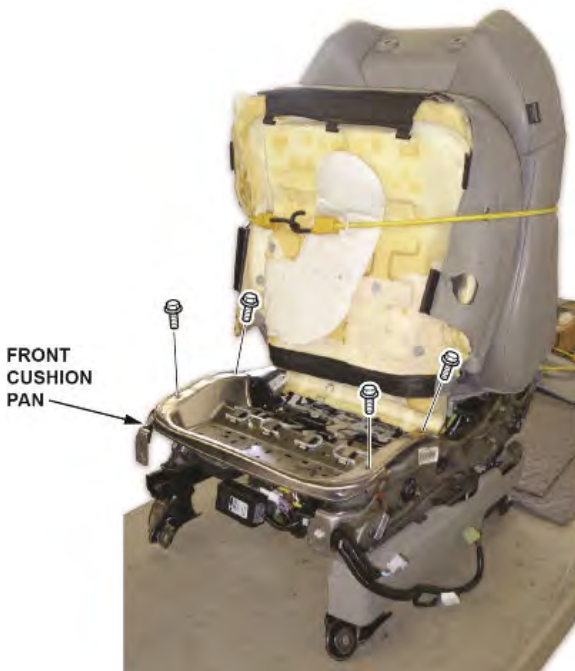
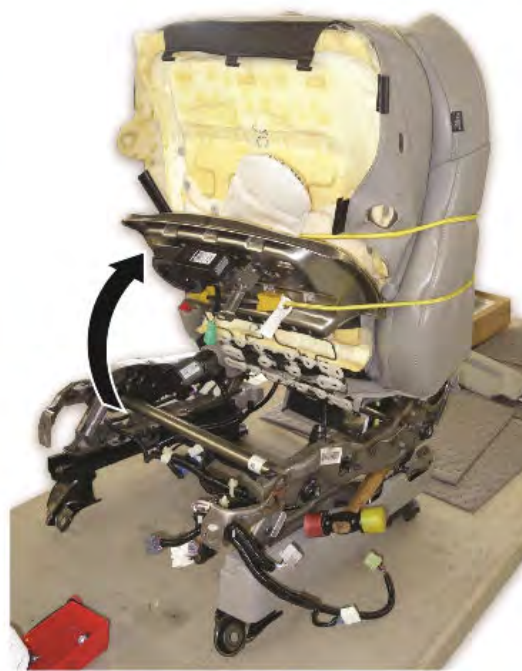
6. Remove any harnesses or harness clips that will prevent the removal of the cushion pan.
7. Remove the four 10 mm bolts from the front cushion pan.

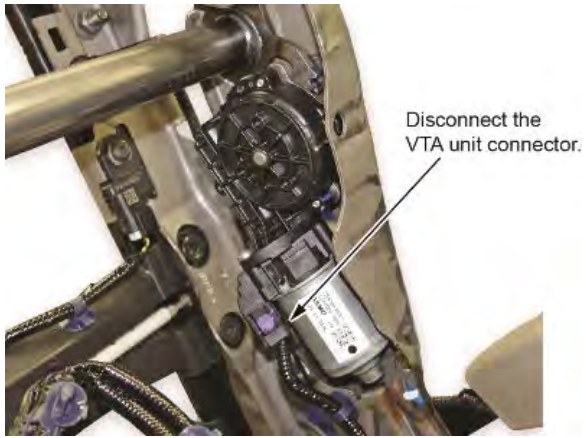
9. Disconnect the VTA unit connector.

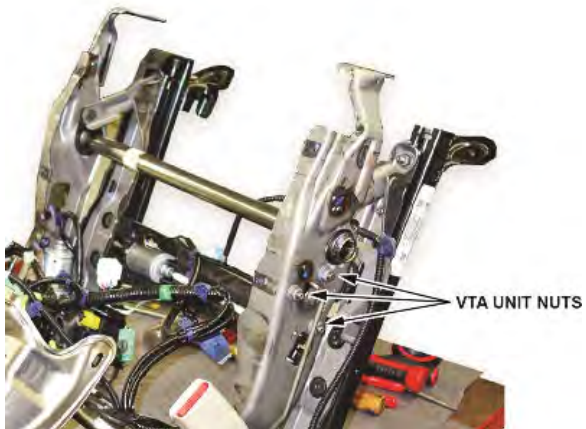
10. Remove the VTA unit nuts.

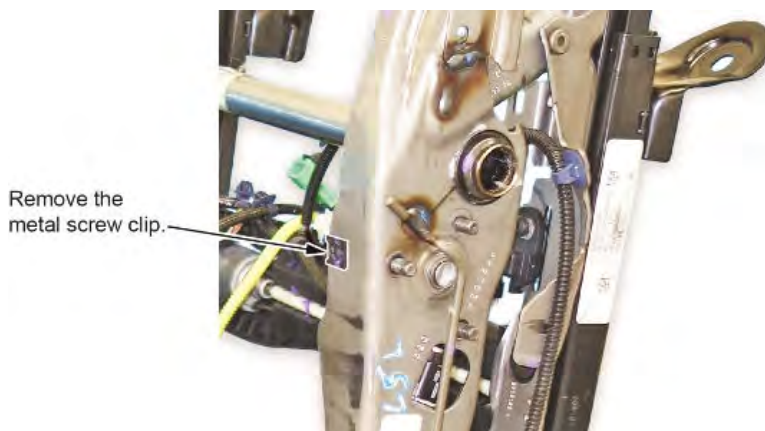
11. Remove the metal screw clip on top of the VTA unit with a clip removal tool.

Make sure you do not damage or lose the metal screw clip.

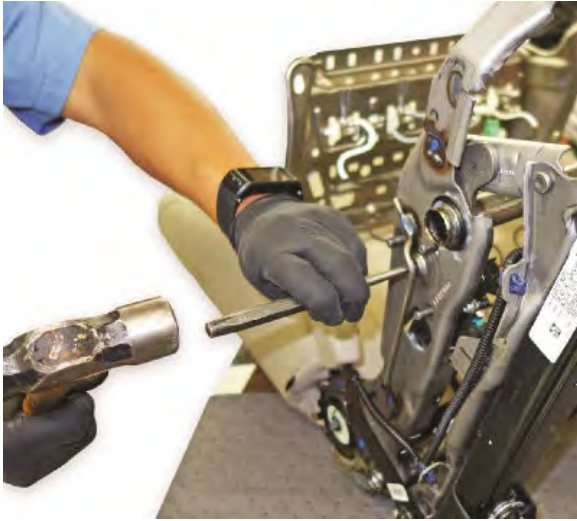
12. Remove the VTA unit.

If it is difficult to remove the VTA unit after removing the nuts, hit the center shaft of the VTA unit with a punch tool and hammer to remove it.

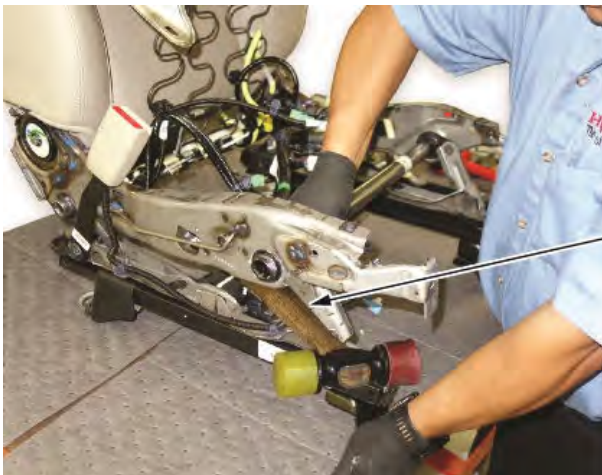
13. Raise the seat as much as possible by grabbing the seat frame as shown. This allows easier meshing of the gear teeth when installing the new VTA motor.

Place a hammer handle (or similar tool) between the upper and lower sections of the seat frame to prevent the rear of the frame from collapsing and pinching fingers. Remove the blocking hammer **ONLY** when you have installed and aligned the new VTA motor.

Prop open the gap between the upper and lower frame sections.

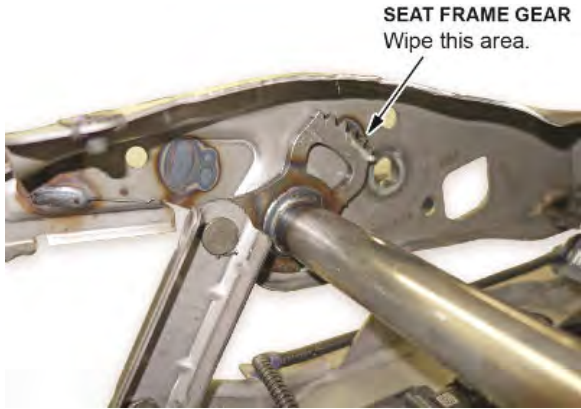
14. Wipe off any excess grease from the seat frame gear teeth with a paper towel or clean rag.

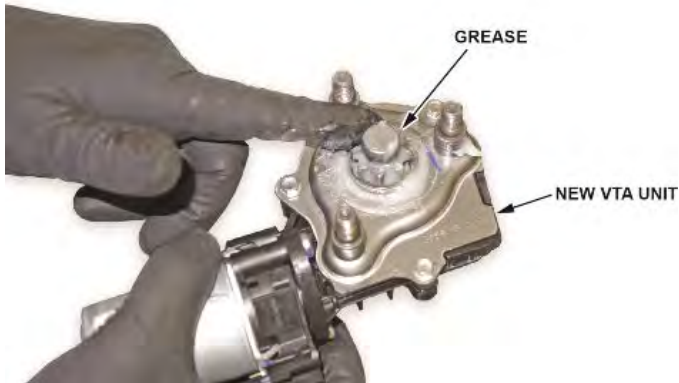
15. Apply the grease provided in the kit to the new VTA unit splines.

Only 1/8th of the grease packet is needed. Do not use the whole packet.

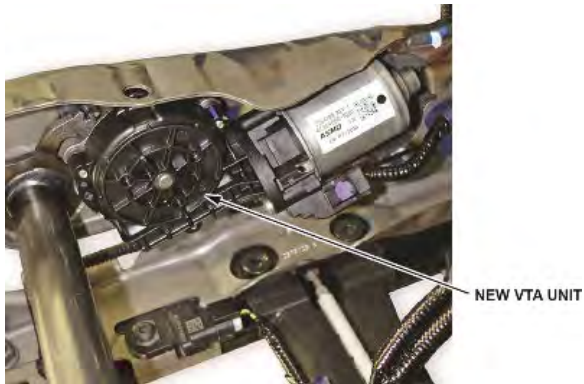
16. Mount the new VTA unit to the seat frame.

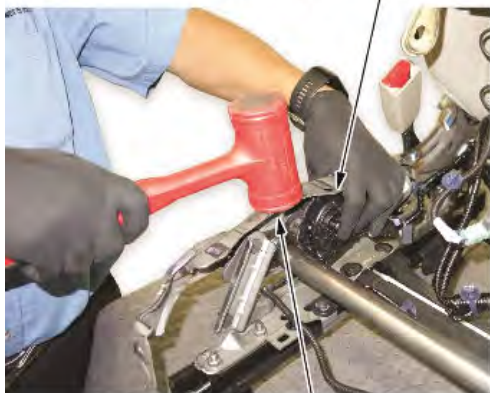
17. While applying pressure to keep the VTA unit against the seat frame, use a rubber mallet or plastic hammer to hit the frame downwards. This will allow the VTA unit splines to align and engage with the frame gear.

Press the VTA unit against the frame.

Hit the frame downward.

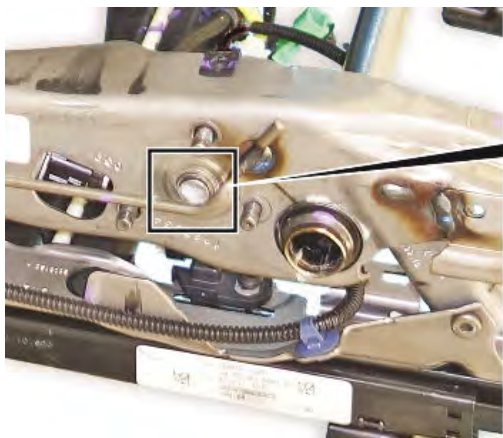
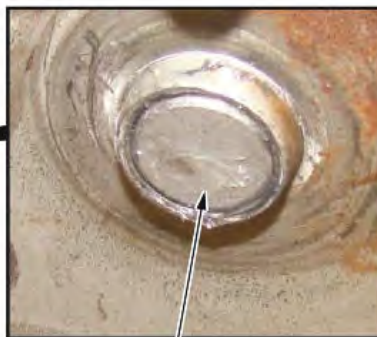
VTA UNIT
CENTER SHAFT

18. Make sure the VTA unit splines and seat frame gear are properly engaged. The VTA unit center shaft should be protruding from the frame.

- You may need to adjust or remove the blocking hammer handle if it is preventing proper gear engagement.
- Use caution as the seat will **NOT** be fully supported and may collapse or pinch fingers until the new VTA unit is secured to the seat frame.

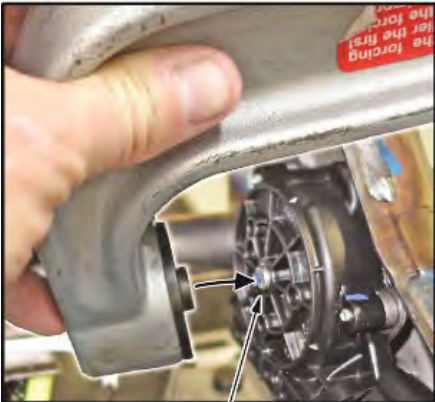
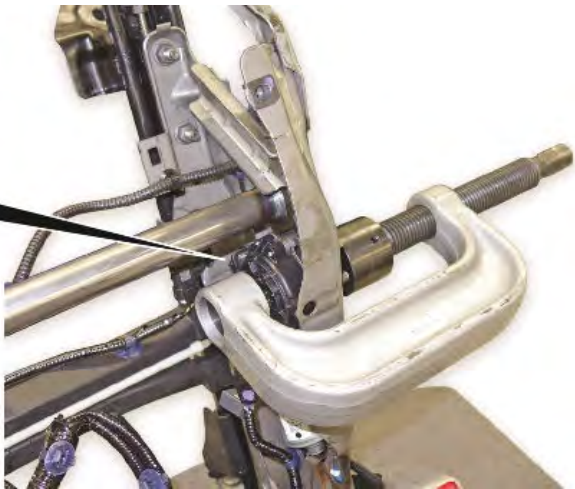
19. Place the meshing tool as shown. Center the tool on the pinion shaft protruding from the VTA unit.

Place the tool on the pinion shaft of the VTA unit.

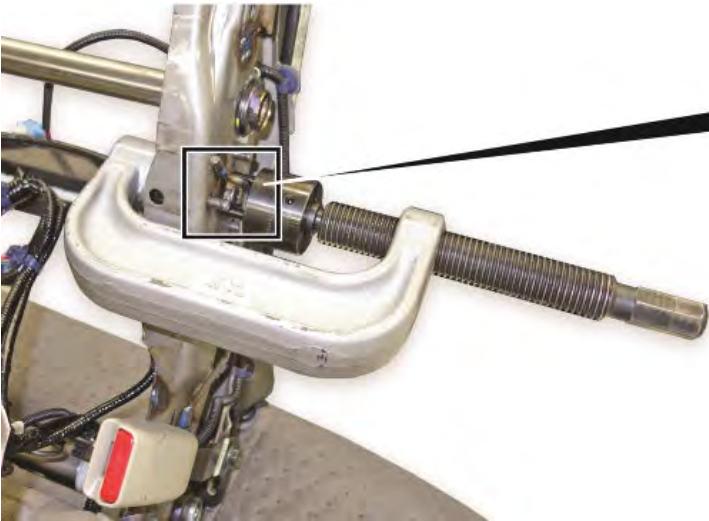
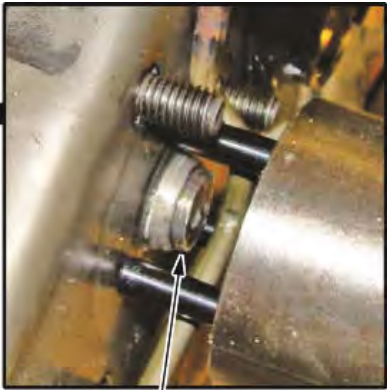
20. Gradually tighten the C-clamp until the VTA unit shaft is protruding from the frame. Once the VTA unit shaft is protruding, go to the next step.

Tighten the tool until the VTA unit shaft protrudes.

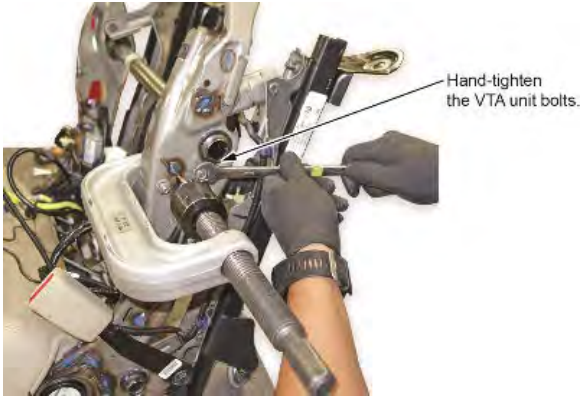
21. With the C-clamp still in place, install the new VTA unit nuts and snug them with a wrench.

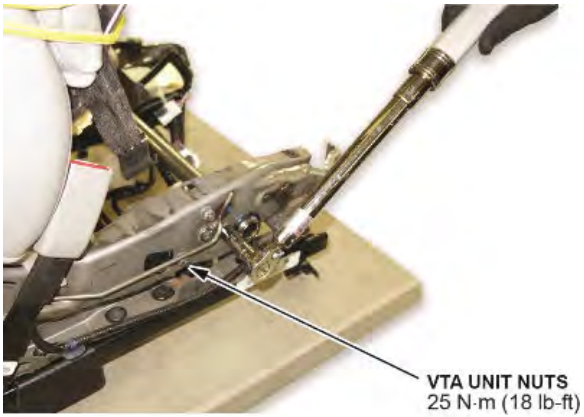
22. Remove the C-clamp, and torque the nuts to **25 N•m (18 lb-ft)**.

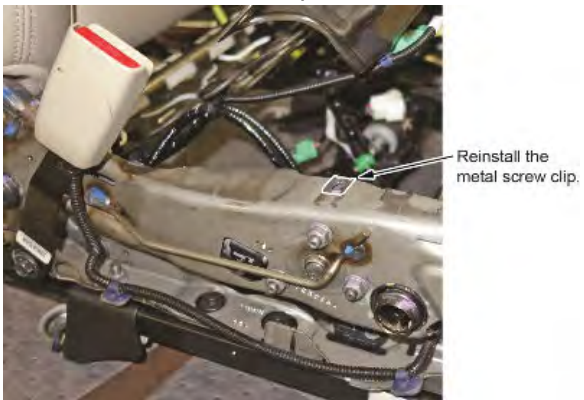
23. Install the metal screw clip.

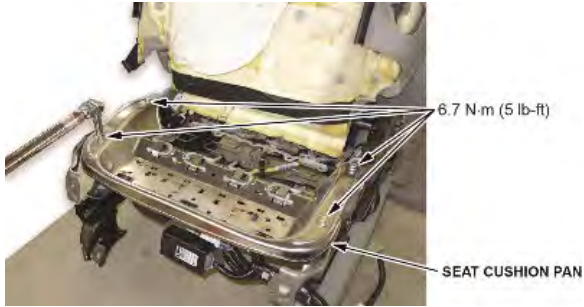
26. Lower the seat cushion pan, and install the bolts. Torque the bolts to **6.7 N•m (5 lb-ft)**.
