# Customer Satisfaction Program

## 17467 Automatic Transmission Fluid (ATF) Hose Replacement

**Reference Number:** N172140400

**Release Date:** February 2018  
**Revision:** 00

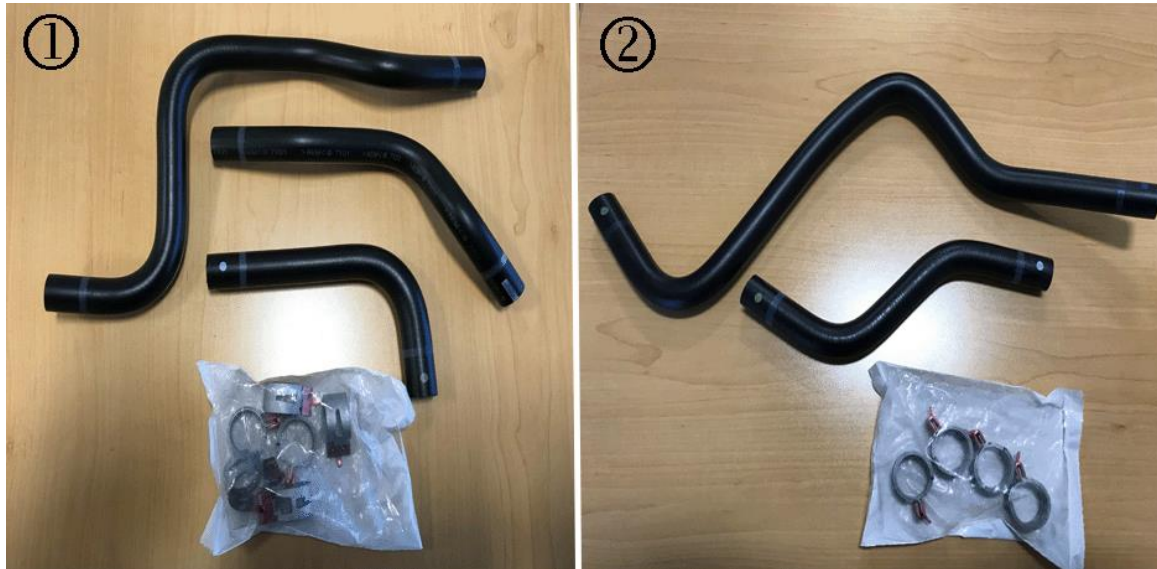
4940910

- (1) Kit part # 97780707 (Isuzu 4HK1)
- (2) Kit part # 97780708 (Isuzu 4JJ1)

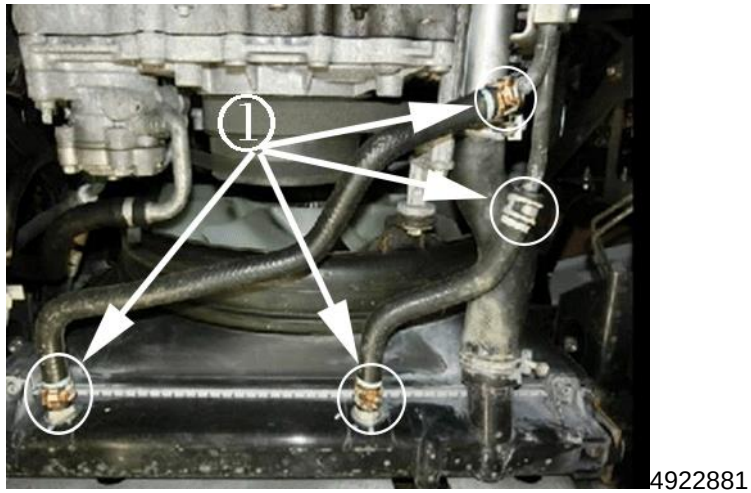
Figure 2

2. Place an oil catch pan underneath the vehicle directly to collect draining ATF as each hose is being replaced.

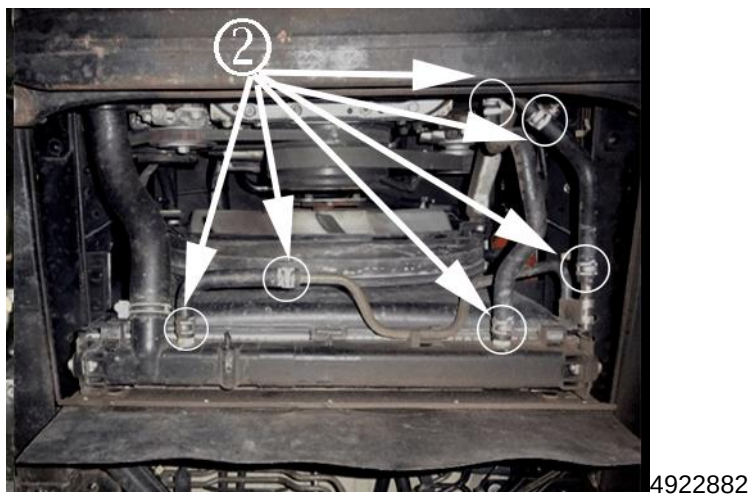
Figure 3

3. Loosen and slide all ATF hose clamps (1) 4JJ1 3.0L Diesel (2) 4HK1 5.2L Diesel) to the center of each hose.
4. With the oil catch pan in place, remove one end of a hose and allow the ATF to drain into the catch pan. When the ATF stops draining, remove the other end of the hose.

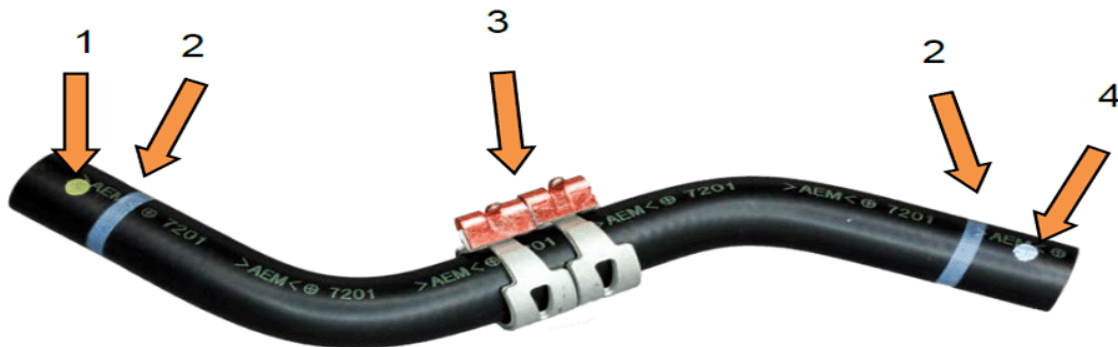
Figure 4

- (1) Yellow Marking Dot
- (2) Blue or White Band
- (3) Hose Clamps w/Lock Tabs
- (4) White Marking Dot

- Slide two new hose clamps onto the replacement hose (see Figure 4). The clamps are held in the open position with factory installed lock tabs (see Figure 5). Install the new replacement hose in the same location as the one that was removed. Every new hose has colored dots or lines at each end to ensure correct orientation on the vehicle (see Figure 4). Refer to Chart 1 to determine the orientation of each hose using these markings. Push each hose onto the pipe until the blue or white band on the hose is just over and beyond the bead on the pipe (see Figure 7). Push the hose onto the radiator fittings until the hose will go no further.

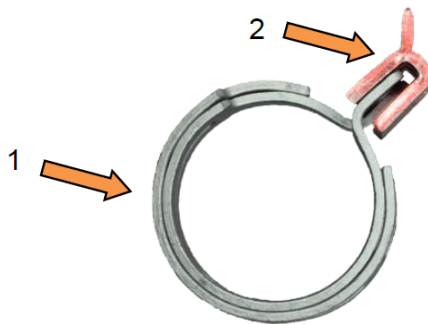
Figure 5

- (1) Hose Clamp
- (2) Lock Tab

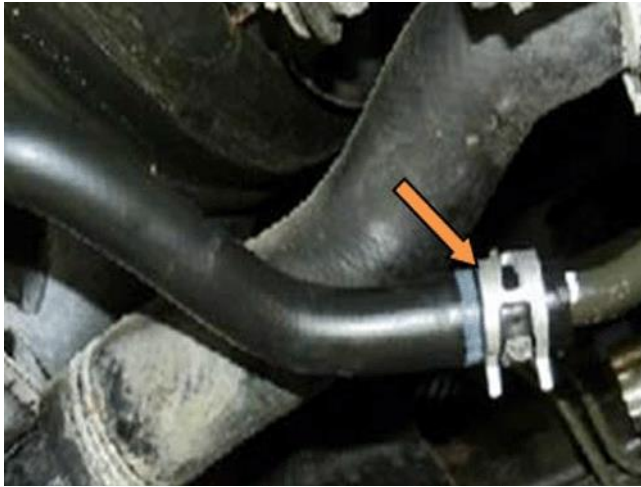
Figure 6

- Slide the hose clamps over the blue or white band and into position as shown in Figures 6 and 7. Remove the lock tabs from the clamps to allow them to compress onto the hose.

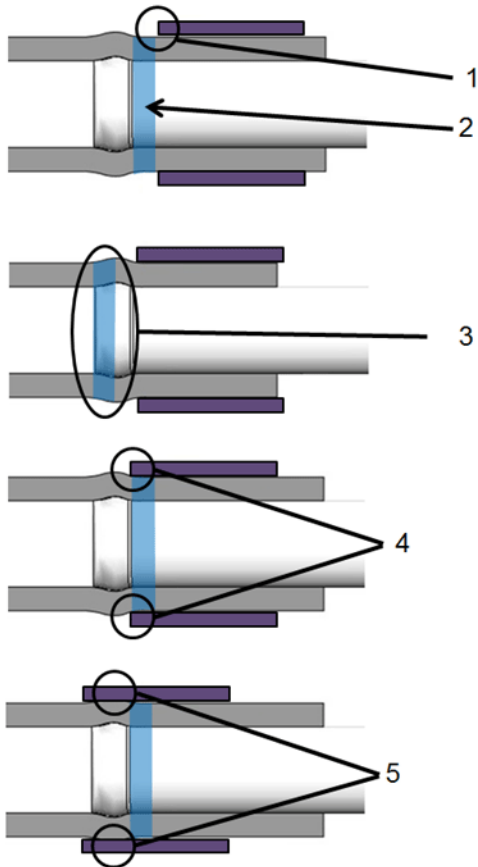
**Figure 7**

- (1) Proper distance between bead and clamp (GOOD)
- (2) Blue or white band is beyond the bead (BAD)
- (3) Blue or white band is not beyond the bead (BAD)
- (4) Clamp is too close to the bead (BAD)
- (5) Clamp is on top of the bead (BAD)

7. Ensure that the hose clamps are not placed over the beads on the pipes (see Figure 7). Adjust the clamps as necessary.
8. Perform steps 4 through 7 for the remaining hose(s).
9. Depress the brake pedal and start the engine, and move the shift lever through all gear positions, returning to the "P" position. Inspect for leaks.

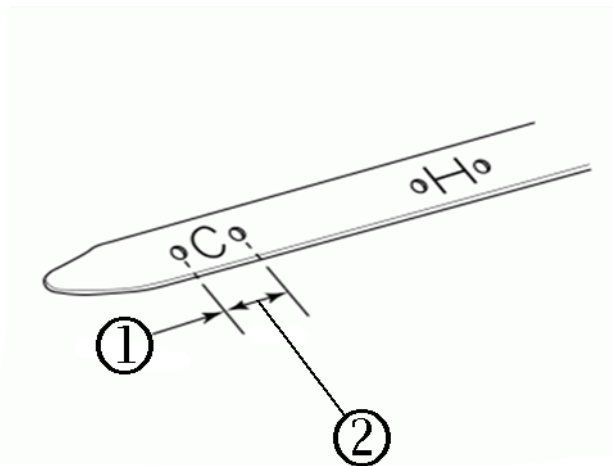
4922888

11. Remove the transmission level gauge and wipe off any debris or ATF with a clean towel. Completely insert the transmission level gauge into the gauge tube and remove it again. If the TFT value in GDS2 is cold (68 - 86°F, 20 - 30°C), the ATF level on the gauge should be within the "C" range (2). A preliminary adjustment can be made here only if the TFT value is in the specified range. Once the TFT value is in the specified range, wipe off any debris/excess ATF from the transmission level gauge and securely reinsert it into the gauge tube.

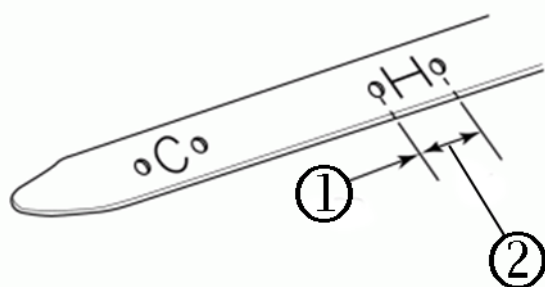
4922889

13. Using the transmission fluid level gauge, recheck the transmission fluid level. The ATF level should now be in the "hot" range (2). If the level is at (1), adjust the transmission fluid level if necessary to bring it within the correct "hot" range (See above). Clean the transmission level gauge and reinsert it into the gauge tube.
14. Turn the engine off and disconnect GDS2.
15. Unblock the rear wheels.
