Knocking noise from area of front axle when driving over thresholds or edges with front wheels steered

Topic number	LI46.35-P-064639
Version	2
Function group	46.35 Electrical steering
Date	01-25-2018
Validity	MODEL 205 except 4MATIC (code M005) MODEL 213 except 4MATIC (code M005) MODEL 238 except 4MATIC (code M005)
Reason for change	Under remedy step 19: BR238 added.
Reason for block

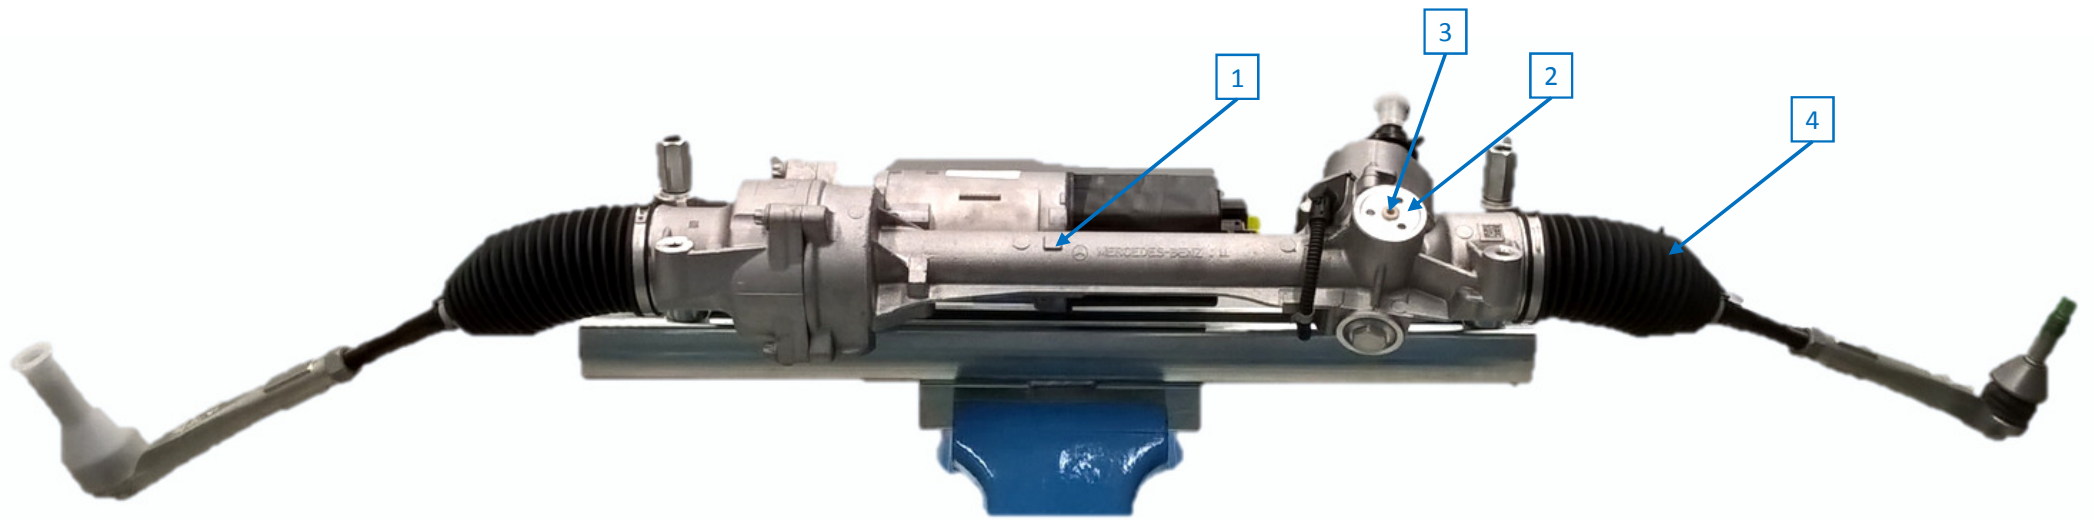
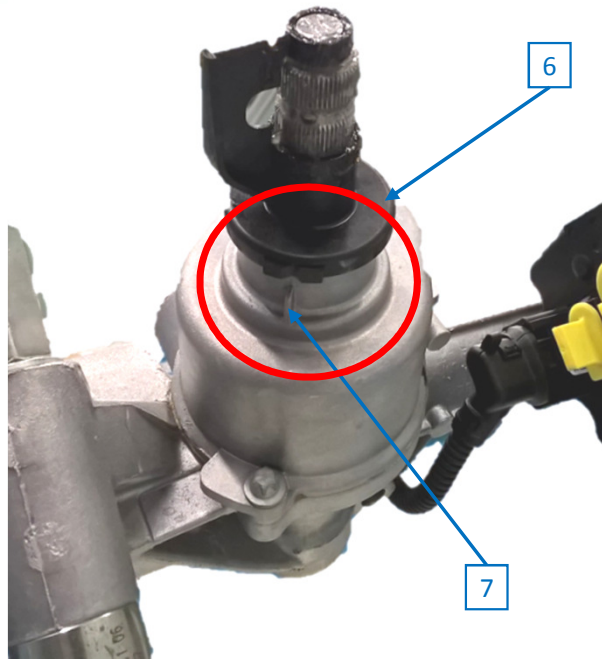
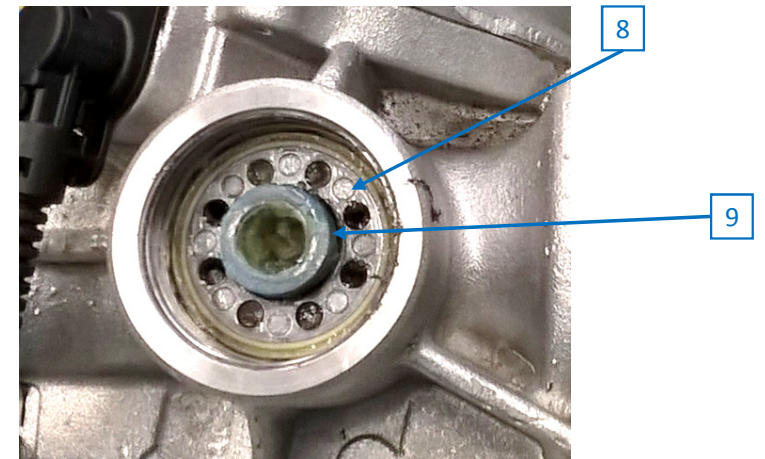
Also, the "injection gate" on the thrust piece must be checked (Attachment 002). If a burr can be seen there (picture framed in red), this must be removed using a suitable tool (such as a screwdriver). The reason for this is that the tip of the dial indicator rests on this surface.
