# TECHNICAL CAMPAIGN

## Side Case Release Lever

K 1600 B (K61, 0F53)

Service Information No. **SI 46 001 18**

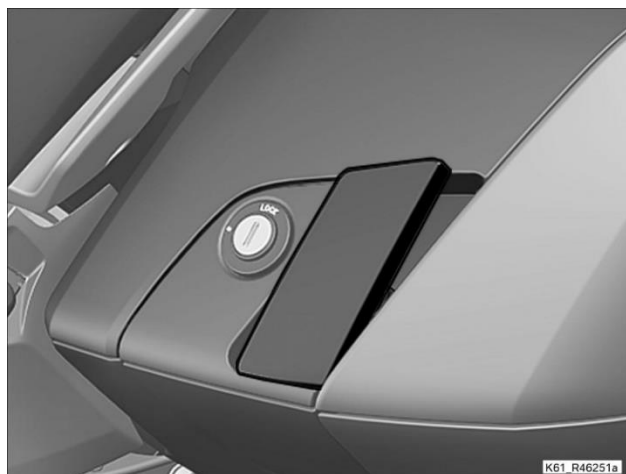
Fig. Release lever

BMW Motorrad quality analysis has established that on K 1600 B (K61) models with central locking system (SA 417) in rare circumstances the side case could open while driving.

For affected vehicles, replace the release levers of both cases before delivery or at the next service visit according to repair instructions 46 54 060 Replacing opening flap in Repair and Service Data BMW Motorrad (AIR).
