MODEL
2018MY
Sorento (UMa)
3.3L AWD

TECHNICAL SERVICE BULLETIN

SERVICE ACTION: SORENTO (UMa) 3.3L
PRE-DELIVERY INSPECTION (SA345)

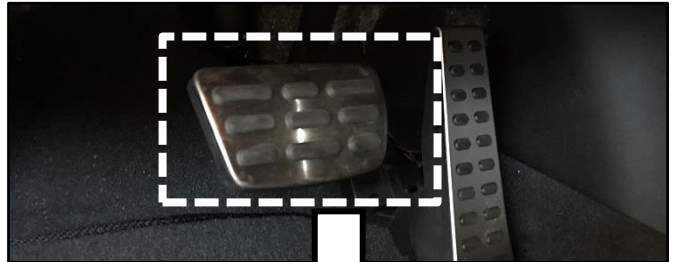
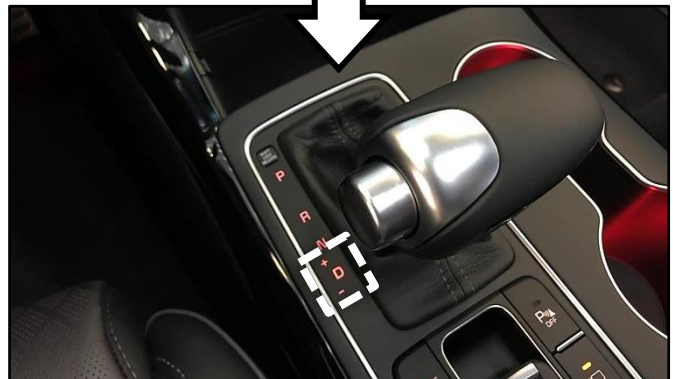
1. Prior to beginning the next step, ensure the engine is at operating temp, at least 90°C (194°F). KDS may be used to confirm operating temperature.

Sensor Name(205)	Value	Unit	Link Up
Engine Oil Temperature	86.2	°C	
Water Temperature	90.0	°C	
Vehicle Speed	0.0	km/h	
Accelerator Pedal Position Sensor	0.0	%	
Actual Engine Speed	644	RPM	
Battery Voltage	14.16	V

2. Hold down the brake pedal fully with your left foot and put the vehicle in “Drive”.

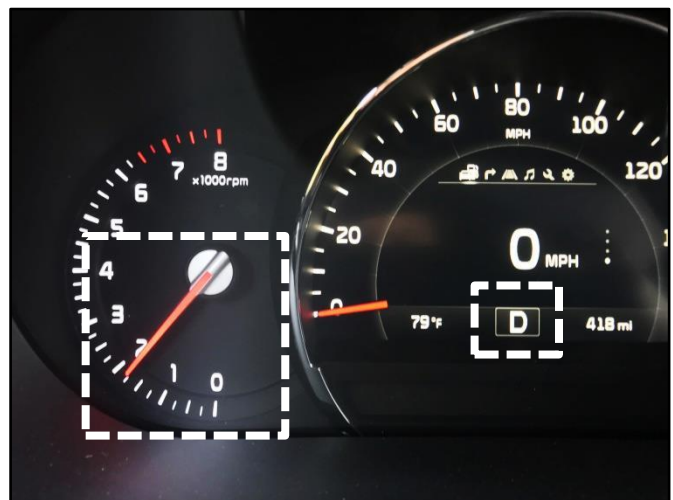
3. With the brake pedal pressed fully, press the accelerator pedal with your right foot and raise and hold the engine RPM between 1,500 and 2,500 for five (5) seconds.

Release the accelerator pedal and let the engine idle for 10 seconds.

Ensure the brake pedal is fully pressed while pushing on the accelerator pedal and ensure no one else is in front or near the vehicle during this inspection procedure.

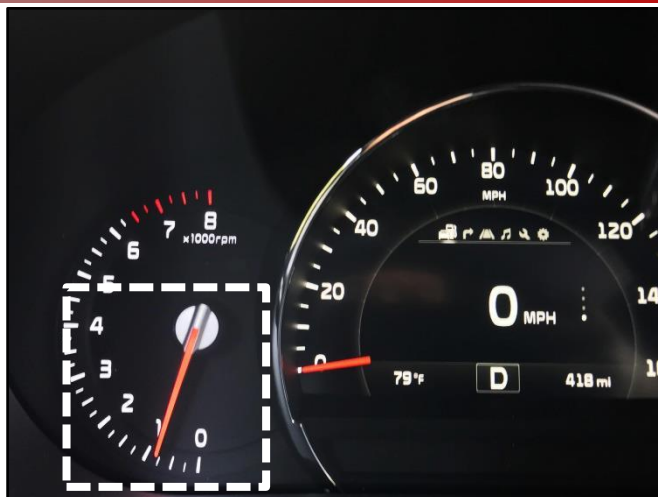
4. After 10 seconds of engine idle, repeat step 3 four (4) more times for a total of five (5) times.

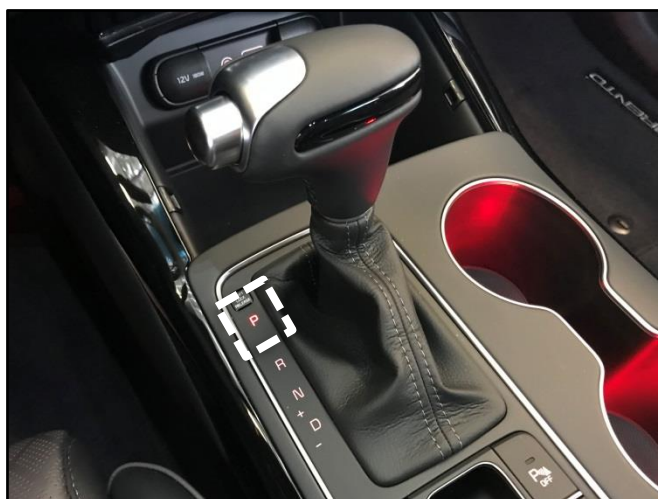
5. After the 5th time of performing step 3, shift the vehicle to “Park” and perform the next step within ten (10) seconds.

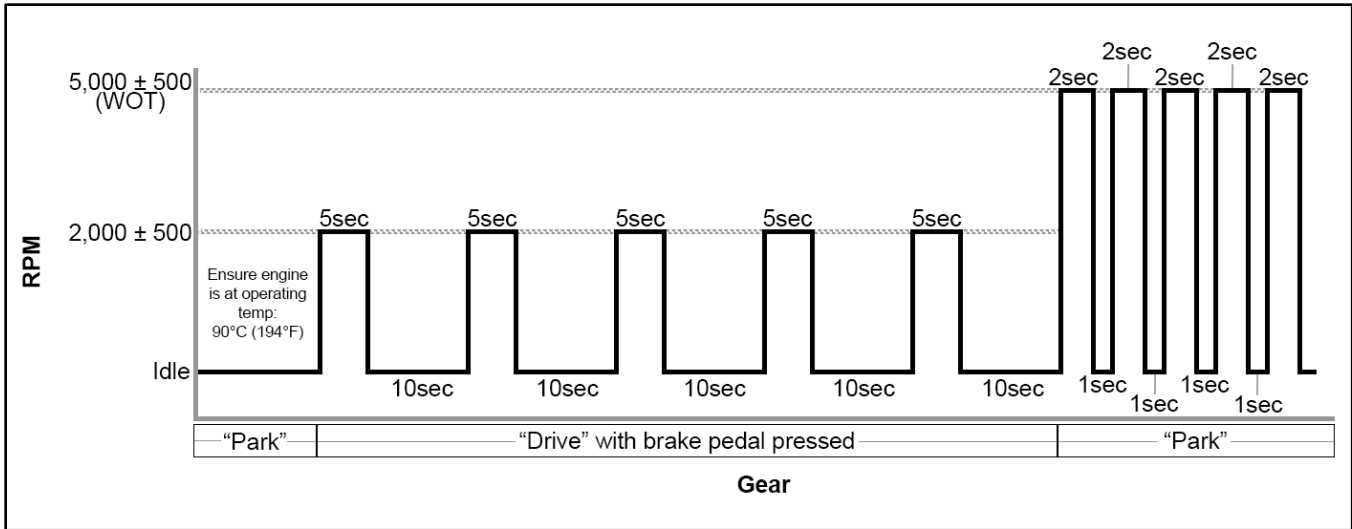
Inspection Procedure Visualization:

See page 4 for a visualization of this inspection procedure.
