This bulletin provides the procedure to replace the Canister Close Valve (CCV) on some 2012-2017MY Rio (UB) vehicles, produced from June 21, 2011 through March 28, 2016, which may exhibit the engine warning lamp DTCs P0455 and P0456 for an evaporative emission system leak due to the Canister Close Valve (CCV) stuck open. Follow the procedure outlined in this bulletin to replace the CCV with an improved part. Before conducting the procedure, verify that the vehicle is within the affected production date range.

CANISTER CLOSE VALVE (CCV) REPLACEMENT

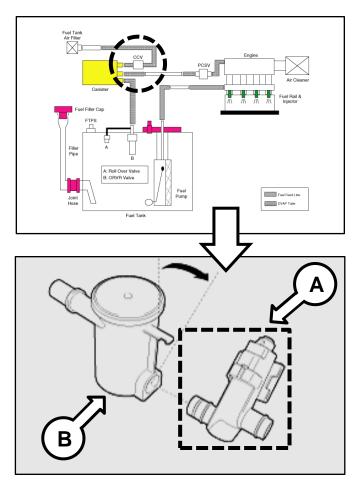
The Canister Close Valve (A) is a separate part from the Fuel Tank Air Filter assembly (B) where it is inserted.

<u>Improved CCV:</u> Rubber seal material change and port color change (black to tan) as shown.

Old CCV

New CCV

Replace the Canister Close Valve (A) by referring to the "Engine Control / Fuel System → Engine Control System → Canister Close Valve (CCV) → Repair procedures" chapter in the applicable Shop Manual on KGIS.
