**Technical Service Bulletin:**  
TSB180045

**Enhanced Oiling Rocker Lever Identification**

- ISX (All Versions)
- ISX15 (All Versions)
- QSX15 (All Versions)
- X15 (All Versions)

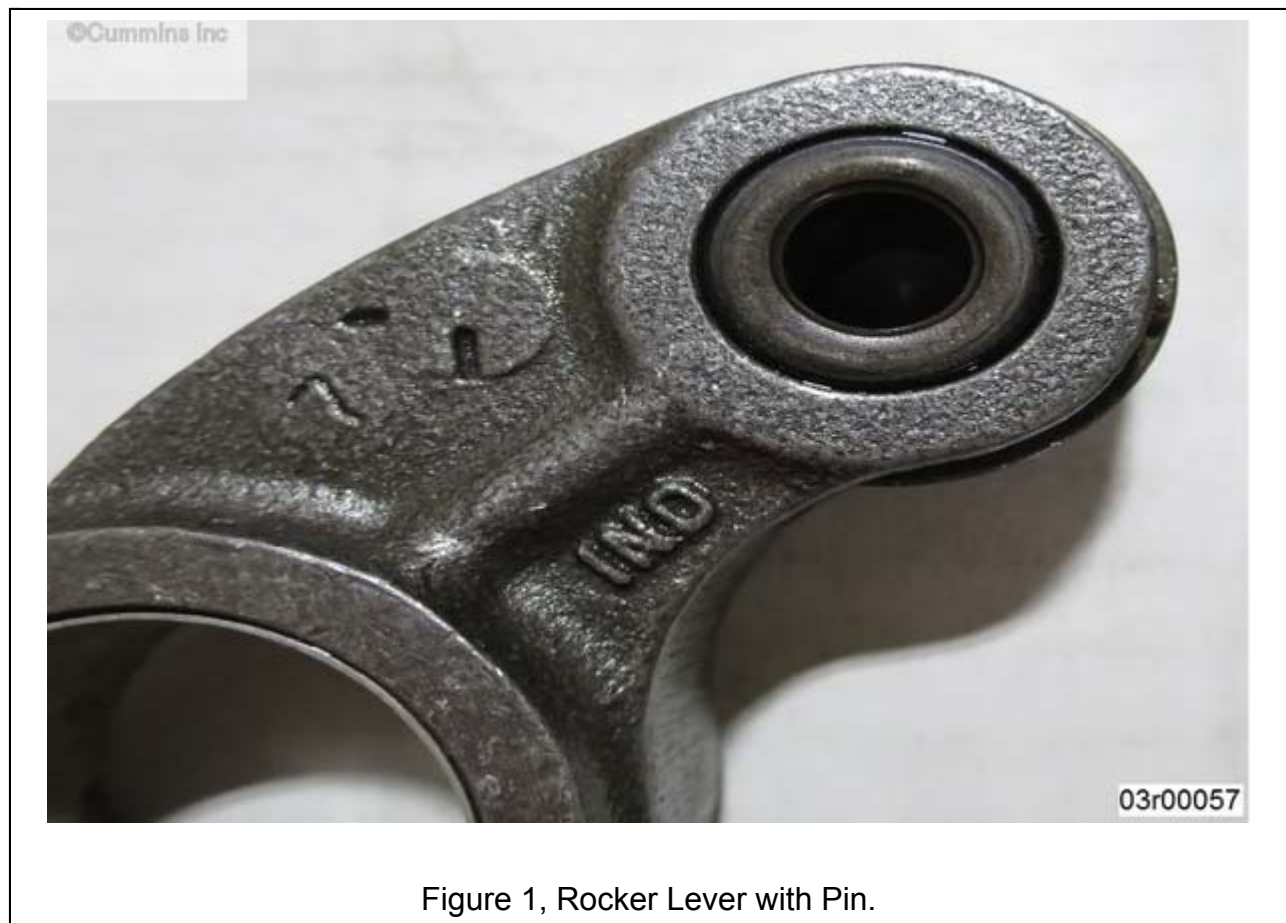
- A roller pin which is black in color. See Figure 1 below.
- A drilling on bottom leg of rocker lever. See Figure 2 below.

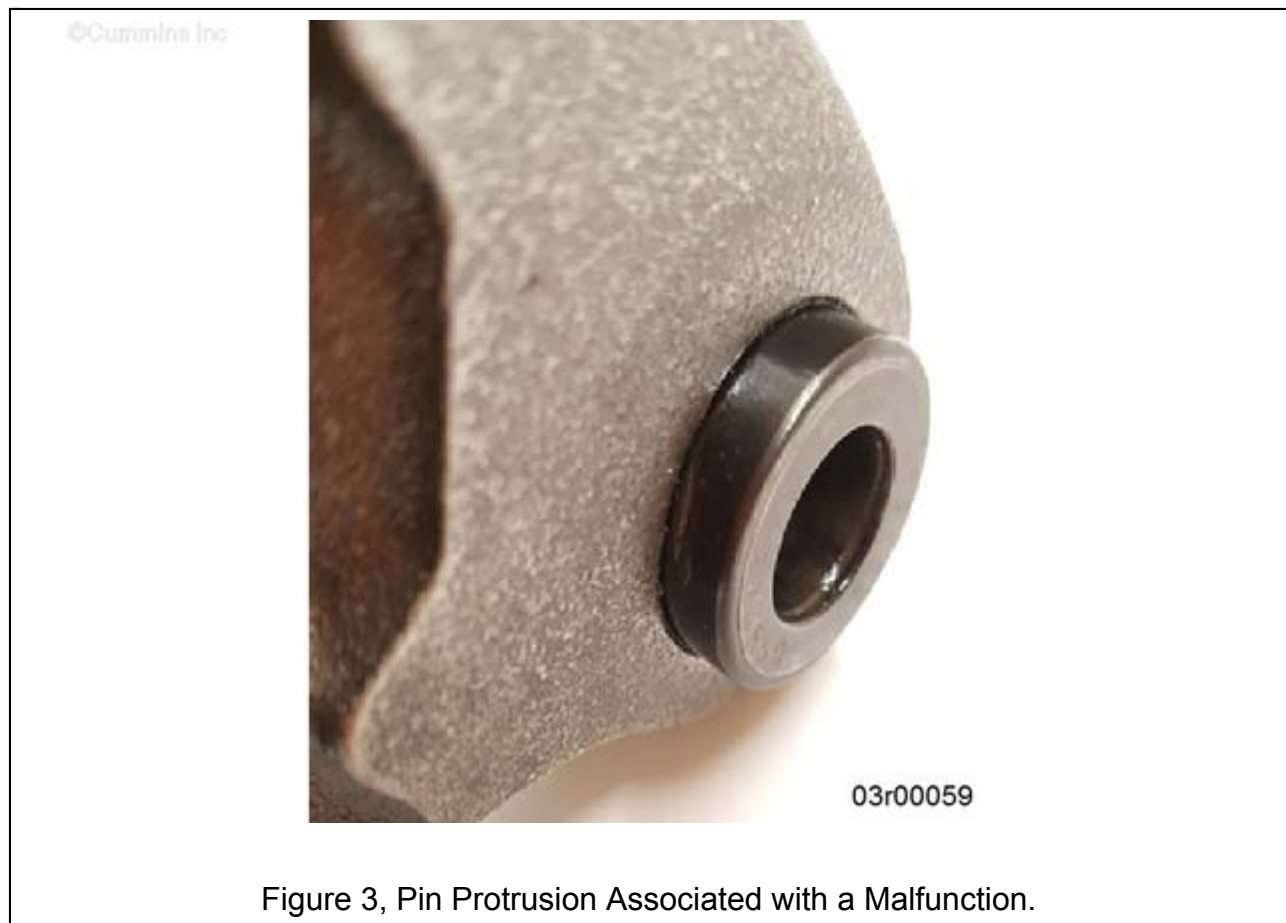
**Pin Protrusion:** Since the introduction of the hollow pin design, in some cases, it has been identified to have the cam follower pin to be protruding out of the side of the rocker lever cast surface. This condition is often associated with a pin and roller seizure issue (See Figure 3 below). This visual appearance condition does also exist on new production parts to a lesser extent and is considered normal. The graphics below have been provide to give an anticipated range of pin position (Figure 4). The amount of pin that protrudes past the cast surface may vary to the normal manufacturing process. If rocker levers are found to exceed the specifications provided, the rocker lever may need replaced.

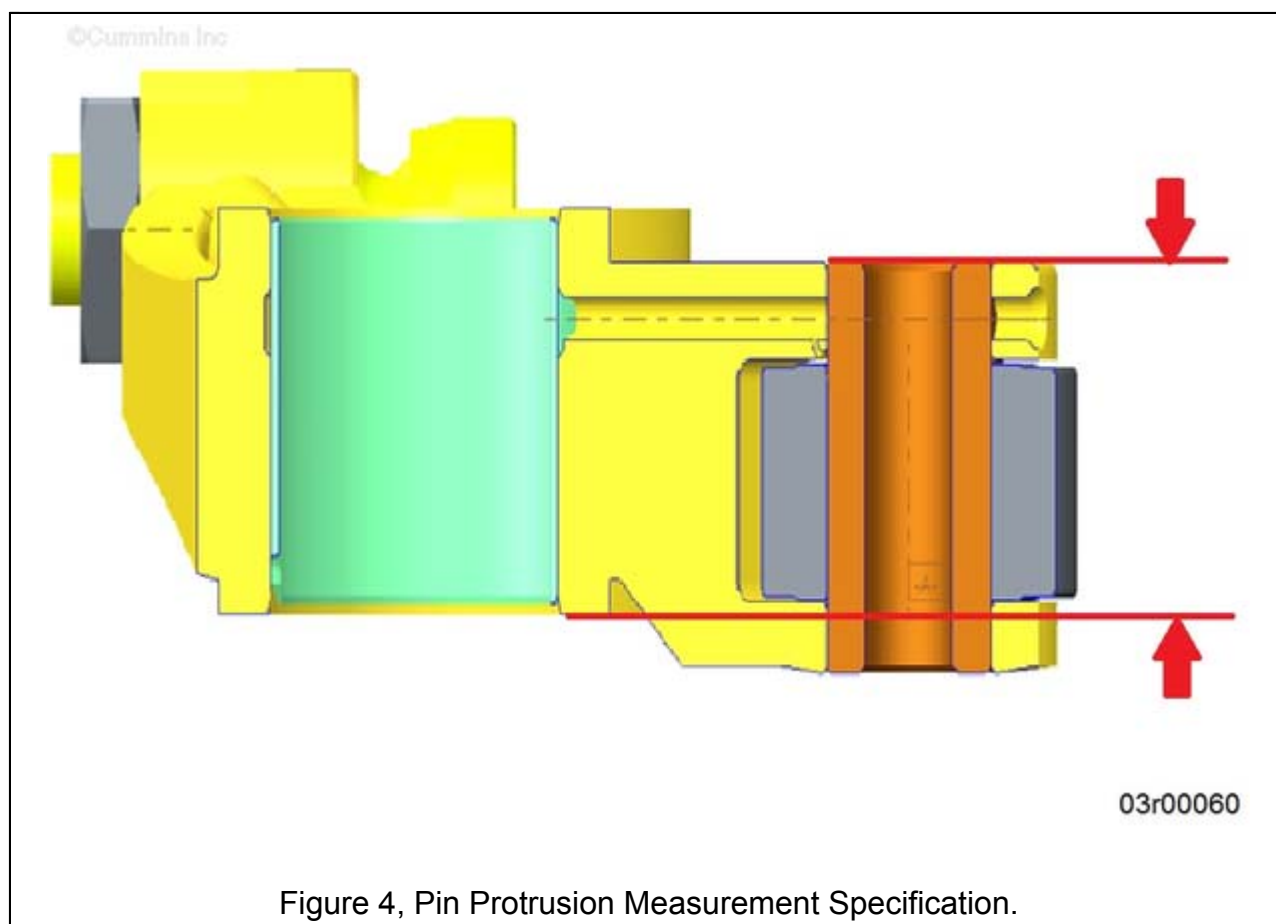
The pin location is determined by measuring the distance from the face of the cam follower pin from the side of the rocker lever that has the thick cast leg (it is also the surface that is on the same side of the lever as the adjusting screw) to the opposite thrust face of the rocker lever. The specification limit for this distance is 25.25 +/- 0.3 mm. See Figure 4.
