**\* \* TECHNICAL INFORMATION NOTICE \* \***

**DATE:** April 19, 2018  
**TO:** Mitsubishi Motors US Dealer Service and Parts Managers  
**RE:** Coolant Leaking from Hoses at CVT7 Fluid Cooler  
**TIN NO.** TIN-18-23-002

**AFFECTED VEHICLES:** 2014 – 2018 Mirage and 2017 – 2018 Mirage G4

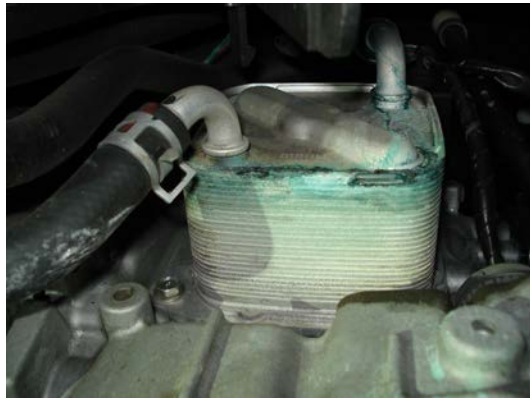
Dealers have reported coolant leaking from the transmission cooler line hoses at the CVT7 fluid cooler (see photo below). Normal dealer repairs have been to replace the hoses and/or clamps at the affected area.

(View looking up from the bottom of the vehicle)

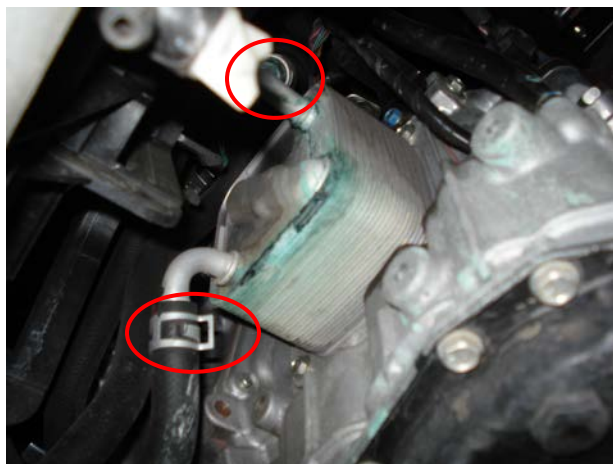
In order to investigate this condition further, MMNA is looking to collect 5 complete sets of CVT7 fluid coolers with the hoses and clamps undisturbed. Please do not remove the hose clamps indicated by the circled areas in the photo below. This is important since MMC needs to perform a duplication test to confirm the area of leakage.

Please open a Techline case, attach photos of the condition, and contact Techline (800-446-6064) to review the findings. Product Support will then contact the dealership to arrange return of the original parts to MMNA.
