LTB01162NAS1

TECHNICAL BULLETIN

501-05: Interior Trim and Ornamentation

Interior Veneer Inserts Scratched

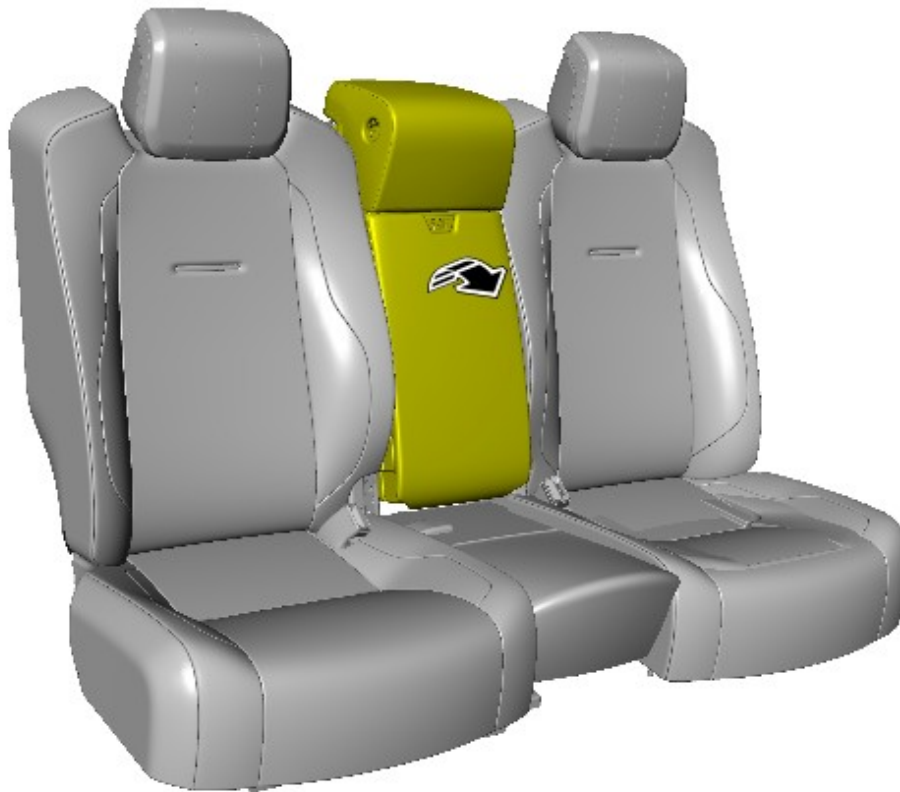
E223196

Lower the second row seat center backrest.

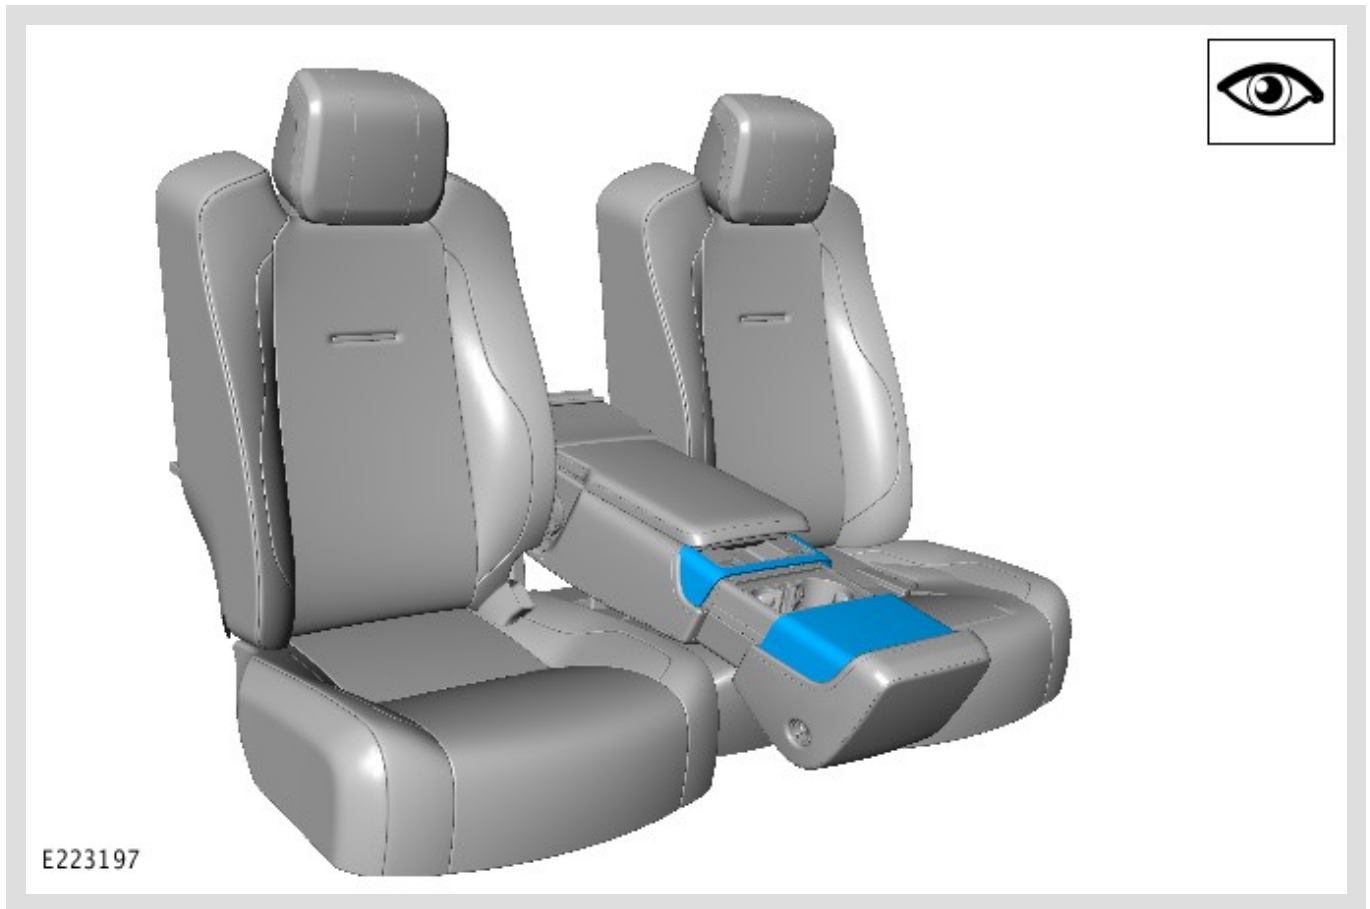
11

Inspect the second row seat center backrest veneer inserts for scratches.

- If scratches are not present, go to Step 13.
- If scratches are present, go to Step 12.

Use the polish and a clean, lint-free microfiber cloth (or equivalent) to gently remove any scratches from the veneer inserts.
