## DRAG LINK REPLACEMENT

Prevost vehicles

On the vehicles affected by this bulletin, proceed to the replacement of the drag link.

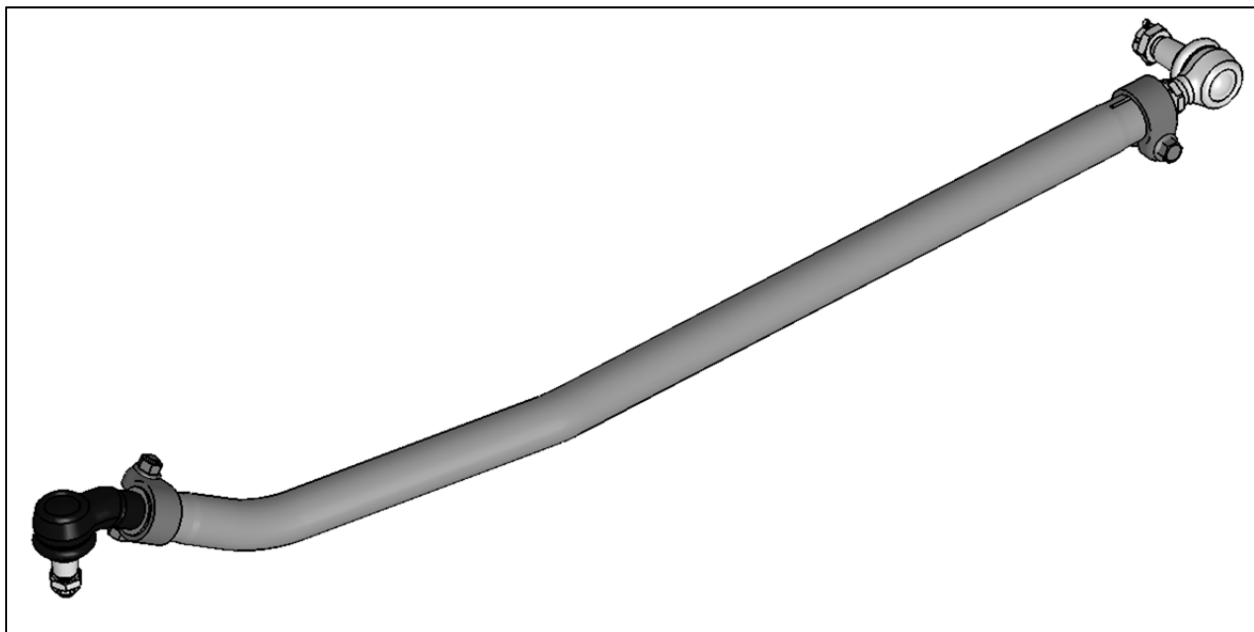
PART NO 660699

| Part No. | Description | Qty |
|---|---|---|
| 660699 | DRAG LINK ASSEMBLY | 1 |

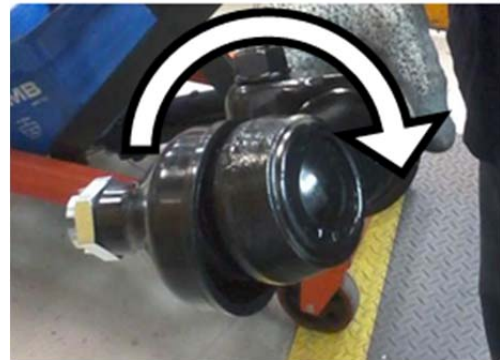
**FIGURE 2**

6. Screw the drag link elbow ball joint (knuckle side) fully in drag link tube.

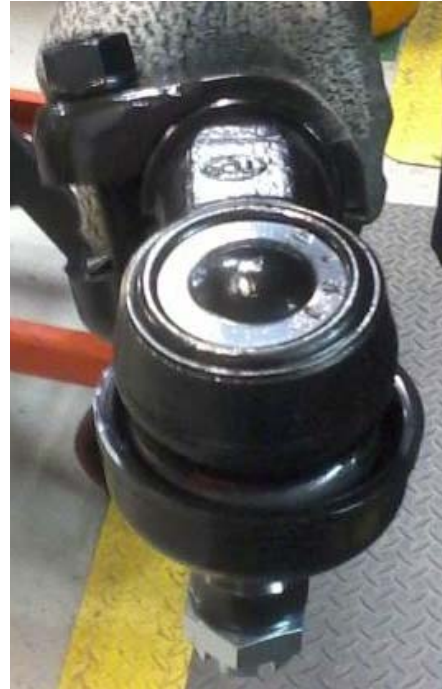
FIGURE 3

7. Unscrew the drag link elbow ball joint back out (**not more than 1 turn**) so the tapered shank points down as shown on FIGURE 1.

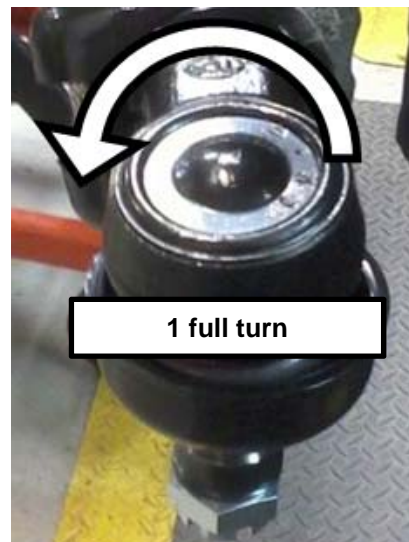
FIGURE 4

8. Unscrew the drag link elbow ball joint back out **one (1) full turn**. The tapered shank must point down as shown on FIGURE 1.

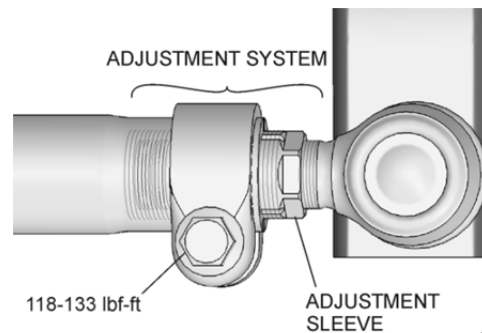
FIGURE 7

- On the drag link front end you will find an adjustment sleeve which has internal and external left and right threads.

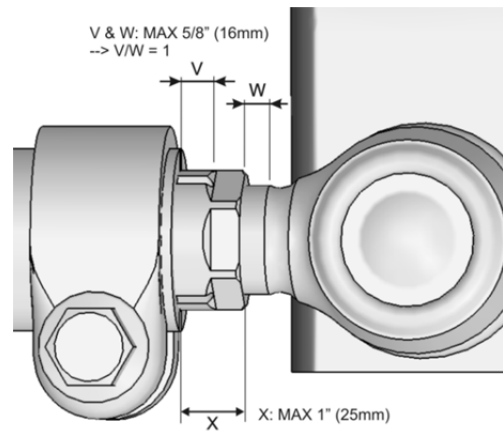
FIGURE 9

- Max dimension **V** : 5/8" (16mm) ± 1 thread pitch
- Max dimension **W** : 5/8" (16mm) ± 1 thread pitch
- Max dimension **X** : 1" (25mm)
- Dimension **V** and **W** should be equal. ( $V/W = 1$ )

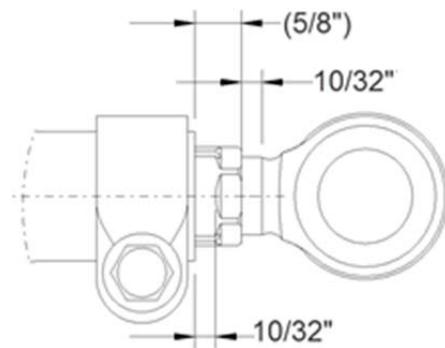
FIGURE 10

13. Adjust sleeve to the values of FIGURE 10.
14. Once the proper length adjustment is done, tighten the front end ball joint clamp. To prevent interference between the ball joint clamp bolts with other components of the steering system, the clamp bolt must be positioned horizontally as shown on FIGURE 11. **Tighten the clamp nut to 118-133 lbf-ft.**

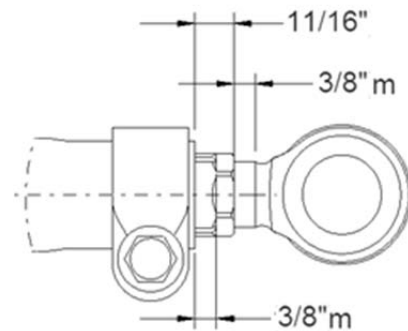
**FIGURE 12**

15. Adjust sleeve to the values of FIGURE 12.
16. Once the proper length adjustment is done, tighten the front end ball joint clamp. To prevent interference between the ball joint clamp bolts with other components of the steering system, the clamp bolt must be positioned horizontally as shown on FIGURE 13. **Tighten the clamp nut to 118-133 lbf-ft.**

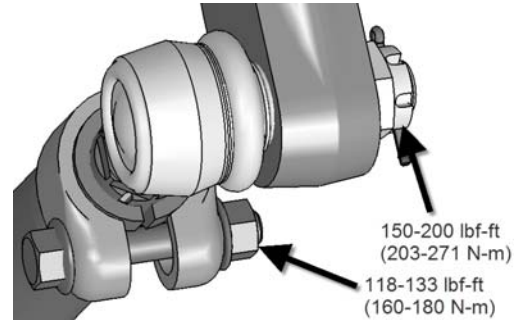
FIGURE 14

17. Install the drag link.
18. Ball joint castellated nut on both ends should be tightened to **150-200 lbf-ft**.
19. Install cotter pin **p/n 502104** and bend to lock bolt in place (see an example of a correct installation of a cotter pin on the image below).
20. Apply a small amount of anti-seize compound on all exposed threads for corrosion protection. Be sure to avoid smearing the ball joint boot.
