| REFERENCE: | Nova Bus Manuals |
| RS N°: | MQR 7621-1275 |

| SUBJECT: | Seat Rail (60' bus) |
| JUSTIFICATION: | Seats might get detached from damaged seat rails. |

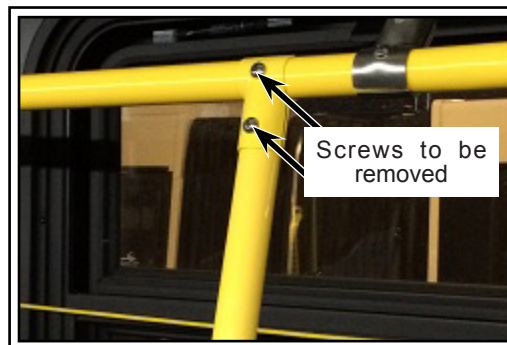
Figure 9 - Removal of Screws on the Stanchion

2.1.2. Remove screws on both sides top of stanchion bracket using phillips head screwdrivers (see Figure 9).

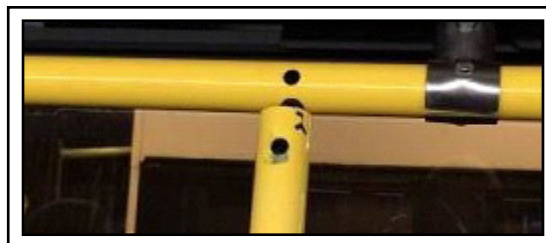
Figure 10 - Typical View of Wiring Slack

2.1.3. Remove the stanchion bracket and carefully pull wiring slack out of the stanchion (see Figure 10).

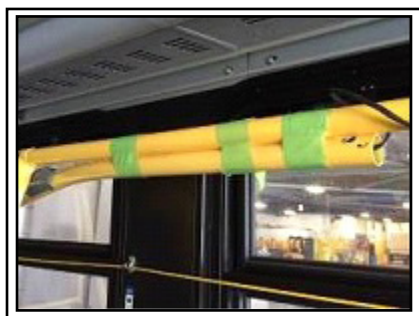
Figure 12 - Typical View of Securing the Stanchion

2.1.5. Temporarily tape the stanchion onto the top rail (see Figure 12).

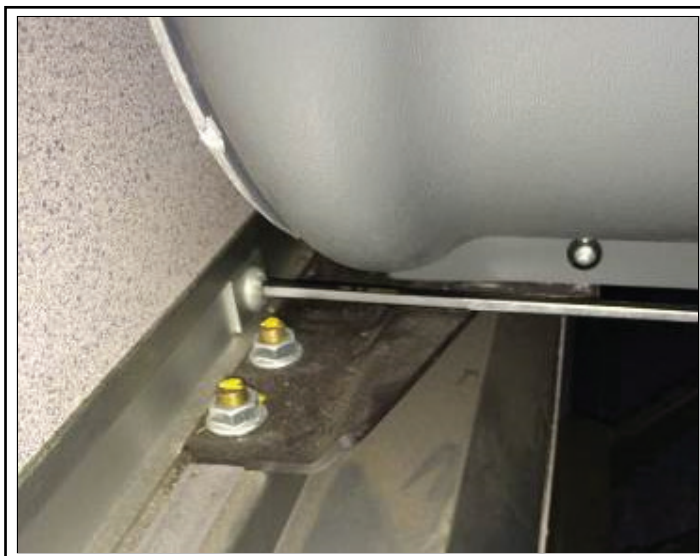
Figure 23 - Installation of Damaged Hardware to attach Seat Rail on Wall

- 2.20. Replace the damaged hardware with new hardware provided (see Figure 23).

- 2.21. Apply loctite and torque hardware to 16 lb-ft (21 N•m).  
2.22. Apply torque seal on all hardware torqued. Proceed to step 2.26.  
2.23. Replace the damaged hardware with new hardware provided (see Figure 24).

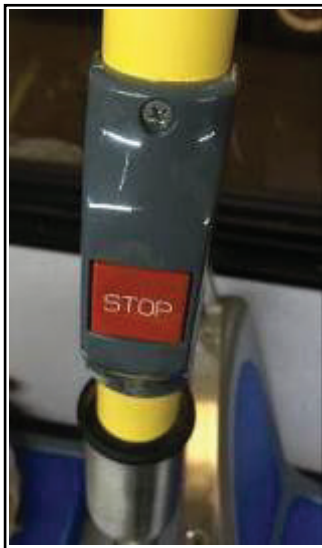
Figure 25 - Typical View of Next Stop Request Button

- 2.26. Set the battery disconnect switch in the battery compartment to ON position.
- 2.27. Test and Confirm that the next stop request activates when button is pushed (see Figure 25).
