SUBJECT:	ZF service bulletin 80-17 for wheel bearing assembly - ZF axles (Type A/AV/AVN)
JUSTIFICATION:	Inner slotted nuts may mislocate the wheel bearing assembly.

ANNEX - CHECKING OF SLOTTED NUT-HUB BOLT CONNECTION ON A 132, AV 110/132/133, AV 132

Checking of slotted nut-hub bolt connection on A 132, AV 110/132/133, AVN 132

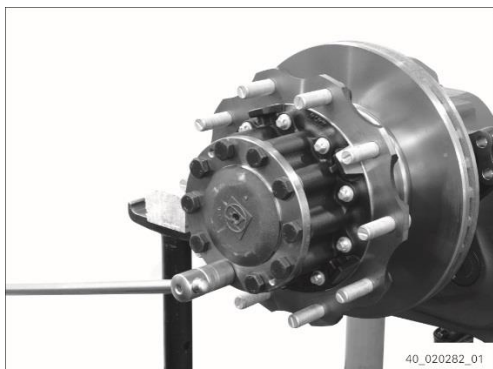
Figure 1

1. Fix hub by inserting the parking brake.
2. Loosen screws of the flange shaft.

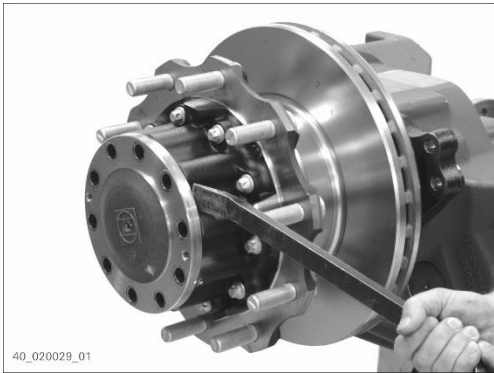
Figure 2

3. Observe safety instructions environment.
Remove flange shaft and collect leaking oil.
4. Unlock outer slotted nut.

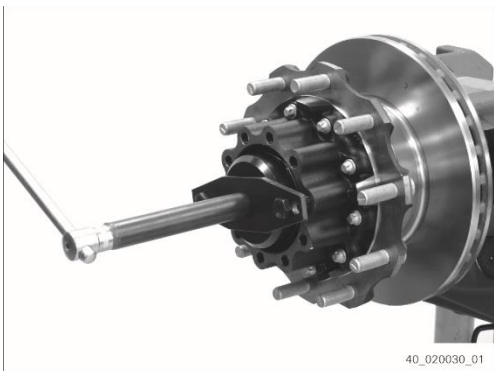
Figure 3

5. Loosen outer slotted nut with 5870.401.146 [slotted nut wrench].
6. Remove locking plate.
7. Loosen inner slotted nut with 5870.401.146 [slotted nut wrench].

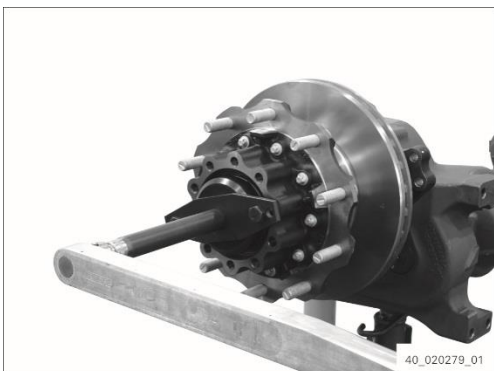
Figure 4

8. Tighten inner slotted nut with 5870.401.146 [slotted nut wrench].
Tightening torque: **100 Nm**
9. Rotate the hub in both directions several times.
10. Tighten inner slotted nut with 5870.401.146 [slotted nut wrench].
Tightening torque: **850 Nm**
11. Push **new** locking plate with tab pointing inwards onto the hub carrier.
12. Bolt on outer slotted nut with the chamfer pointing inwards.
13. Tighten outer slotted nut with 5870.401.146 [slotted nut wrench].
Tightening torque: **1200 Nm**

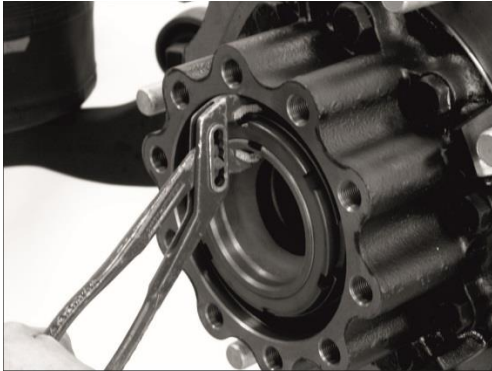
Figure 5

14. Secure outer slotted nut with locking plate.

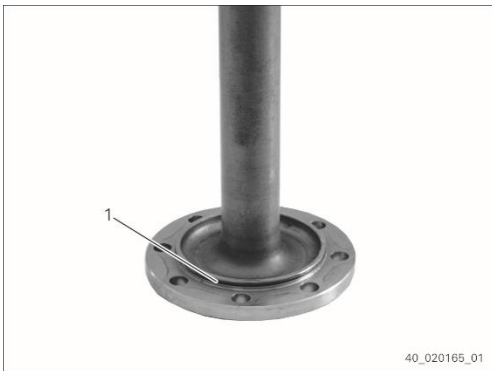
Figure 6

15. Grease **new** O-ring (1) and insert it into the annular groove of the flange shaft.

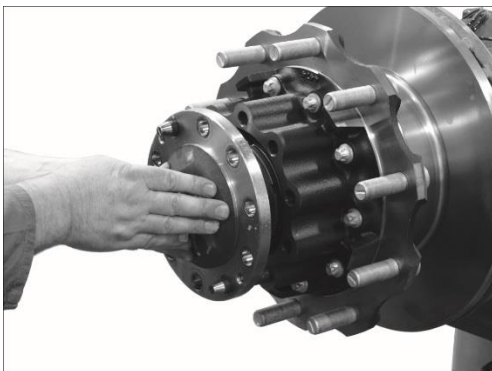
Figure 7

16. Push flange shaft into the hub carrier.

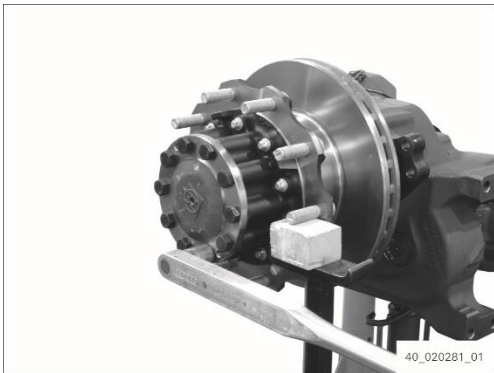
Figure 8

17. Fix hub by inserting the parking brake.
18. Turn in and tighten the screws.
Tightening torque: **440 Nm**

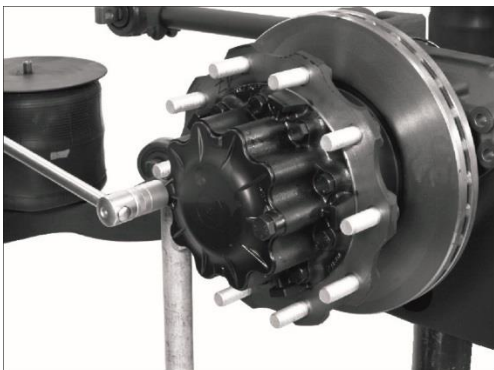
Figure 9

1. Fix hub by inserting the parking brake.
2. Loosen screws of the cover.
3. Observe safety instructions environment. Remove cover.
4. Unlock outer slotted nut.

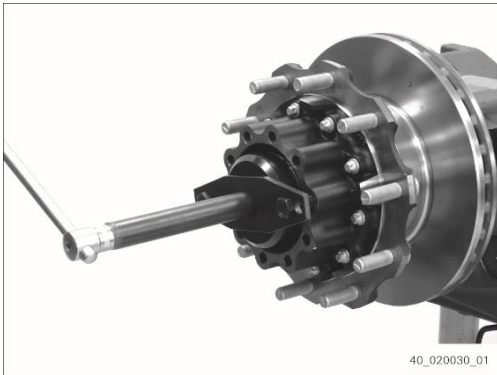
Figure 10

5. Loosen outer slotted nut with 5870.401.146 [slotted nut wrench].
6. Remove locking plate.
7. Loosen inner slotted nut with 5870.401.146 [slotted nut wrench].

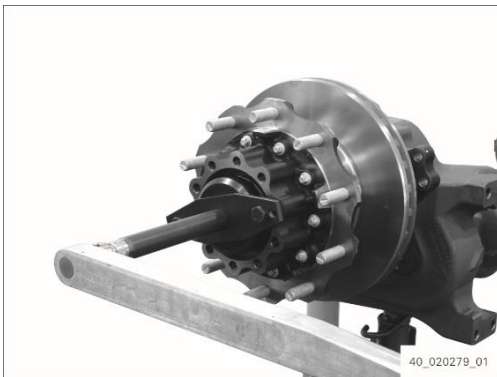
Figure 11

8. Tighten inner slotted nut with 5870.401.146 [slotted nut wrench].
Tightening torque: **100 Nm**
9. Rotate the hub in both directions several times.
10. Tighten inner slotted nut with 5870.401.146 [slotted nut wrench].
Tightening torque: **850 Nm**
11. Push **new** locking plate with tab pointing inwards onto the hub carrier.
12. Bolt on outer slotted nut with the chamfer pointing inwards.
13. Tighten outer slotted nut with 5870.401.146 [slotted nut wrench].
14. Tightening torque: **1200 Nm**

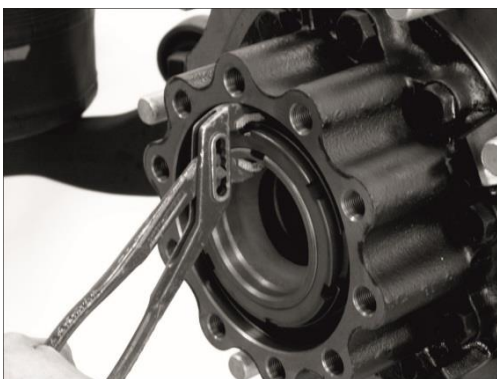
Figure 12

15. Secure outer slotted nut with locking plate.

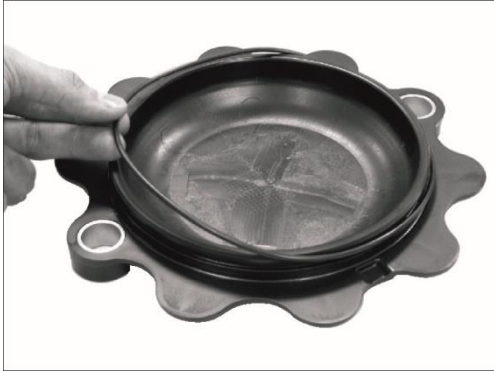
Figure 13

16. Grease **new** O-ring and insert it into the annular groove of the cover.

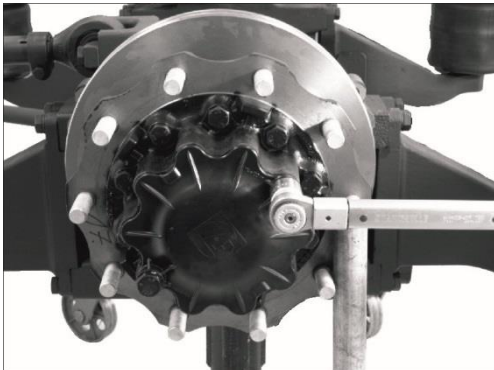
Figure 14

17. Insert cover until contact is obtained.
18. Fix hub by inserting the parking brake.
19. Turn in and tighten the screws.
Tightening torque: **100 Nm**
