SERVICE ACTION

Reference number:	SA-00-1080	Issued: 20 April, 2018
Subject:	DB11 Volante Emergency Roof Tool	
Model(s):	DB11 Volante	
VIN range:	Refer to the separately published list of Vehicle Identification Numbers (VINs)	
Applicable to:	All Dealers	
Distribute to:	After Sales Manager Executive Manager Service Manager Sales Manager	Warranty Staff Technician(s) Parts Staff

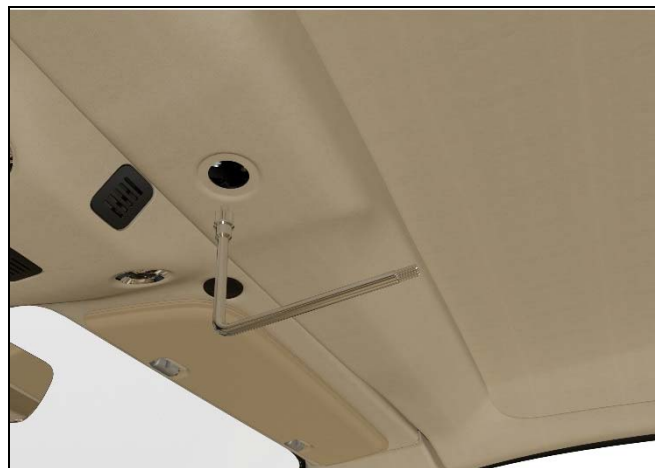
Figure 1

Due to a parts supply issue some of the initial DB11 Volantes do not have the emergency roof tool. This is used to lock and release the convertible roof in the event of a failure (refer to Figure 1).

This Service Action gives instructions to supply and fit the emergency roof tool to these vehicles.

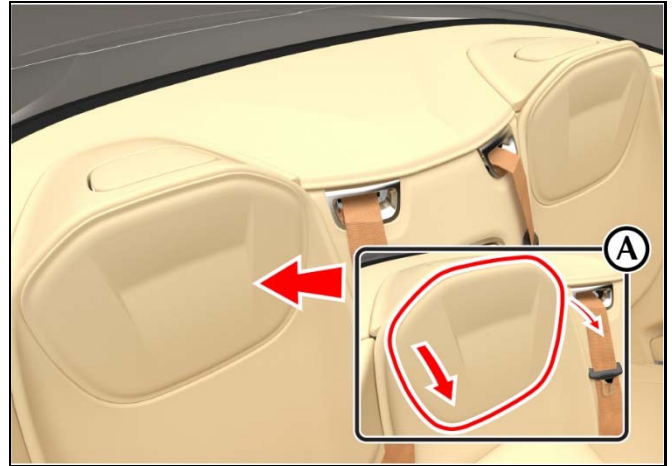
**Figure 2**

1. Remove the head rest trim panel for the right side rear seat area (A) (refer to Figure 2).

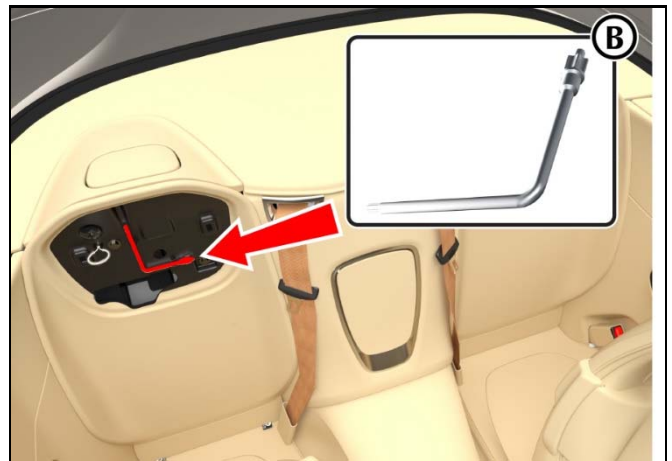
**Figure 3**

2. Install the emergency roof tool (B) into the storage compartment in the right side rear seat. (refer to Figure 3).
