## TECHNICAL SERVICE BULLETIN

### Manual Liftgate Difficult To Close - Power Liftgate Bounce Back And/Or Will Not Cinch - Built On Or Before 1-Sep-2017

18-2099

<b>Ford</b> 2017 Escape
----------------------------

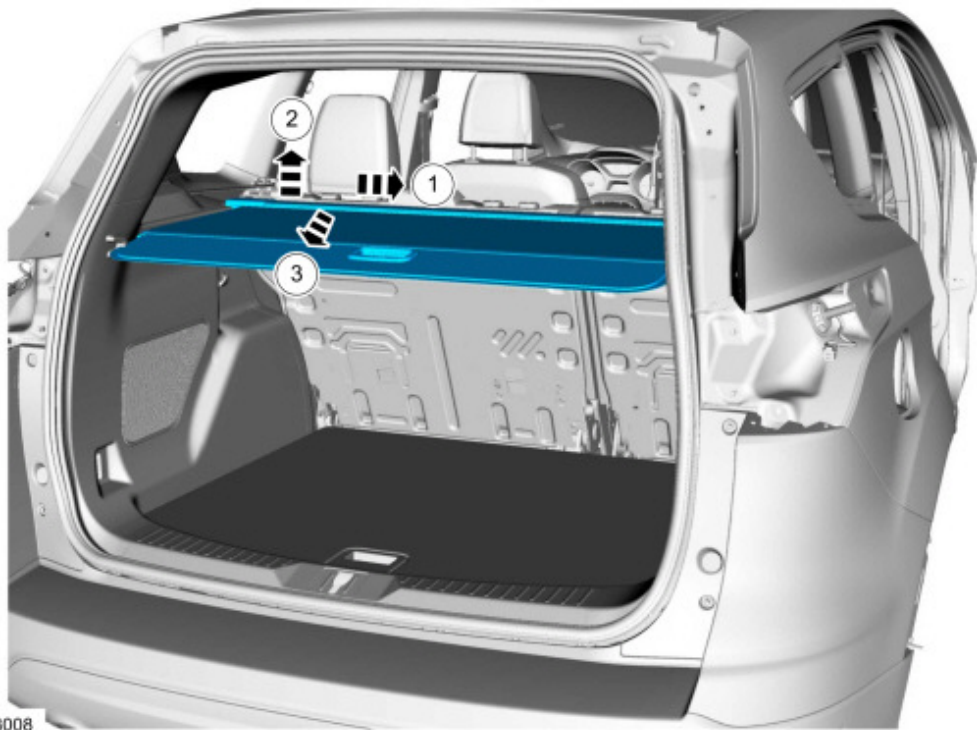
Figure 1

- Check the vehicle build date. Was the vehicle built on or before 1-Sep-2017?
  - Yes – proceed to Step 2.
  - No – this article does not apply. Refer to Workshop Manual (WSM), Section 501-03 for normal diagnostics.
- If equipped, remove the package cover. (Figure 1)
  - Slide the package cover to the side to release from the loadspace trim panel.
  - Lift up on the package cover to disconnect from the loadspace trim panel.
  - Remove the package cover.

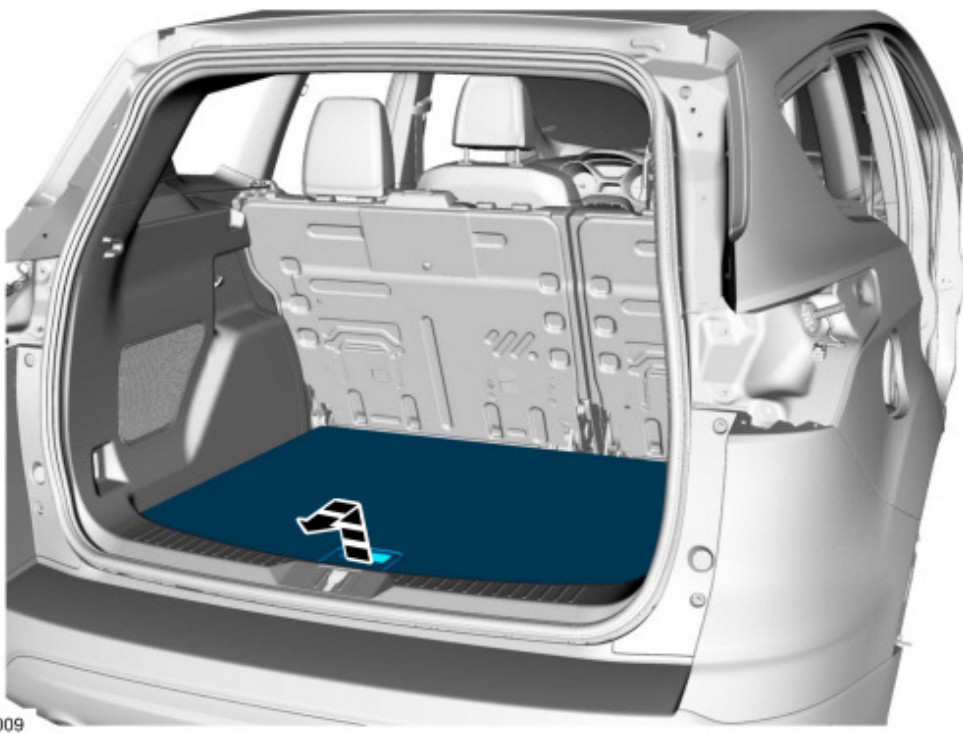
Figure 2

3. Remove the luggage compartment floor covering. (Figure 2)

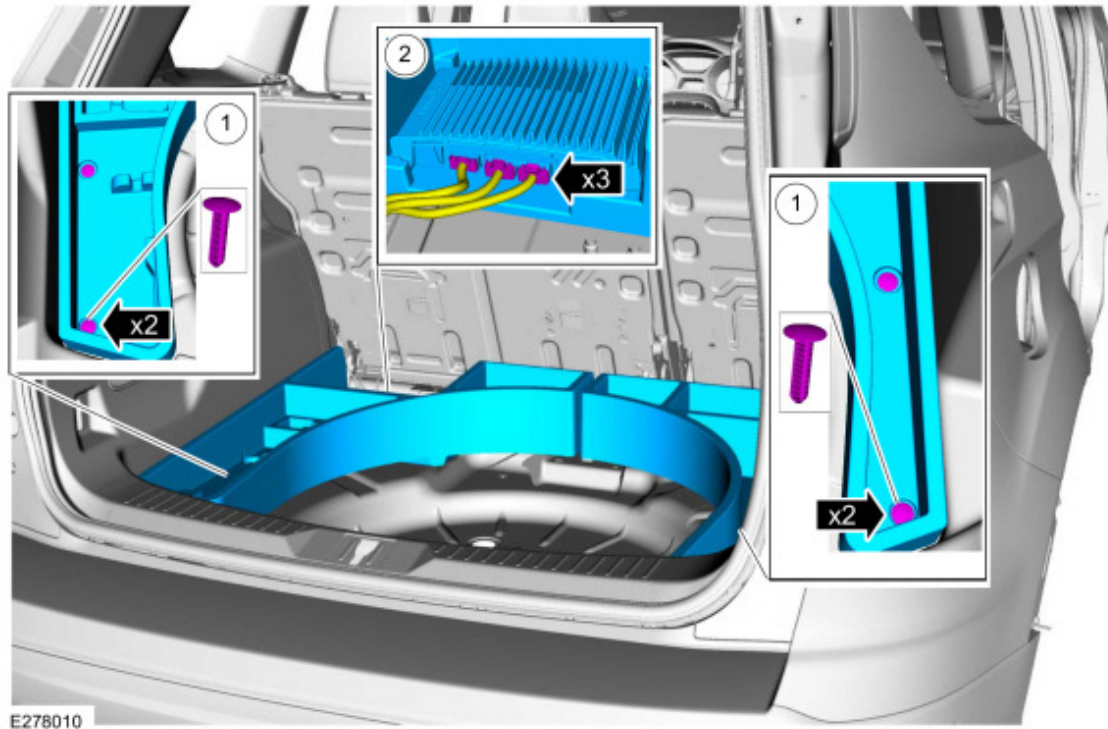
Figure 3

4. Remove the loadspace storage compartments. (Figure 3)

(1). Remove the retainers.

(2). If equipped, disconnect the amplifier electrical connectors and remove the storage compartments.

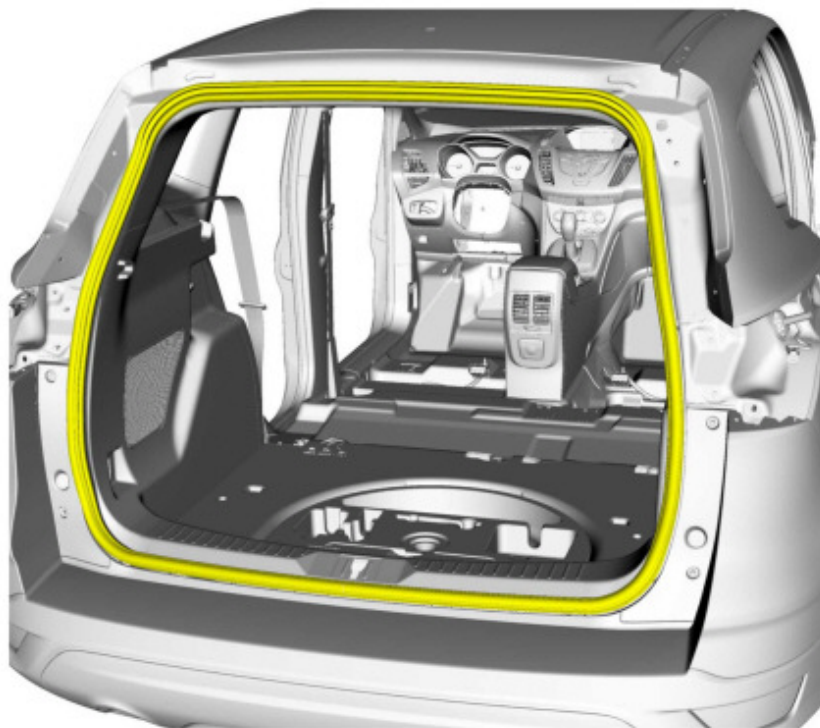
Figure 4

5. Position the liftgate weatherstrip aside. (Figure 4)

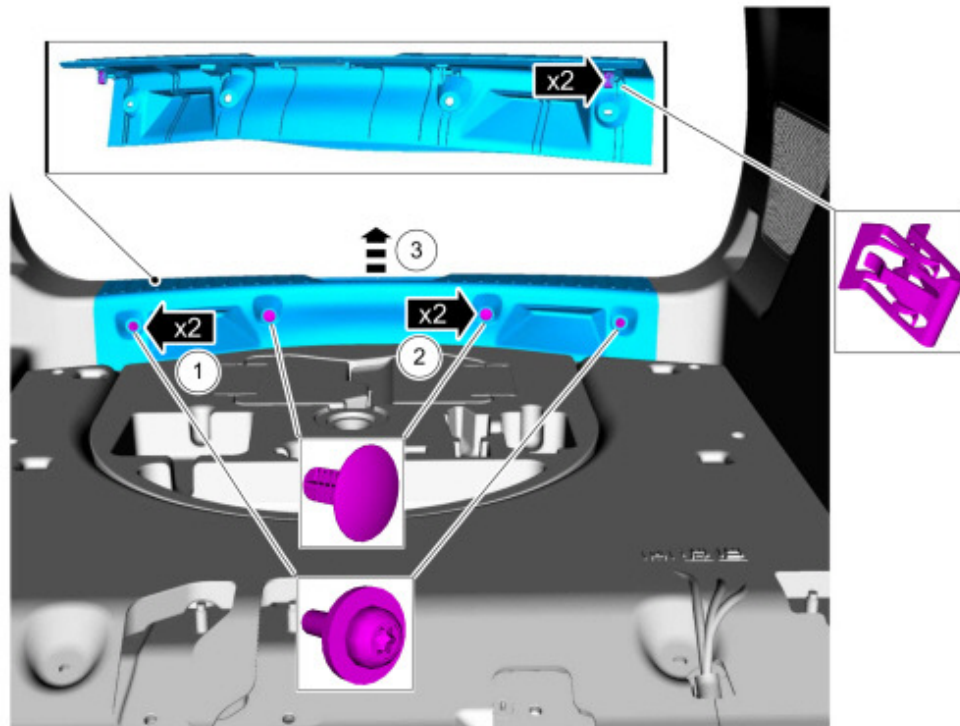
Figure 5

6. Remove the liftgate scuff plate trim panel. (Figure 5)

- (1). Remove the retainers.
- (2). Remove the pin-type retainers.
- (3). Release the clips and remove the liftgate scuff plate trim panel.

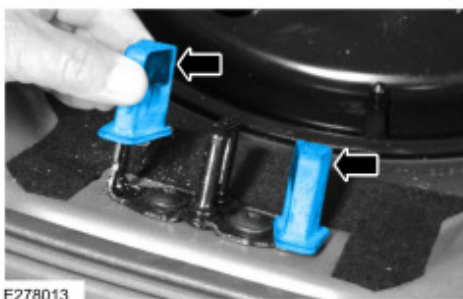
Figure 6

7. Remove the striker bumpers by hand from the liftgate striker. (Figure 6)

**9.** Install striker bumpers to liftgate striker.

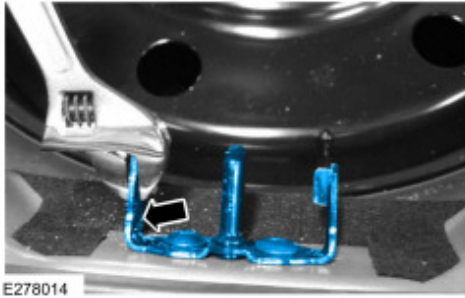
Figure 7

8. Using an adjustable wrench, bend the striker wings outward equally on each side until 84.5-85.0 mm (3.327-3.346 inches) is attained. If bent too wide, gradually bend each side in equally to attain this distance. (Figure 7)
