Service Bulletin

Bulletin No.: 16-NA-252

Subject: Information on Rear Tire Front Air Deflector Missing One Fastener Per Side

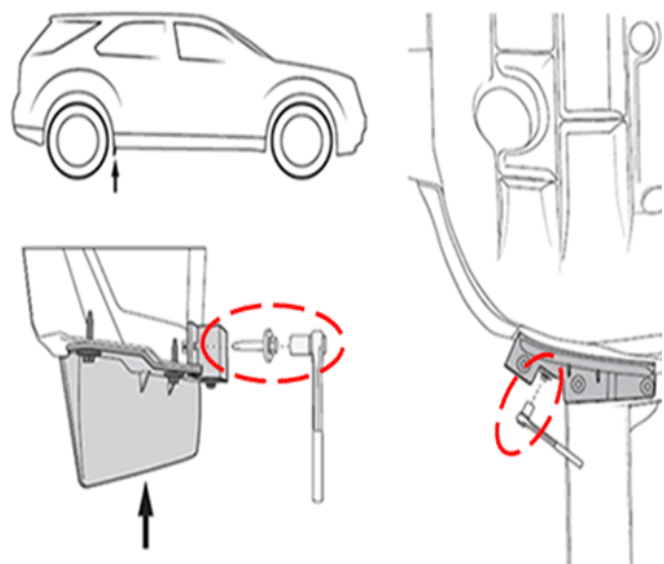
4568517

Involved Region or Country	North America and N.A. Export Regions
Additional Options (RPOs)	PLANT CODE-INGERSOLL, ONT, CANADA (CAMI) — (NGT)
Condition	During Pre Delivery Inspection (PDI), a technician may find two bolts and an instruction sheet in a loose part bag, and/or may find both rear tire front air deflectors missing one fastener per side.
Cause	The cause of the condition may be that the assembly plant was unable to install the rear tire front air deflector fasteners at these two locations.

1. Reaching under the rocker panel, feel along the rear tire front air deflector for the open hole at the **only horizontal** fastener location, shown circled in the illustration above.

Install both missing rear tire front air deflector bolts (one per side) from the supplied service kit found in the loose part bag. If kit is missing, order a replacement kit using the Parts Information below.

2. Install the bolt and tighten to 2.5 N•m (22 lb in).
3. Repeat bolt installation on the opposite side.
