# Service Bulletin

Bulletin No.: 18-NA-085

**Subject:** Information On Performing an Exhaust Leak Test

Brand:	Model:	Model Year:		VIN:		Engine:	Transmission:
		from	to	from	to		
Chevrolet	Silverado Models	2017	2018			L5P	
GMC	Sierra Models

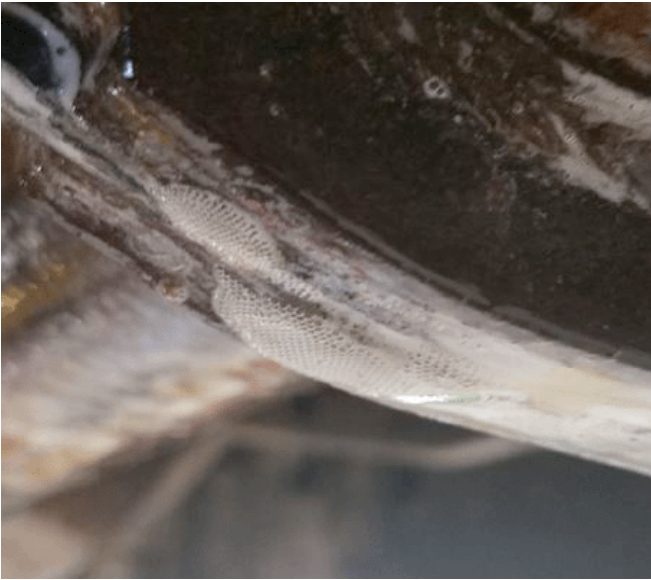
5001644

- This should be considered a level 1 leak due to the small amount of very small bubbles in the soapy solution. The service procedure leak test may indicate if this is an acceptable leak.

⇒ If required, take corrective actions to repair the leaks.

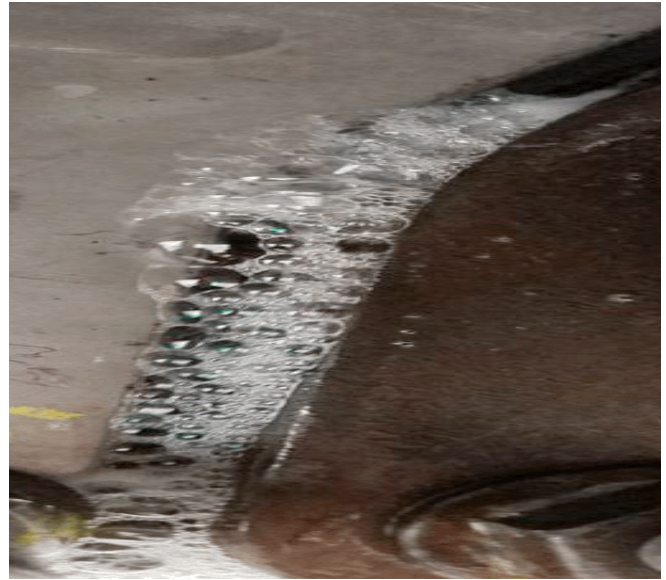
5001655

- This photo represents a level 3 leak since it shows larger bubbles than the level 2.

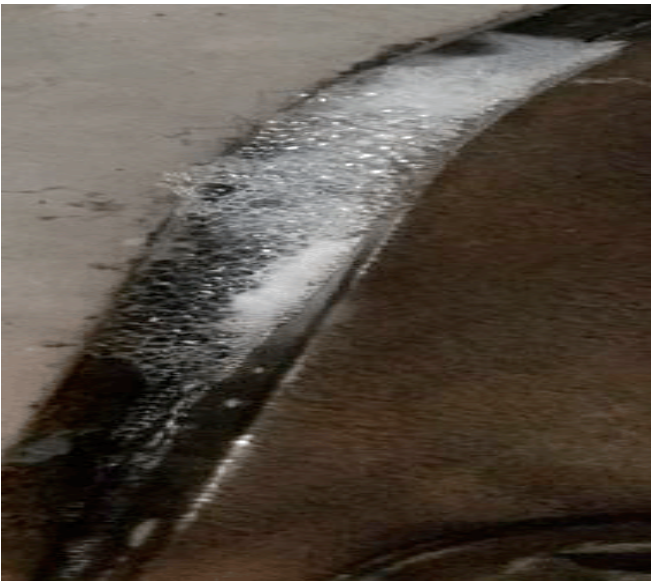
5001647

- This should be considered a level 2 leak due to the small amount of small bubbles in the soapy solution.

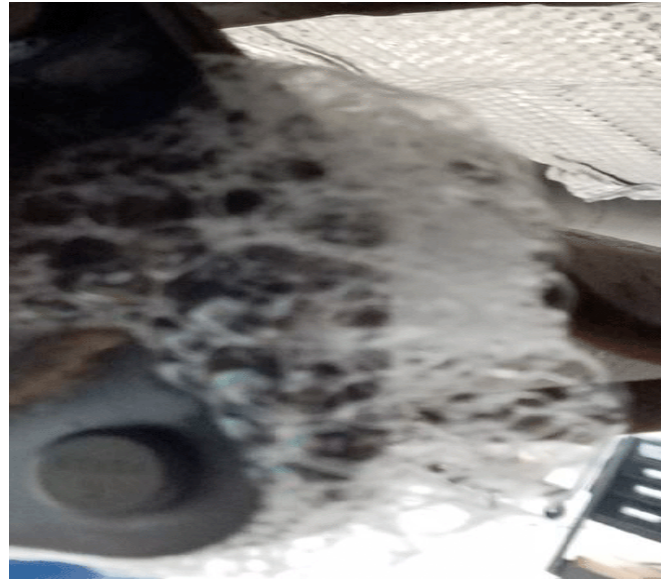
5001665

- This photo represents a level 4 leak since it shows very large bubbles. This leak should also be visible when performing a smoke leak test.

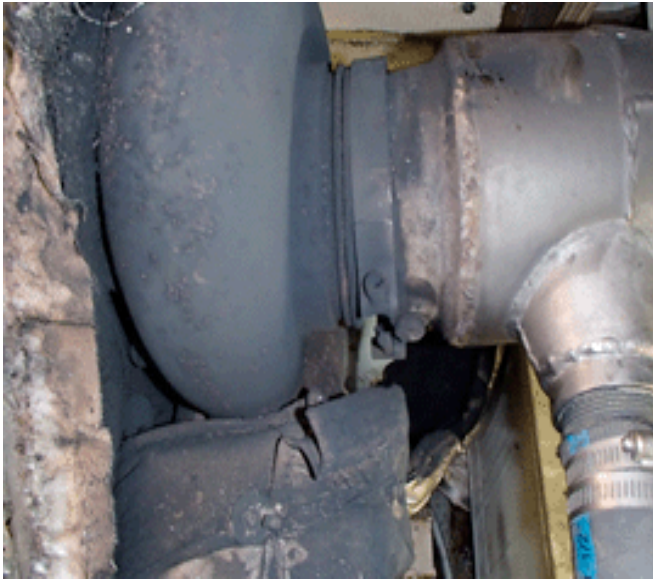
5001683

- This photo represents a level 5 leak. This leak is so large that soapy solution will not form around the leak. This leak can be found using a smoke leak test.
