Service Bulletin

Bulletin No.: 18-NA-046

Subject: Headlamp Bezel Loose or Falling Off

| Brand: | Model: | Model Year: | | VIN: | | Engine: | Transmission: |
|---|---|---|---|---|---|---|---|
| Chevrolet | Silverado - Light Duty | 2016 | 2018 | | | All | All |

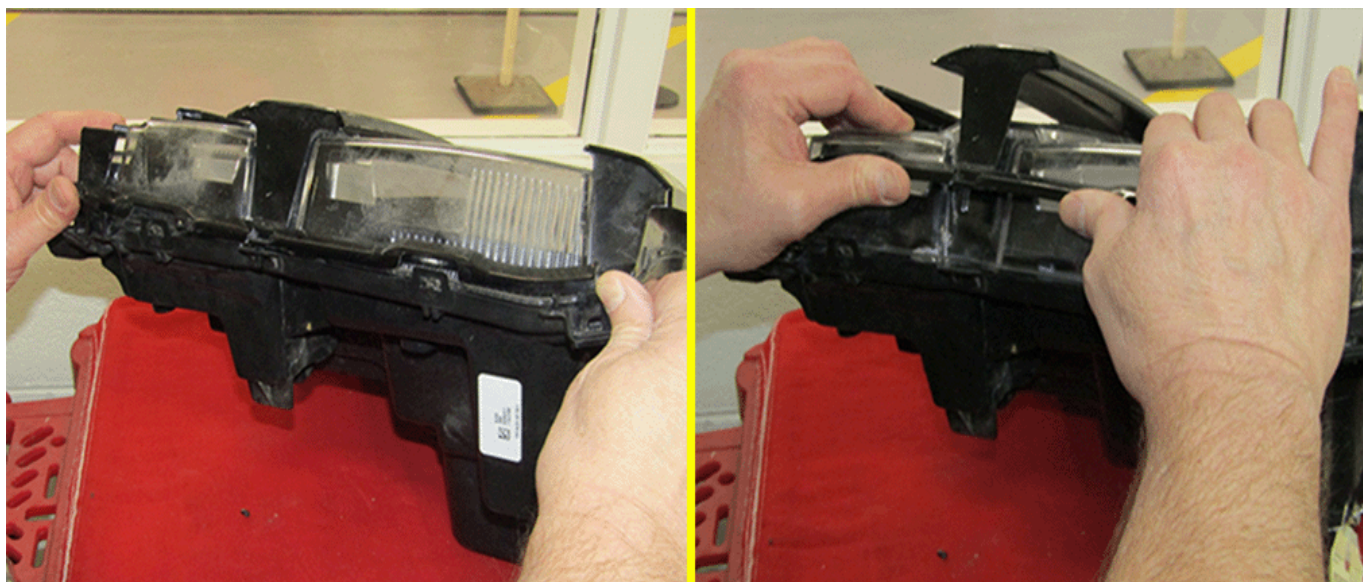
4971116

1. Remove the affected headlamp assembly from the vehicle. Refer to the appropriate side *Headlamp Replacement (Chevrolet)*, in SI.
2. Place headlamp on a protected surface.

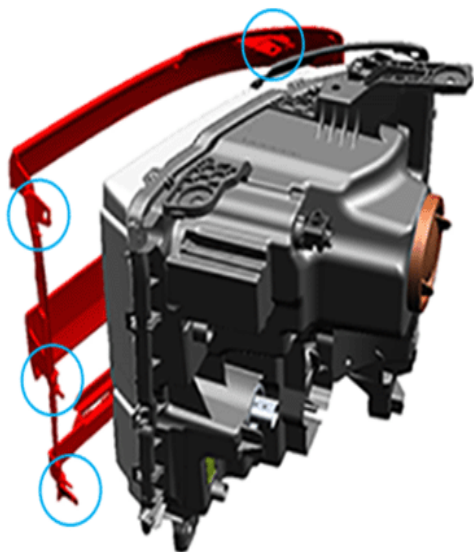
4971117

Important: To avoid damaging the bezel, gently push upward in a uniform manner, without twisting the bezel. This should release the attachment tape from the loose side across to the opposite side and the bezel can be detached from the headlamp.

3. Grabbing the top and bottom corners of the loose side of the headlamp bezel, carefully push the bezel upward to release the remaining tape holding the bezel to the lamp.

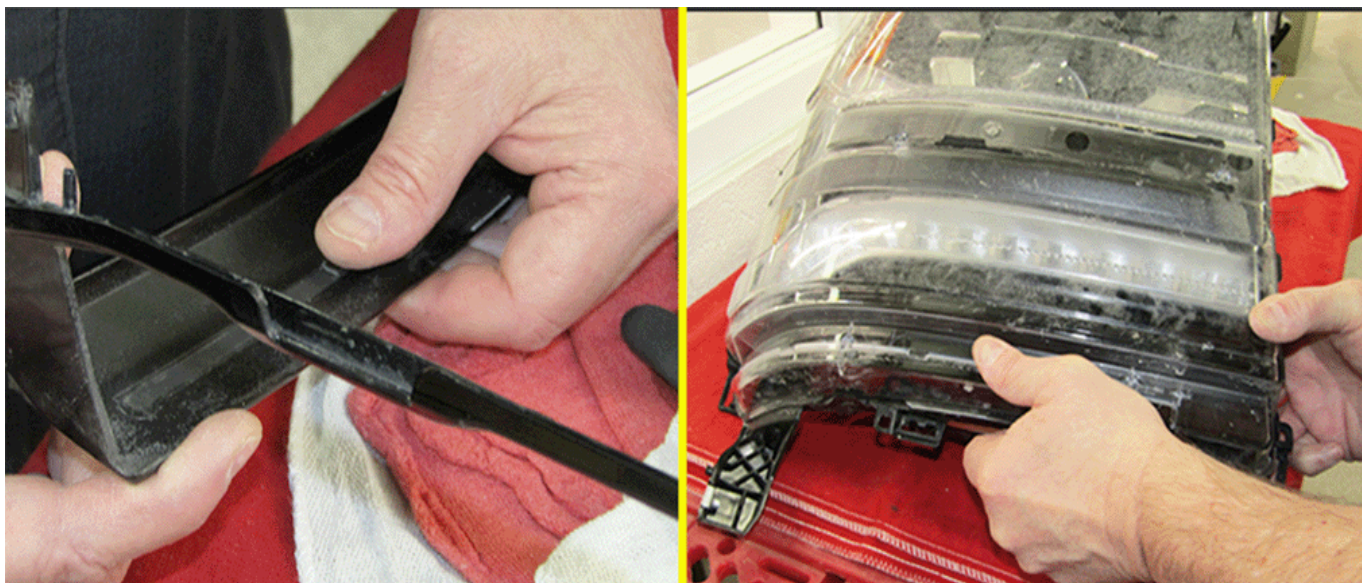
4971119

4. Once the tape is loose, carefully detach the bezel's retention tabs from the mating slots in the headlamp assembly.

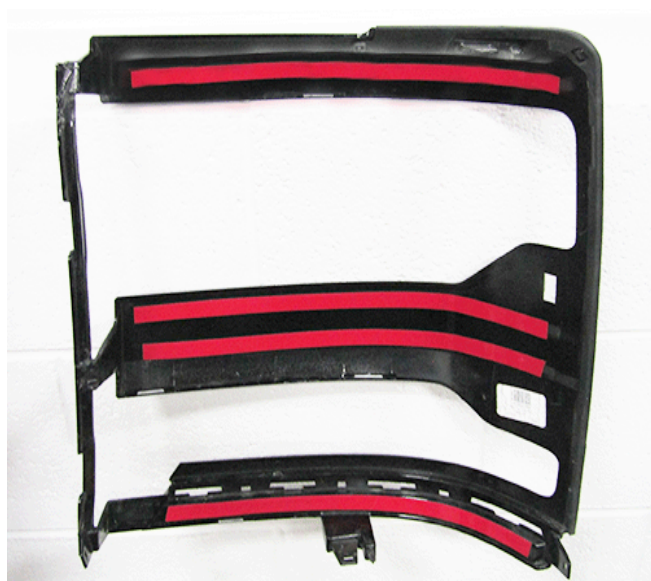
4971121

6. Completely clean both surfaces again with mild soap and water mixture, glass cleaner or equivalent.
7. Wipe both surfaces dry with a clean cloth.
8. Cut two 38 cm (15 in) lengths and two 35 cm (13.5 in) lengths of 3M Automotive Acrylic Plus Tape P/N 06382, or equivalent.

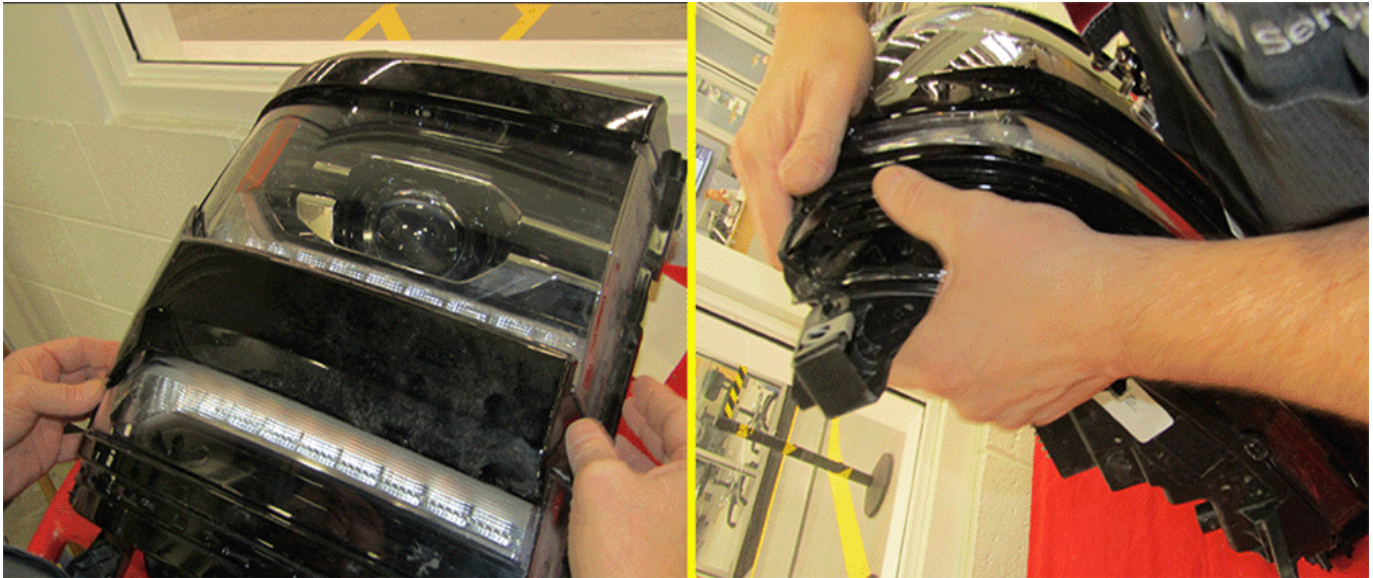
4971122

9. Apply the 38 cm (15 in) lengths of tape to the center of the bezel, positioning it directly over the visible previous location of the tape.
10. Apply the 35 cm (13.5 in) lengths of tape to the top and bottom of the bezel, positioning it directly over the visible previous location of the tape.
11. Firmly press and wet out all four pieces of the tape across the full length of the bezel.
12. Peel the protective film from the tape and position the bezel to the headlamp.

13. Ensure all retention tabs are engaged in their mating slots, and firmly press the bezel to the headlamp. Firmly press along all areas where the tape was applied.
14. Reinstall the headlamp to the vehicle. Refer to the appropriate side *Headlamp Replacement (Chevrolet)*, in SI.
