Bulletin No.: PI0725B

Service Bulletin

Subject: Normal Engine Cylinder Bore Marks

Models: 2009-2014 Chevrolet Aveo
2011-2015 Chevrolet Cruze
2016 Chevrolet Cruze (VIN P)
2012-2018 Chevrolet Sonic
2009-2011 Holden Barina
2009-2010 Pontiac G3, Wave
Equipped with 1.6L or 1.8L Engine (VIN Code E, G, H – RPO LXV, LWE or LUW)

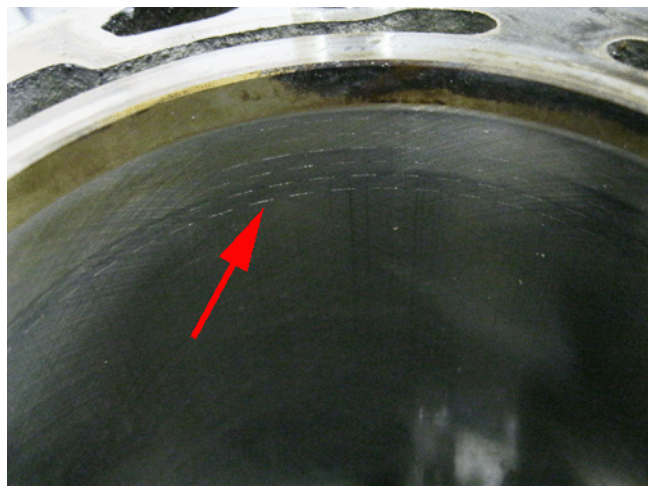
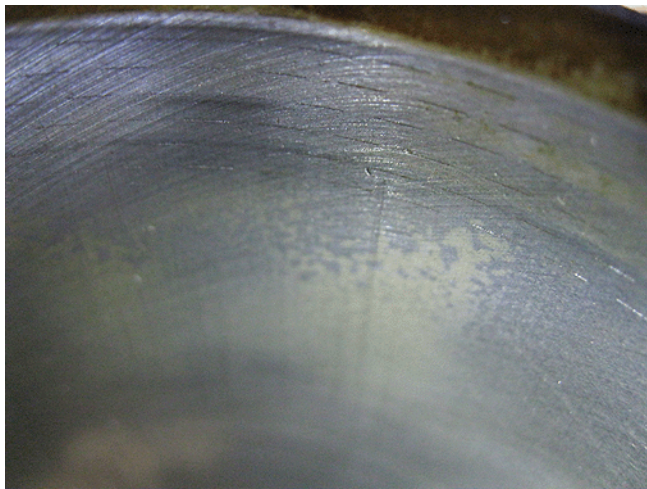
Some technicians may be replacing entire engine assemblies due to marks found at the top of the cylinder bore.

These marks are considered normal and are left as a result of a manufacturing laser honing process. **DO NOT** replace the cylinder block or engine for these normal honing marks.
