# Service Bulletin

Bulletin No.: 18-NA-138

**Subject: Radio Control (ICS) Display Does Not Remain Off at Times after it has Been Turned Off in Radio Settings Menu**

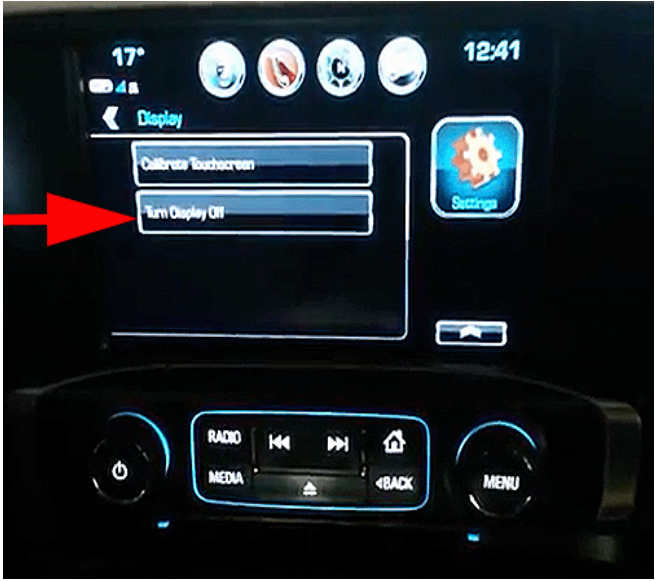
<p style="text-align: right;">5046857</p> <p>Some customers may comment that the radio control (ICS) display does not remain off at times even though it has been turned off in the display settings menu shown above.</p>
<b>Cause</b>	This may be due to an interaction between the radio control display, HVAC module, and OnStar module.
<b>Correction</b>	Refer to the Service Procedure listed below.

If this concern is experienced, check for DTCs. If DTCs are found, diagnose and repair as necessary. If no DTCs are found, use GDS2 to check the part number of the HMI module. If the part number starts with something other than 8433, replace the HMI module using the latest part number listed in the parts catalog for the VIN number you are working on.

HMI module part numbers starting with 8433 include improvements to address this concern. Refer to *Human Machine Interface Control Module Replacement* in SI for detailed replacement instructions.
