# Technical Service Bulletin

## 66 License plate mounting bracket threaded inserts stripped

66 18 64 2030471/5 March 6, 2018. Supersedes Technical Service Bulletin Group 66 number 15-49 dated March 24, 2015 for reasons listed below.

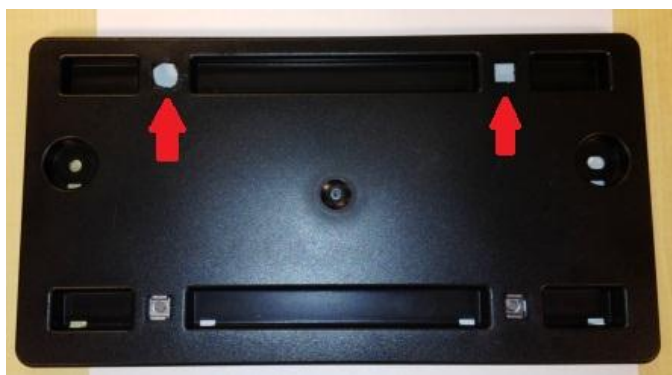
Damaged warranty parts have been returned to Audi of America with evidence of excessive torque used when installing the screw and/or excessive screw length (Figure 1).

Figure 1. Damaged screw inserts.

The appropriate screw length is dependent upon the cumulative thickness of the license plate plus any decorative frame placed over the license plate.

- License plate without decorative frame: M6 x 8 mm
- License plate WITH 2 mm thick decorative frame: M6 x 10 mm

**Tip:** Manually install the license plate screws using a handheld screwdriver. If the screw bottoms out, remove this screw and select a shorter screw instead of applying excessive torque. Otherwise, damage may occur to the license plate bracket screw inserts. In the event the license plate bracket screw inserts are damaged but the openings for the inserts in the license plate bracket are not, the license plate bracket screw inserts are available as a replacement part (WHT 003 200).

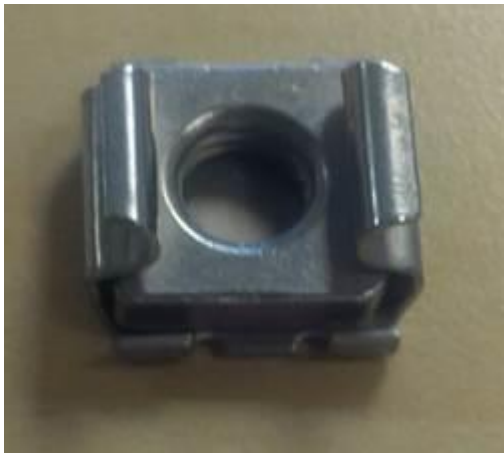
| WHT003200 | | 1 – 4 (as needed) |
| | Nut (M6) | |
