Technical Service Bulletin

96 "Engine start system malfunction" message or Start-Stop button stuck

96 18 25 2050353/2 March 28, 2018. Supersedes Technical Service Bulletin Group 96 number 18-23 dated February 7, 2018 for reasons listed below.

Model(s)	Year	VIN Range	Vehicle-Specific Equipment
Q5	2018	All	Not Applicable

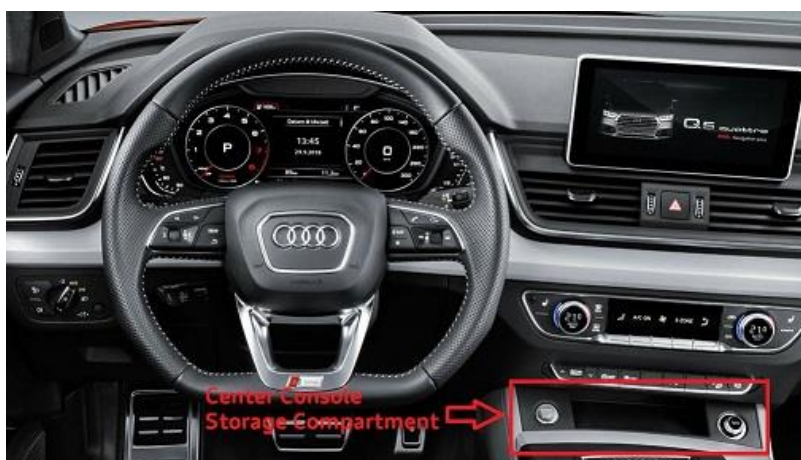
The attachment for the trim surrounding the Start-Stop switch can have insufficient tolerances and cause the button to stick.

Figure 1. Center console storage compartment.

1. Replace the center console storage compartment with the part number 80B 864 131 (Figure 1).

2. Clear the DTC and ensure the button operates freely and that the DTC does not return.
