Engine ATU

Introduction of new coolant for A8 and R8 in 2017

R8 (new model) – checking engine oil level

V8 TFSI – locating cause for loss of coolant

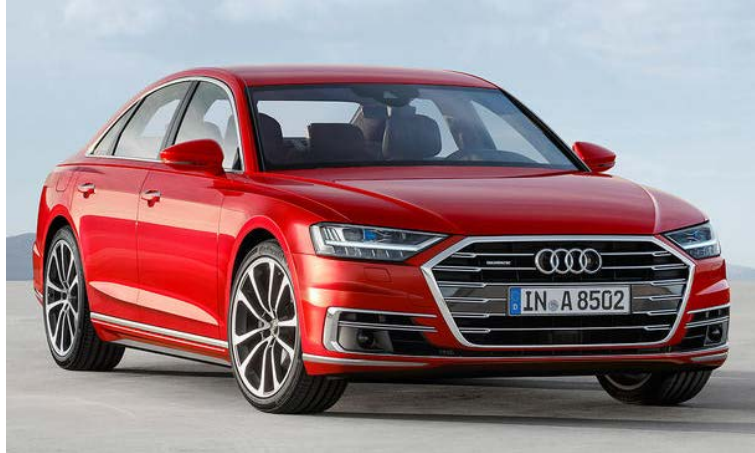
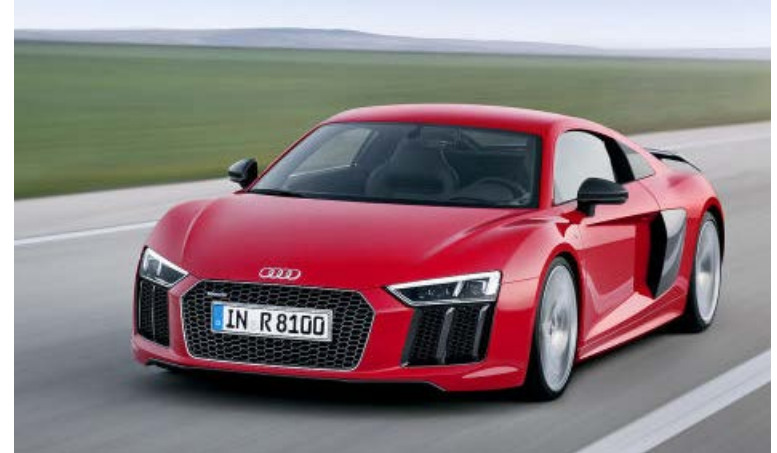
Use of G12evo in the A8 and R8:

WAUYGB4HXHN023176

WUAKBAFX0J7900292

- › Planned for use across the entire Audi fleet.
- › Testing and verification will be performed gradually and individually for each engine/model.

***G12evo must NOT be used for
other vehicle models and engines yet!!***

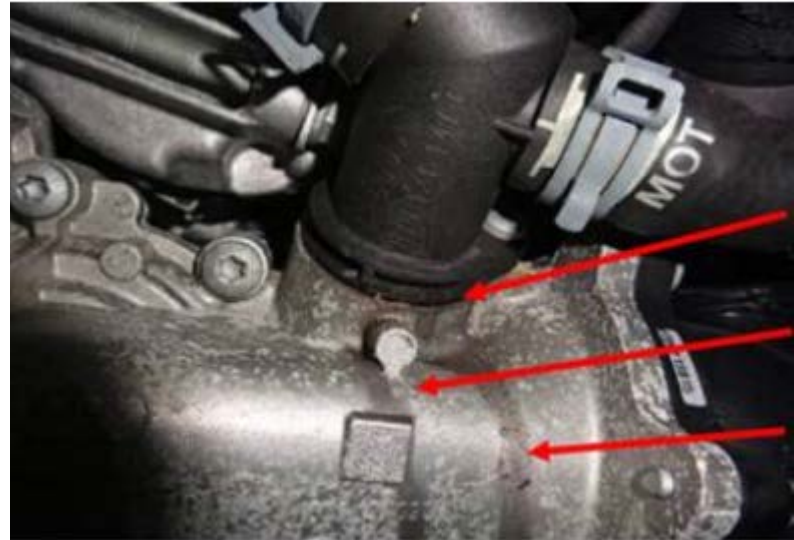
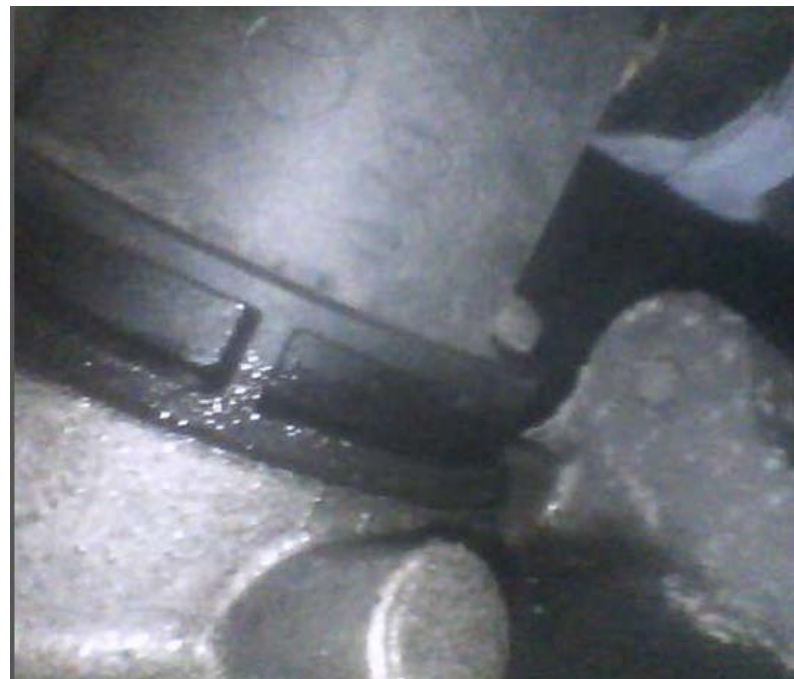
Coolant escaping at connection (Item 7)

Problem reported by customer:

- › Coolant loss.

Workshop findings:

- › Traces of coolant in vicinity of coolant pump.

- › Replacement of O-ring material (item 8).

- › It is sufficient to replace the O-ring in the event of leaks!!!
- › Traces of coolant are often found in the vicinity of the thermostat housing (see next slide, 103). However, the cause for the escaping coolant is further up at the connection. There have not yet been any confirmed instances of thermostat housings which are not leak-tight towards the outside.
- › Check for leaks at the connection using an endoscope or a mirror (slide 104).

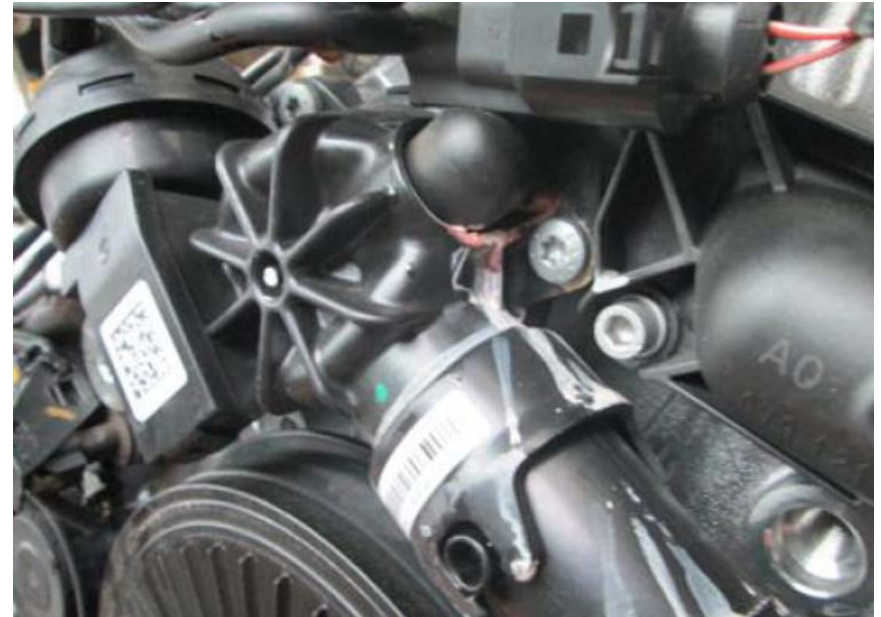
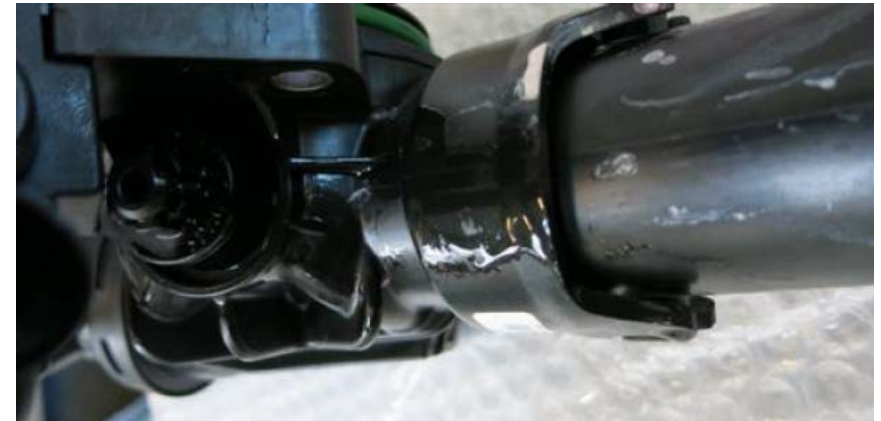
Coolant escaping at ITM valve (Item 20)

Problem reported by customer:

- › Coolant loss.

Workshop findings:

- › Traces of coolant in vicinity of coolant pump, on ITM valve.

- › Optimization of rubber grommet.
- › Optimization of production process.
- › Last measures incorporated into production on production date 07/15.

- › Generally clear traces on ITM valve itself, but also on oil cooler and thermostat housing (see next slide).
- › Inspect leak with endoscope or mirror.

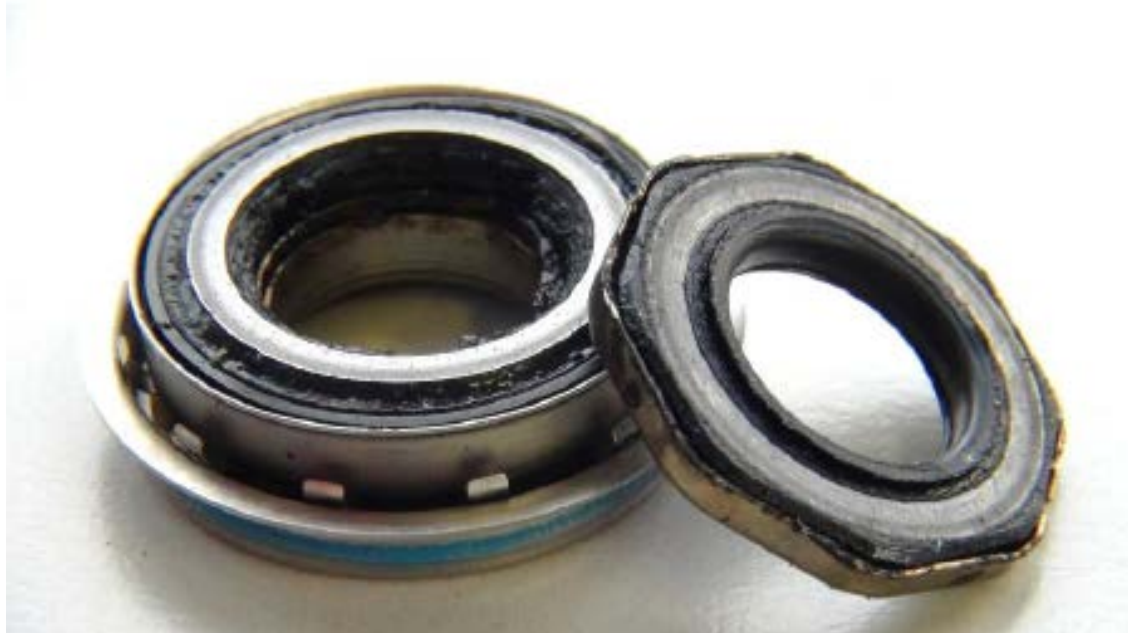
Faulty mechanical seal (running dry)

- › Major leaks at the coolant pump always result in a customer concern.
- › The mechanical seal of the coolant pump develops a fault due to being damaged by air in the system → running dry (see next slide).
- › Leaks at the coolant pump are therefore generally secondary damage resulting from insufficient bleeding of the coolant system or from a faulty ITM valve.

Damaged seal

- › In this case, the coolant pump must be replaced and you must make sure that the ITM valve is not faulty. The cooling system must then be bled correctly in accordance with ELSA.

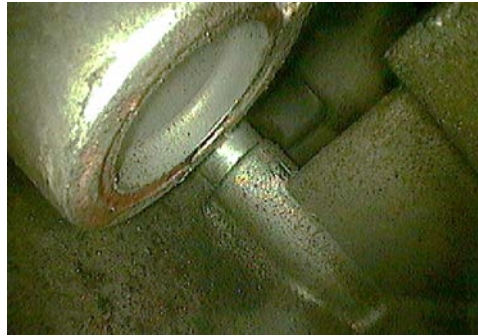
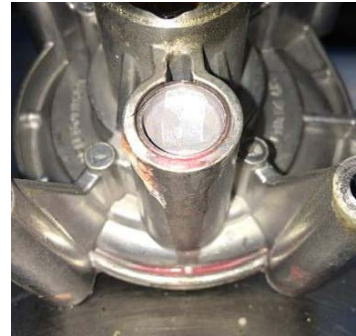
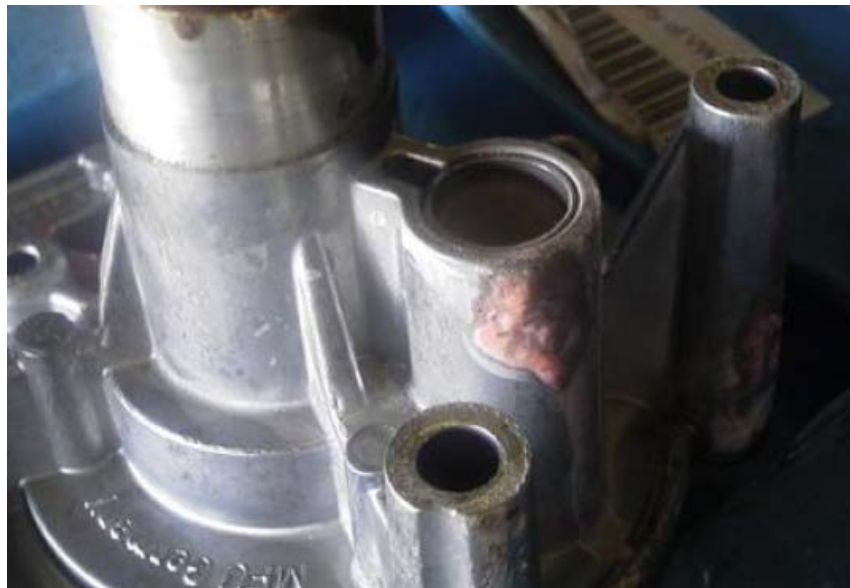
Cause 2: Small leak at cup on coolant pump housing

- › The coolant pump housing is sealed at the drive shaft via a mechanical seal. To ensure that the seal does not run dry, a small amount of coolant leakage is necessary to keep the seal lubricated (for design-related reasons).
- › Slight traces of coolant on the coolant pump cup can therefore be evaluated as okay (see photographs on next slide).
- › Such leaks generally do not result in a customer concern and are found as part of a service inspection or tire change. If there is a slight leak and the coolant level drops significantly, this issue may occasionally result in a customer concern (coolant level warning lamp lights up).

- › In this case, the traces of coolant must be removed and the cooling system must be bled and checked for leaks in accordance with the Repair Manual. Once this has been done, no further repairs should be performed if no fresh traces of coolant are visible.
