SI B34 05 15
Brakes

TICKING NOISE FROM THE FRONT AXLE WHEN CORNERING

This Service Information bulletin replaces SI B34 05 15 dated **February 2018**

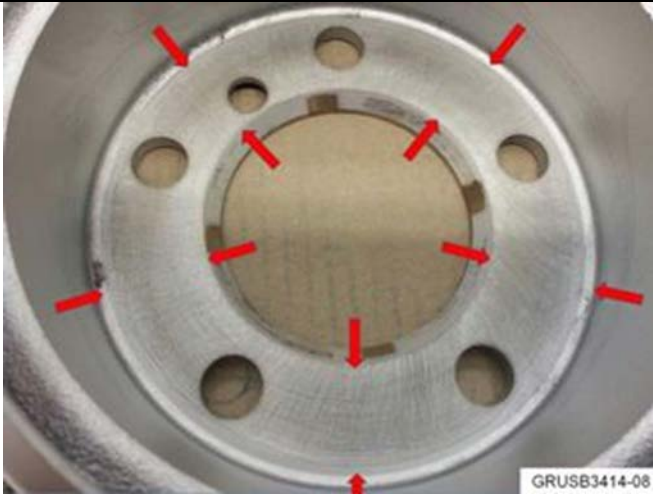
| <p style="text-align: right; font-size: small;">GRUSB3414-08</p> | <ol style="list-style-type: none"> 4. Using 80-grit sandpaper, sand the contact surface of the brake disc to the wheel bearing hub. Sand the surface in a radial motion (inside to outside around the surface). Clean the wheel bearing hub surface with BMW Brake Cleaner P/N 83 19 2 180 805 or P/N 83 19 2 180 806 low VOC. <p style="text-align: center;"> Warning </p> <p>Do not sand the hub surface. Do not apply any type of lubricant to the component's surfaces (wheel bearing or brake disc).</p> |

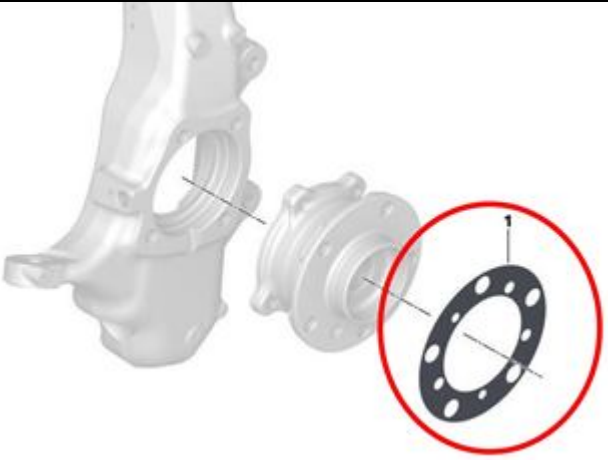
| <p style="text-align: right; font-size: small;">GRUSB3415-03</p> | <ol style="list-style-type: none"> 5. Install friction washer, P/N 31 10 8 053 073, between the drive flange of the wheel bearing and the inner side of the brake disc. Ensure proper alignment of the bolt hole pattern. 6. Reinstall the front axle brake discs per REP 34 11 220. 7. Reinstall the front brake pads and calipers per REP 34 11 000. |

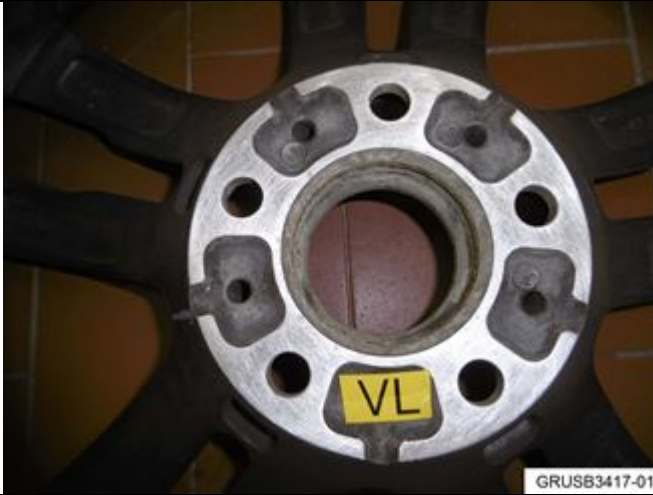
8. Clean the rims on the inside on the bearing surface to the brake disk with a sand paper (80-grit) in the radial direction.

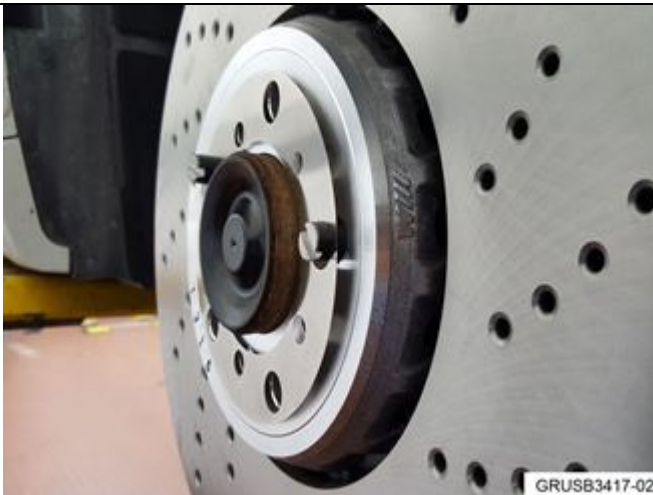
9. **UPDATE!** Use special tool, part number 83 30 2 459 458, centering pins, to hold friction ring in place.

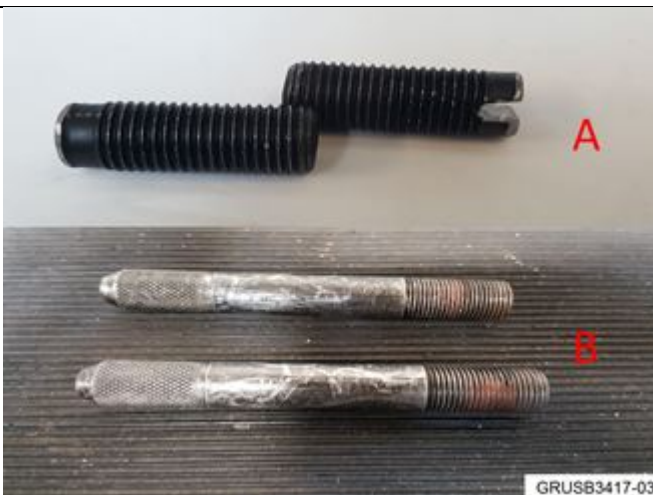
Guide pins can be made by removing the head of a wheel bolt and then slotting it **(A)**; or sourced locally from tool vendors **(B)**.

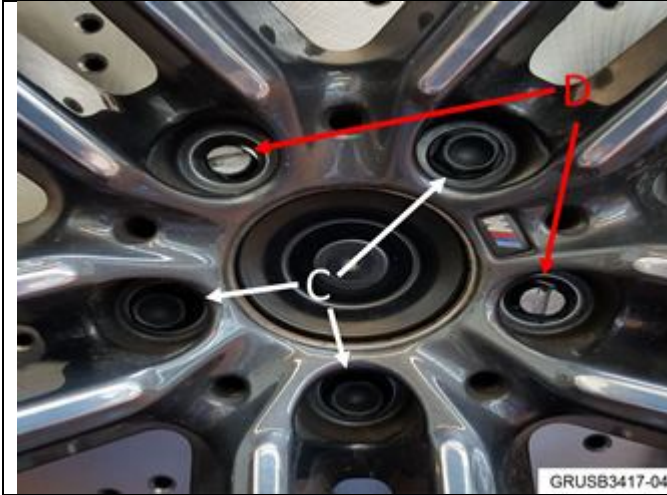
10. Reinstall wheel, after the installation of the first three wheel bolts (**C**) the guide pins (**D**) can be removed and the last two wheel bolts inserted.
