RC-18-84-01

MODEL: 2018 Model Year Karma Revero

TITLE: Remedy, Replacement - Takata Curtain Side Airbag Assemblies

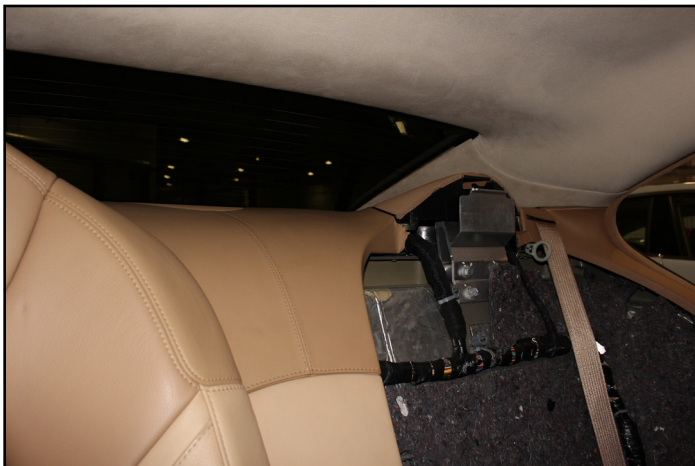
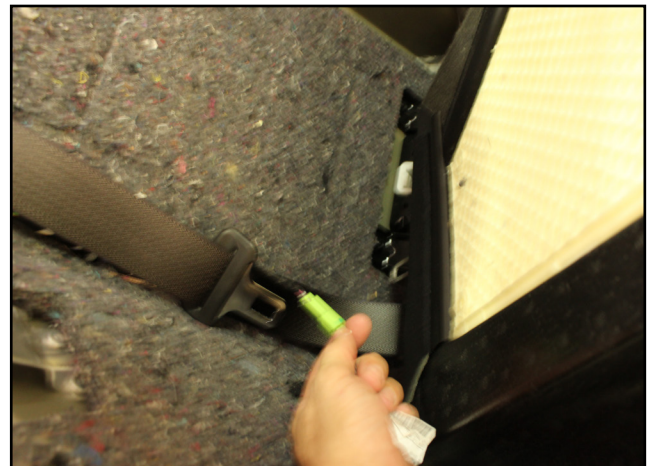
Enter the car to begin disassembly. Begin removal of the rear seat backs, cushions, and disconnect connectors from components as necessary (fig.1a and 1b).

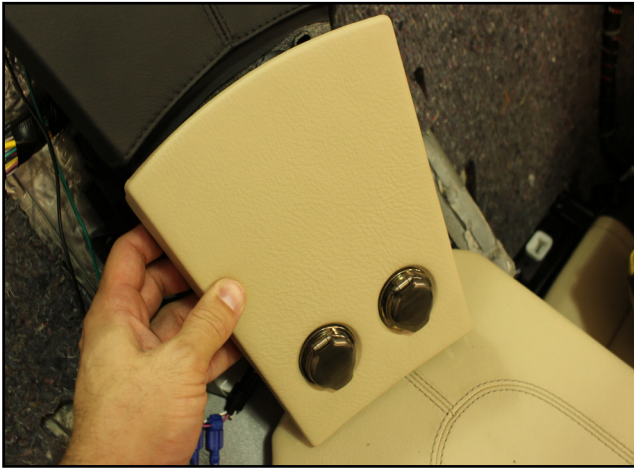
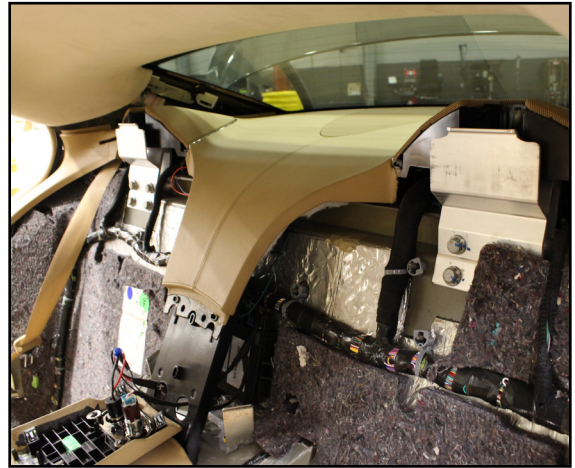
Remove the center bezel, pull firmly forward disconnect the accessory port (fig.2a and 2b).

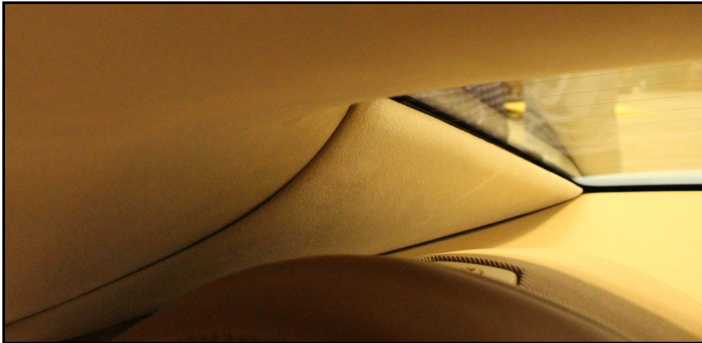
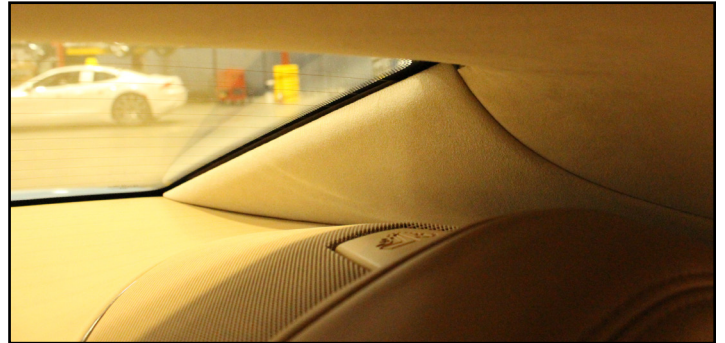
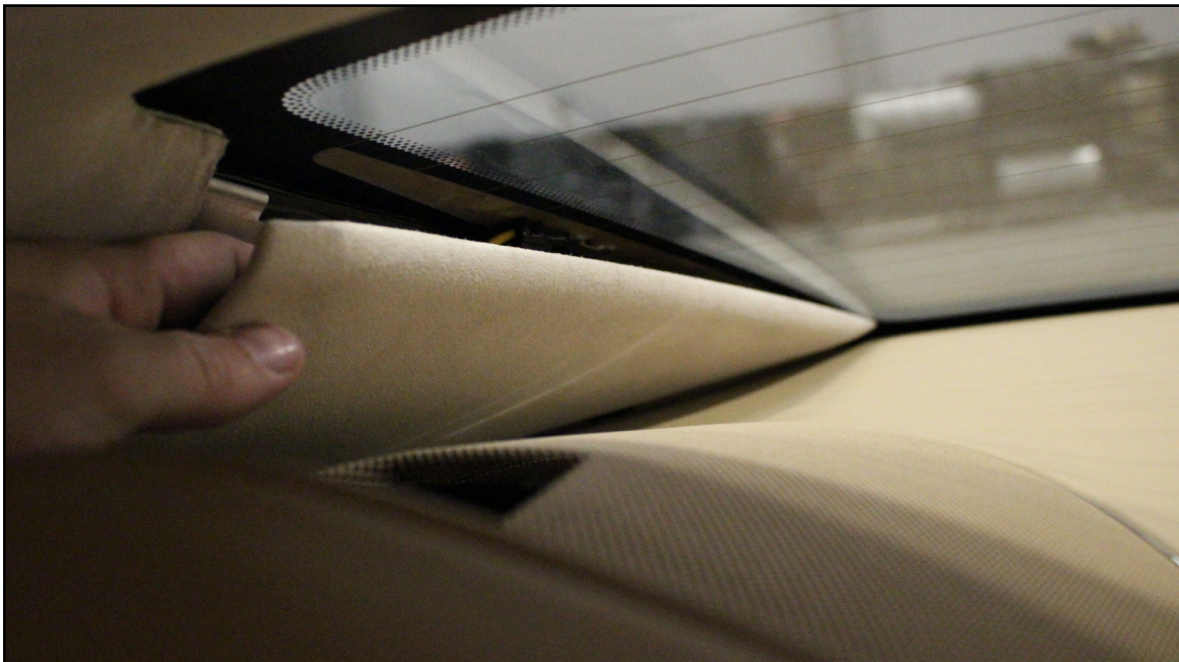
Remove C-pillar trim, from both sides by pulling firmly down on each (fig.3a, 3b, and 3c).

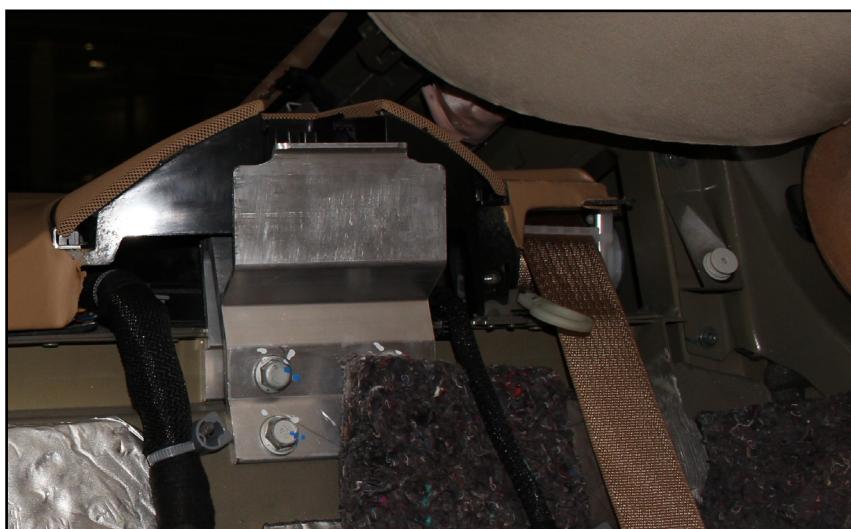
Remove the door molding (both sides) enough to access the trim on the C-pillar, again on both sides, and remove trim panels. Use a T30 bit (fig.4a) and remove bolts on both (LH/RH) quarter garnish panel assemblies and slide out panel (fig.4a, b). Slide out the assemblies, plastic retainer will not come off easily. Note the central clips, and use a panel tool to aid in removal

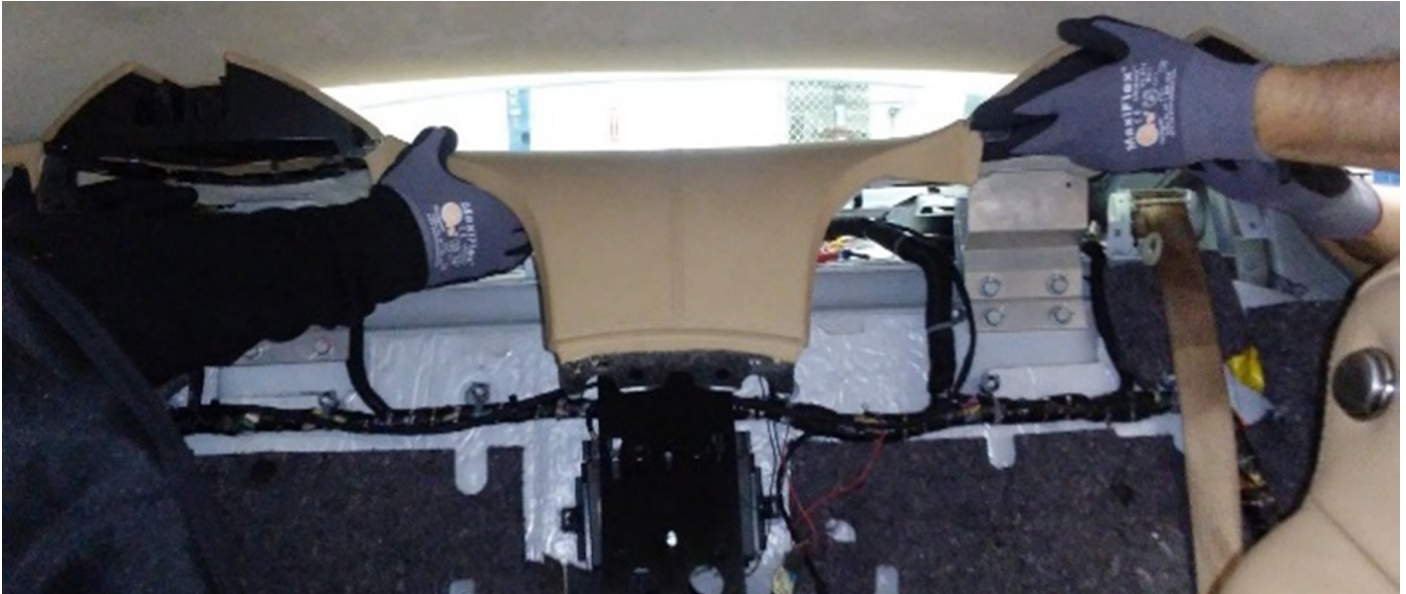
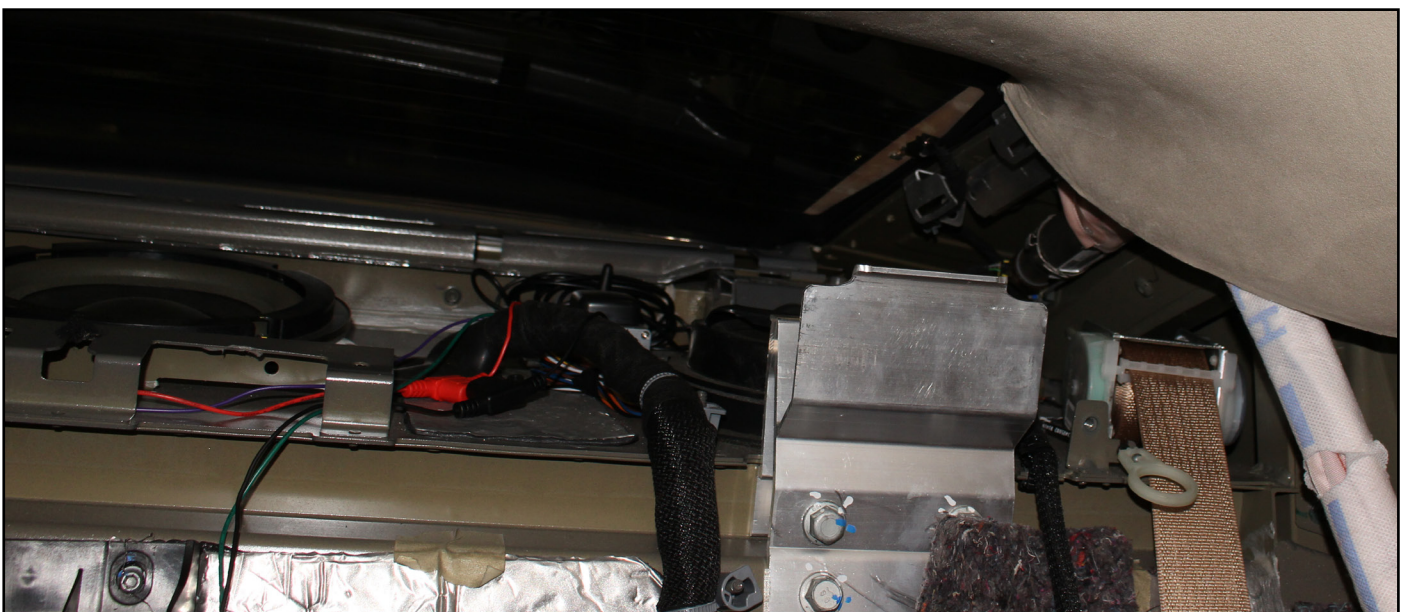
Remove The package tray (fig.5a,b). Set aside all removed trim on a safe table top or work surface to minimize any soiling of the interior panels.

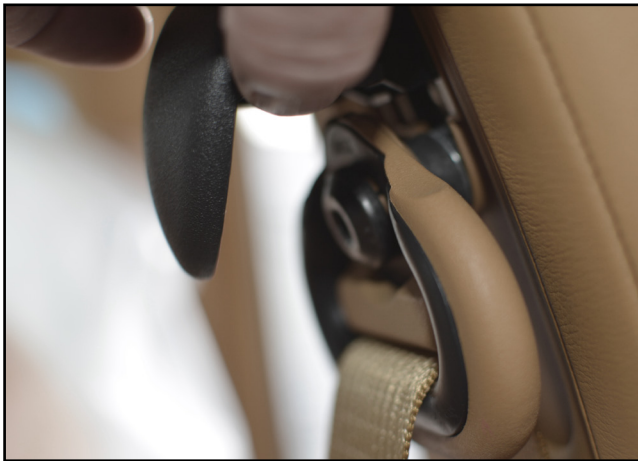
fig.6a

Remove the D-ring cover panel (fig.6a), and undo the fastener for the upper seatbelt (use a T50 torx for the D-ring and a T30 for the upper trim bolt (fig.6b).

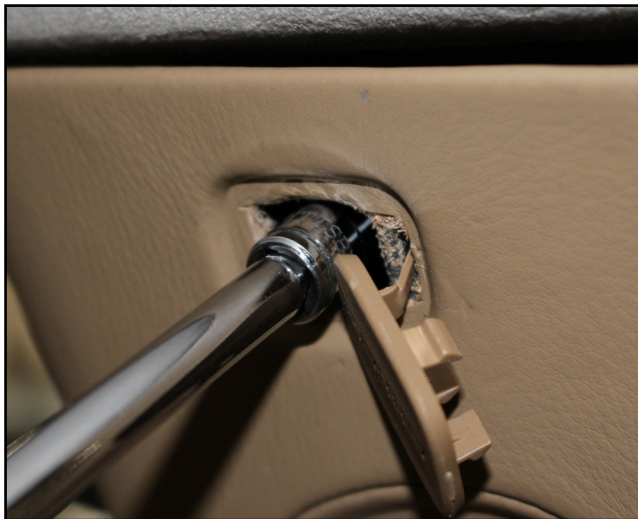
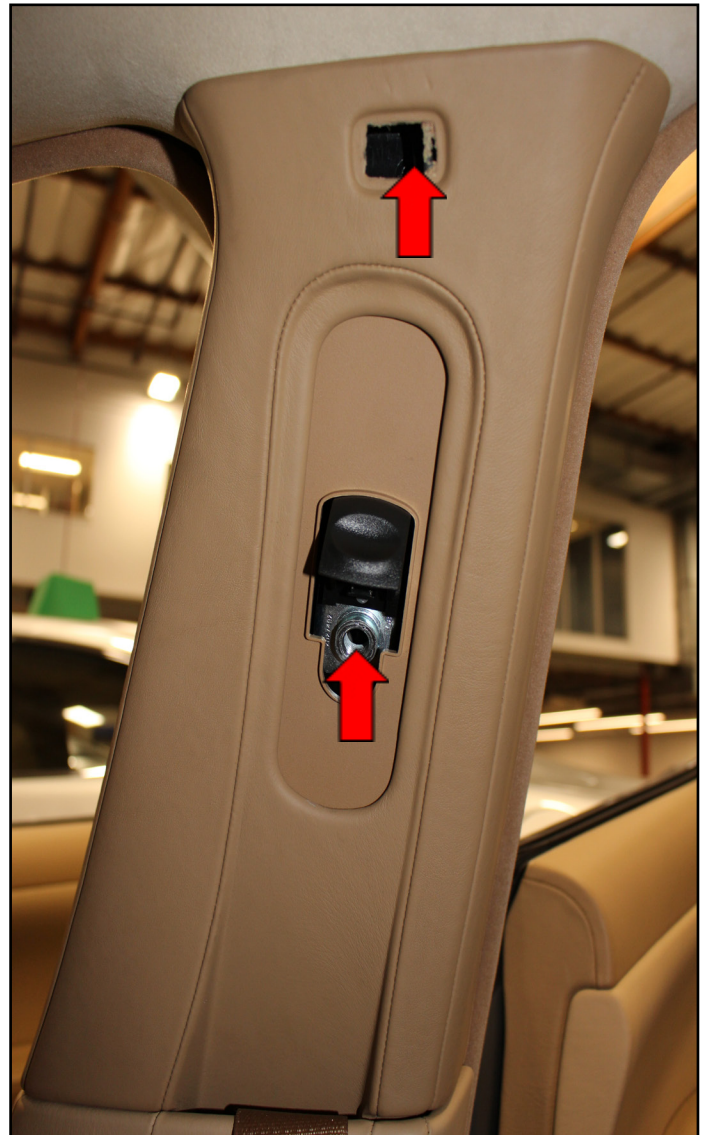
fig.6b

Bolt to secure D-ring. Torque value: 40 +/- 5 N-m

Undo bolt (T30) to secure upper B-pillar trim through airbag logo hole and snap back the airbag logo to avoid loss of component part (fig.6b).

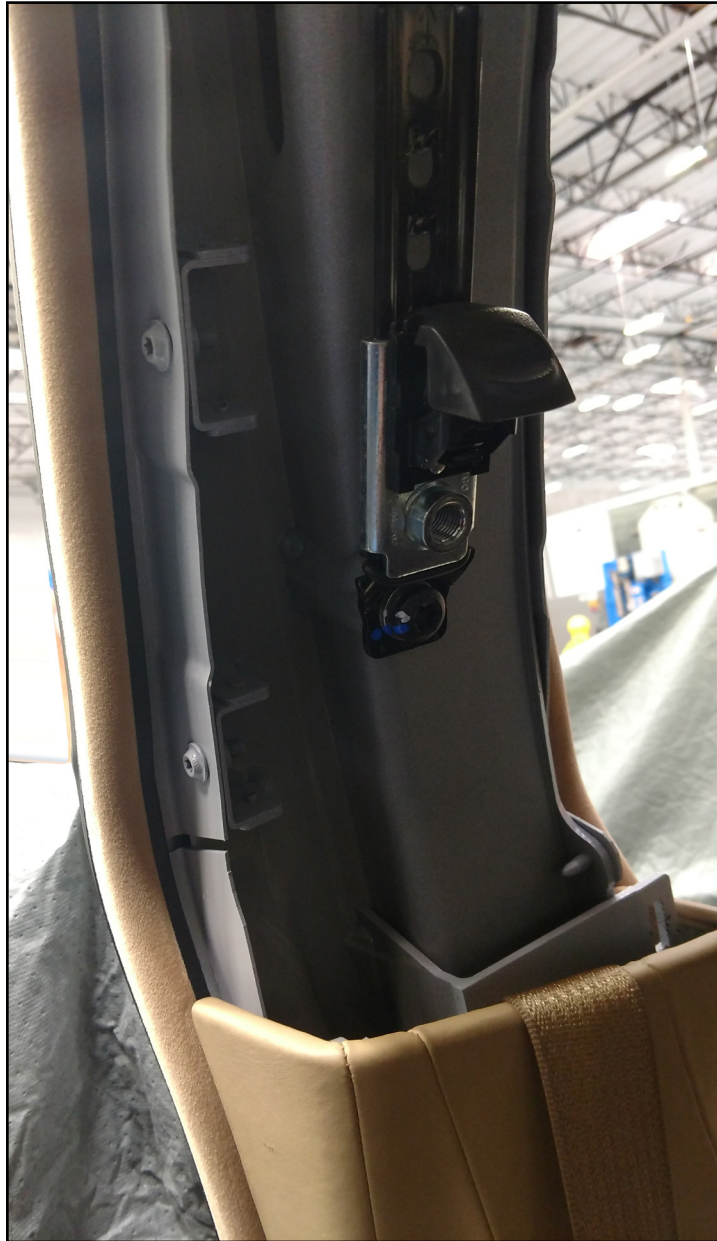
fig.7

Remove the upper B-pillar trim on both sides, this unsnaps from the lower trim as shown below (fig.7).

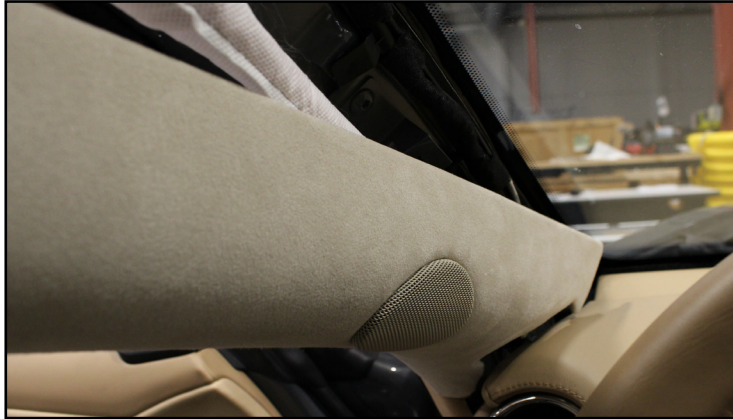
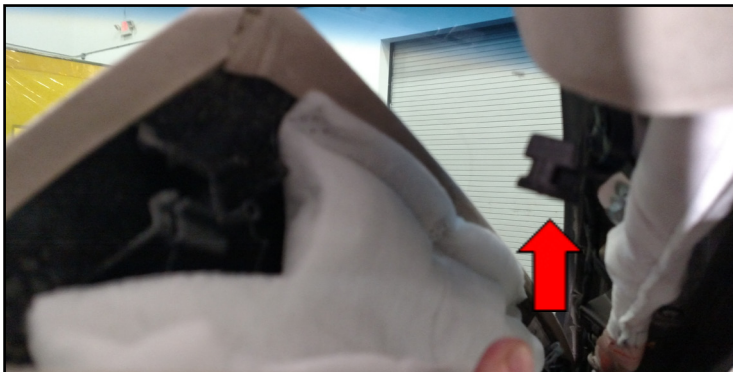
Remove both A-pillars. Remember to remove the tether clip from the top portion by sliding it out of the A-pillar. Remove the speaker connector on the back side (fig.8a,8b,8c).

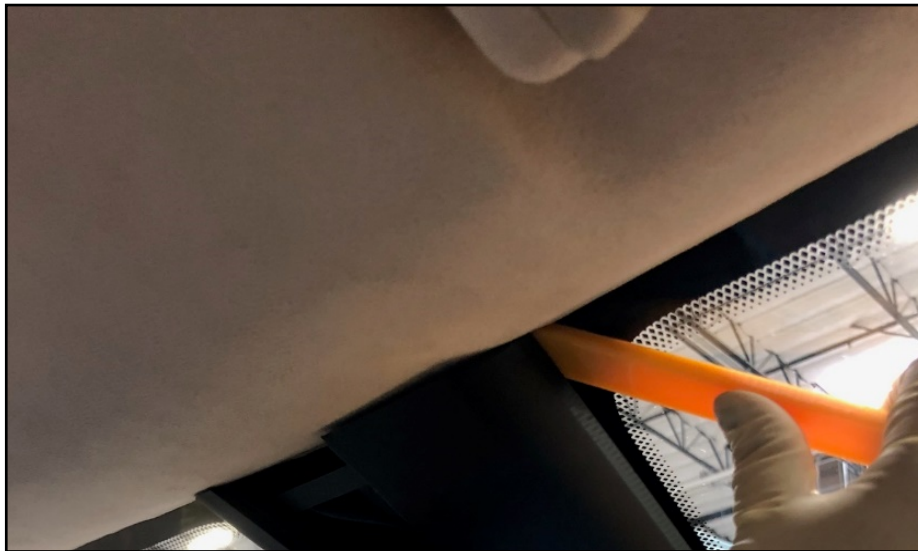
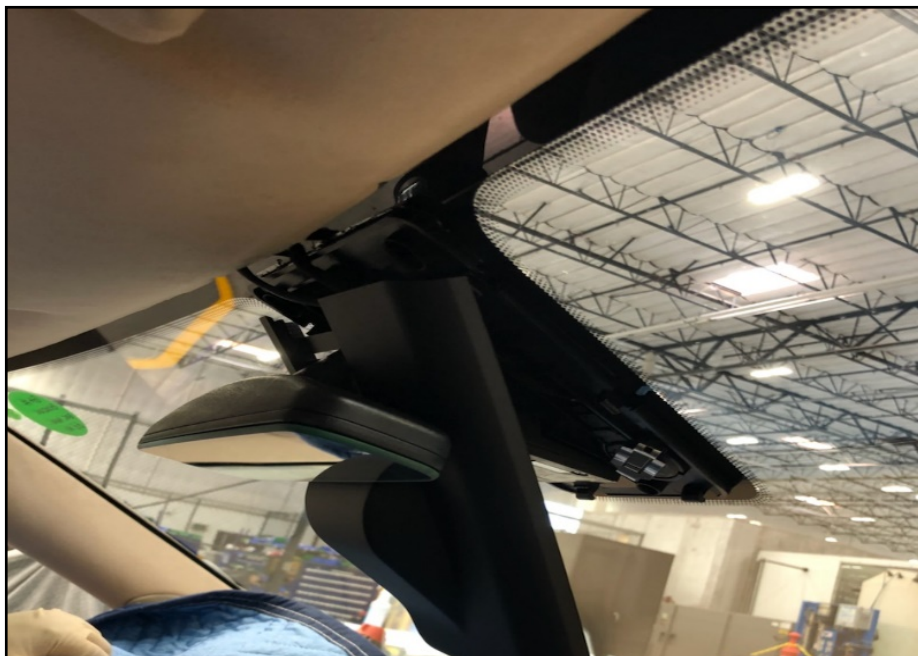
Remove the ADAS cover as shown (fig. 9a, 9b)

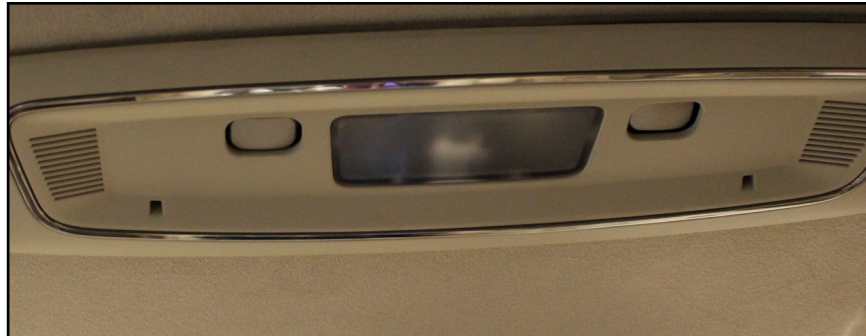
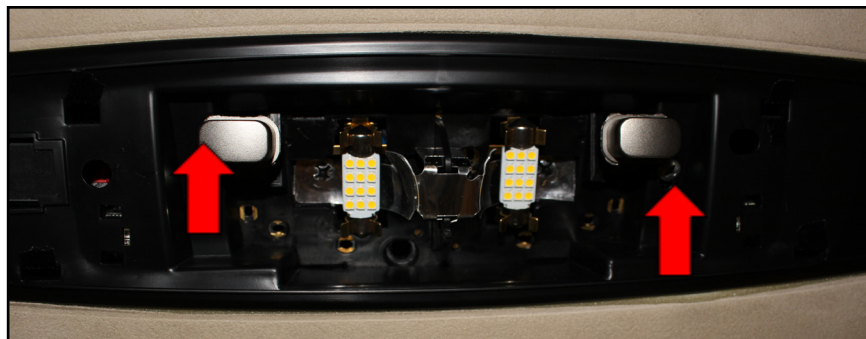
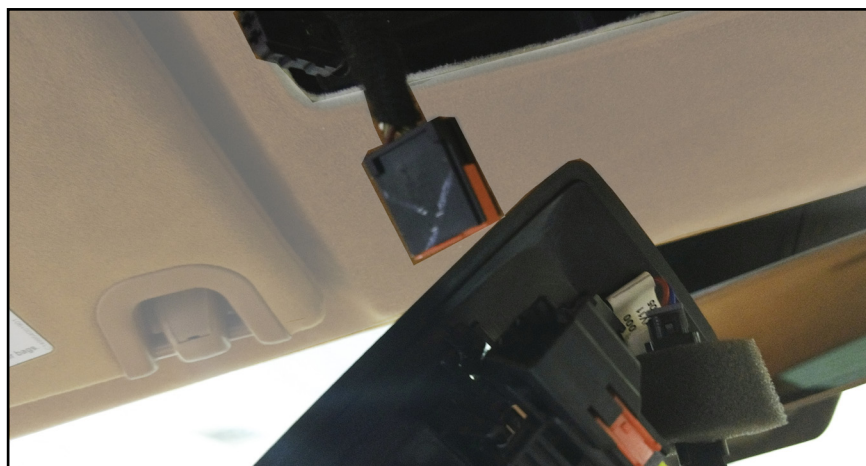
Unsnap the Dome lamp cover (fig.9c) and expose the screws (fig.9d). Undo these and drop down the assembly. Unplug the harness connector (fig.9e). Reinstall screws in dome lamp at 2.0 +/- 0.5 Nm

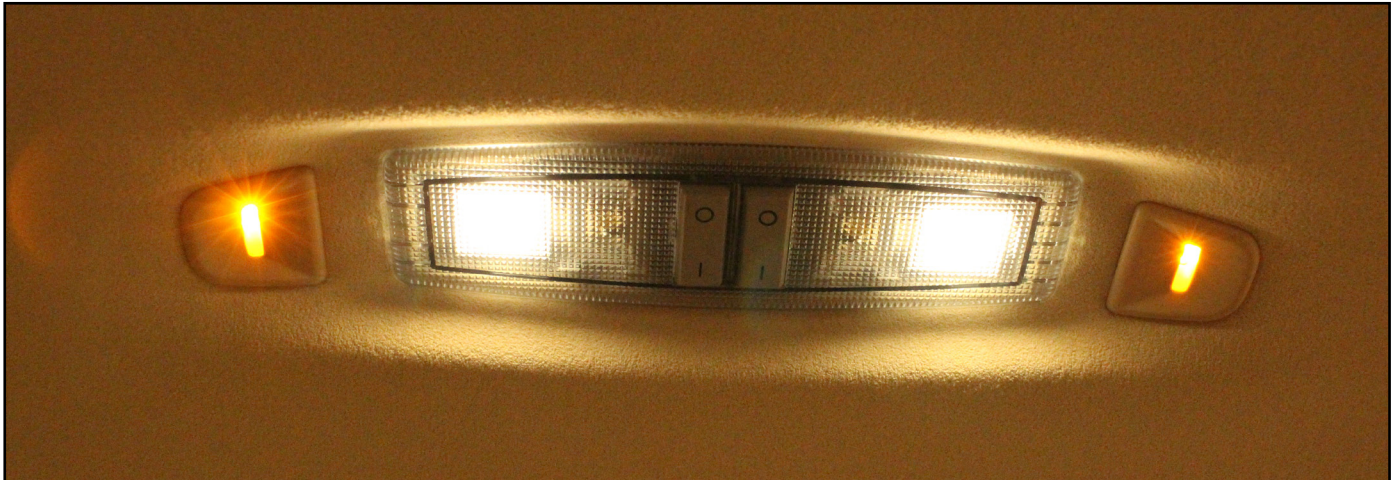
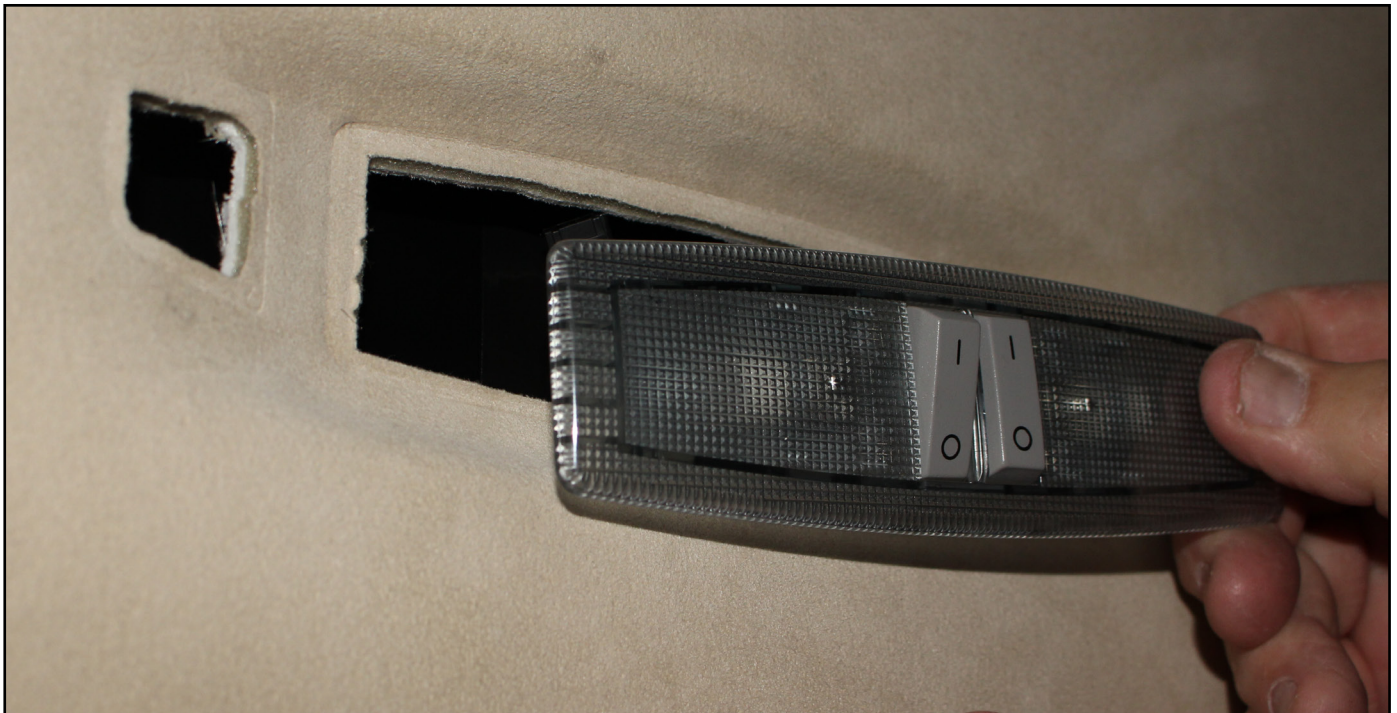
Remove the side lights of the rear dome lamp (fig.10a) and pull down the rear central dome lamp (fig.10b), unplugging the harness as needed.

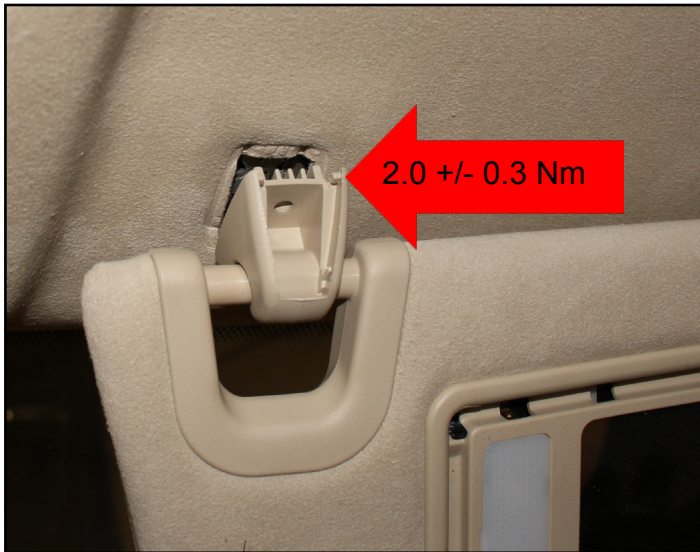
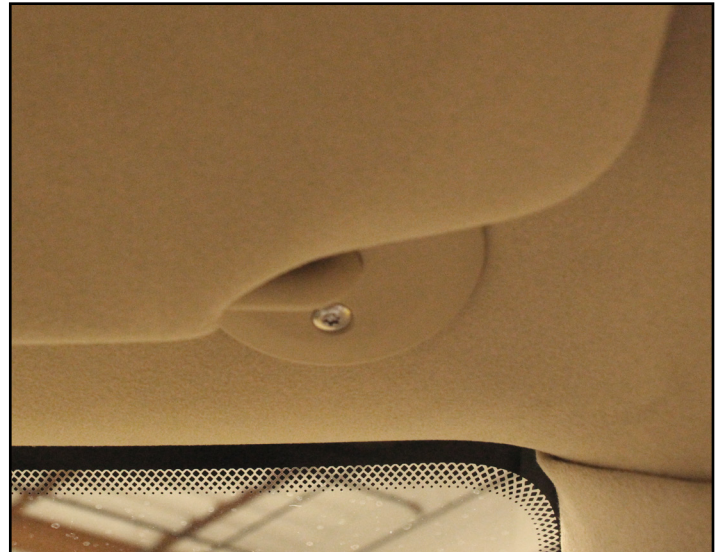
Undo the brackets for the sun visor assembly (fig.11a) and the sunvisor base (fig.11b).
Install torque 2.0 +/- 0.3 Nm

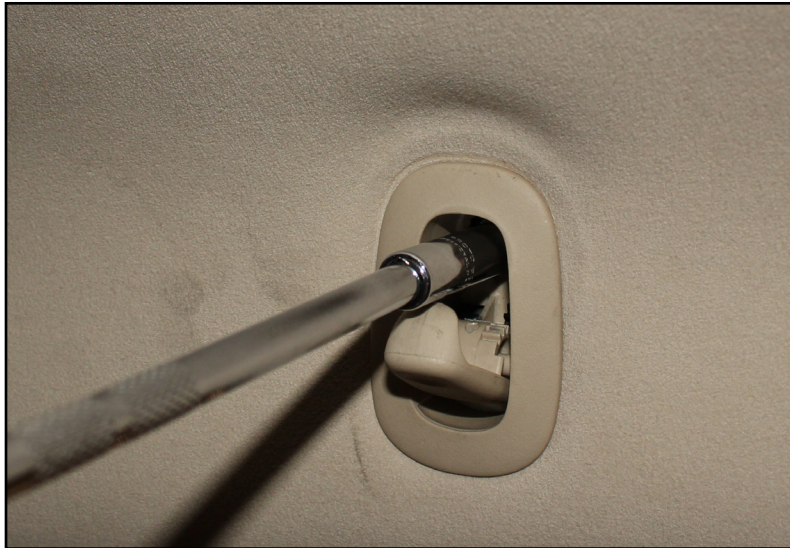
Remove the coat hooks (fig.12a). Again set these aside in the proper location and take care not to soil or discolor the headliner. Install torque is 4.0Nm +/- 0.6 (fig.12b).

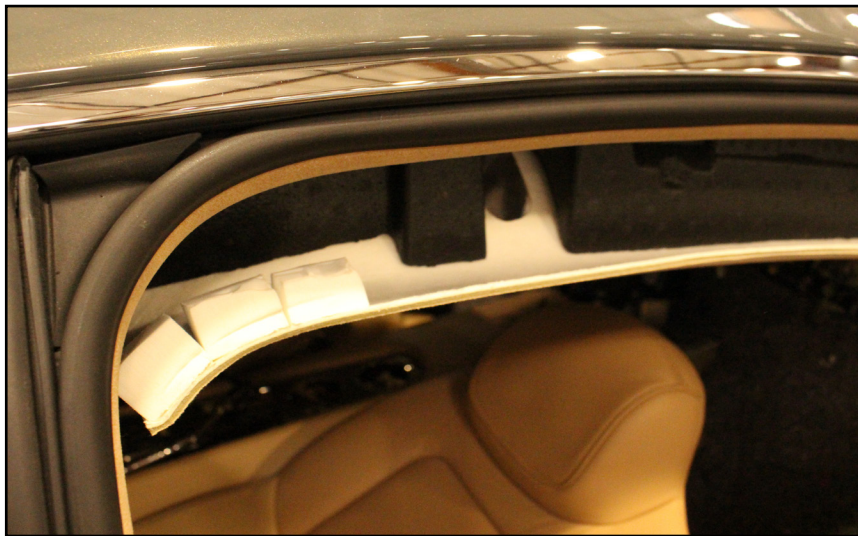
fig.13a

Lean the front seats back to provide more interior room. Cover the front seats in plastic or a clean cloth to avoid soiling. Lower the headliner (fig.13a) This may require some assistance.

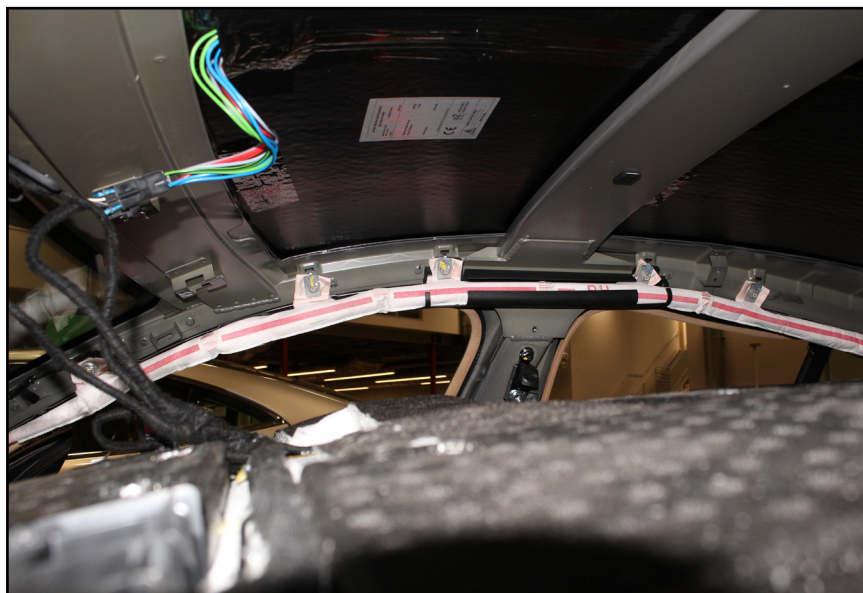
fig.13b

Take care with the harness in the headliner. The airbag fasteners are now accessible (fig.13b). Unclip the wiring harness from the a-pillar for best access.

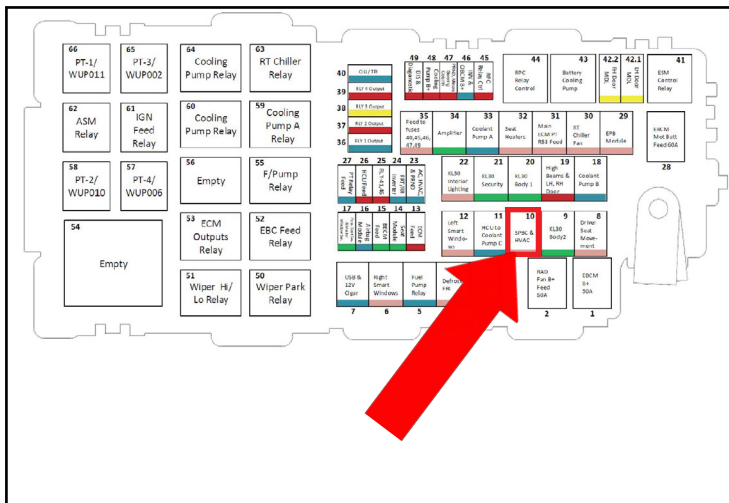
Power off- wait for car to go to sleep (45sec-1 minute)
 Remove the #10 solar panel (“SPBC and HVAC”) fuse from the fuse block (fig.14a).
 Disconnect the 12 V battery cable as shown: located on the passenger side shock tower (fig. 14b).

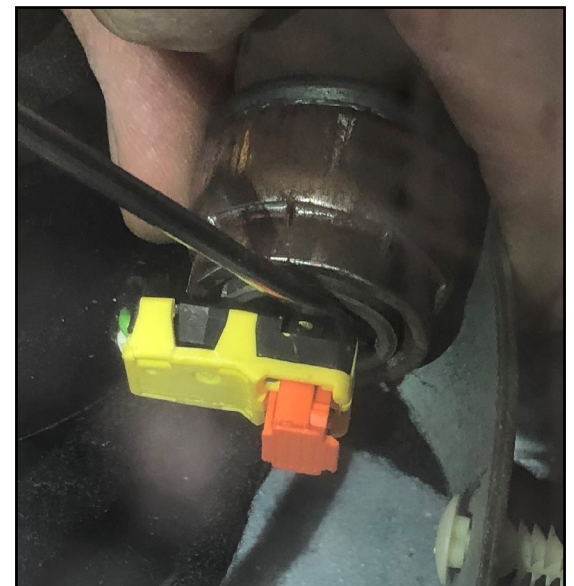
Disconnect the airbag inflator and unbolt from its location (fig.14c, 14d)

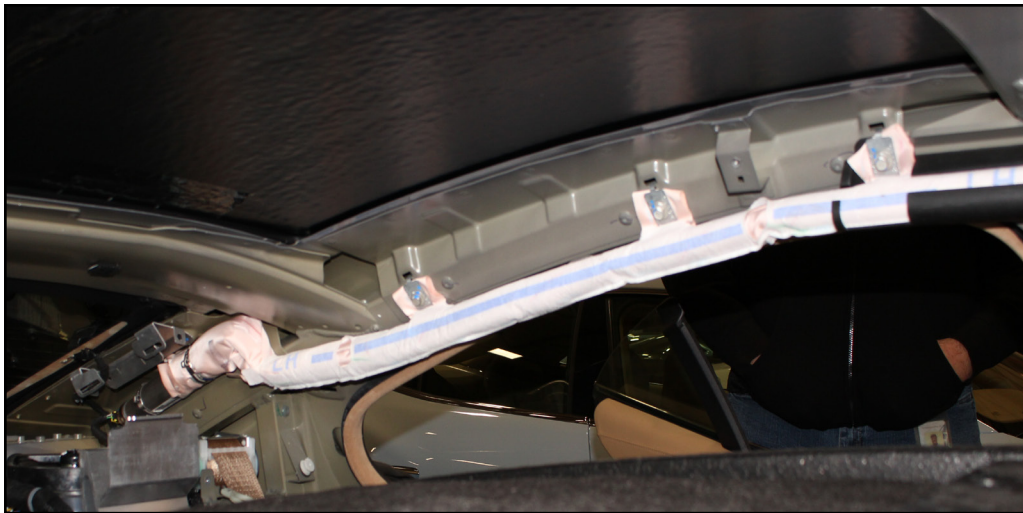
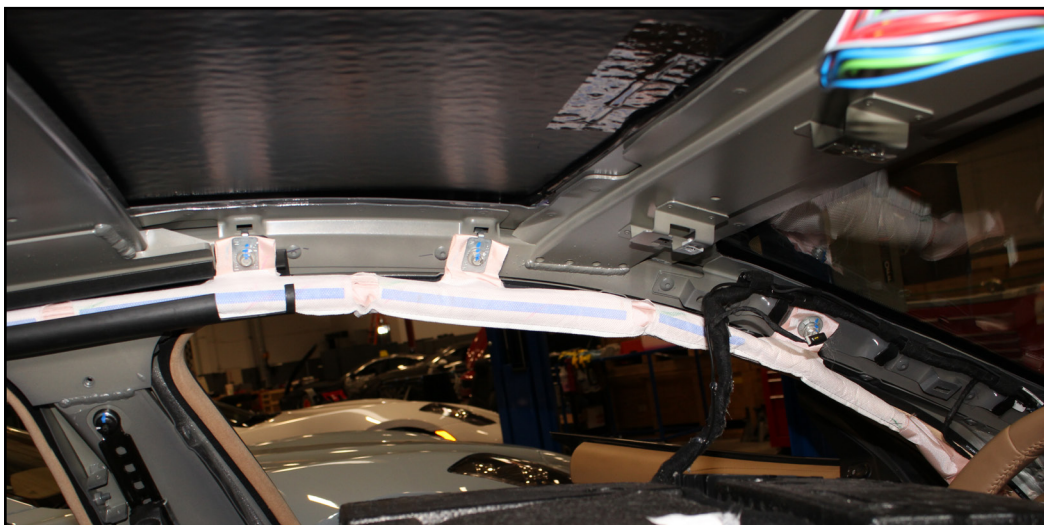
Note that each airbag has eight (8) total fasteners from the inflator (1) along the rail to the A-pillar (7), on each side (fig.15a,b)

The new airbags has three Oetiker clamps by the inflator and it has an anti-twist stripe marking along the curtain material.

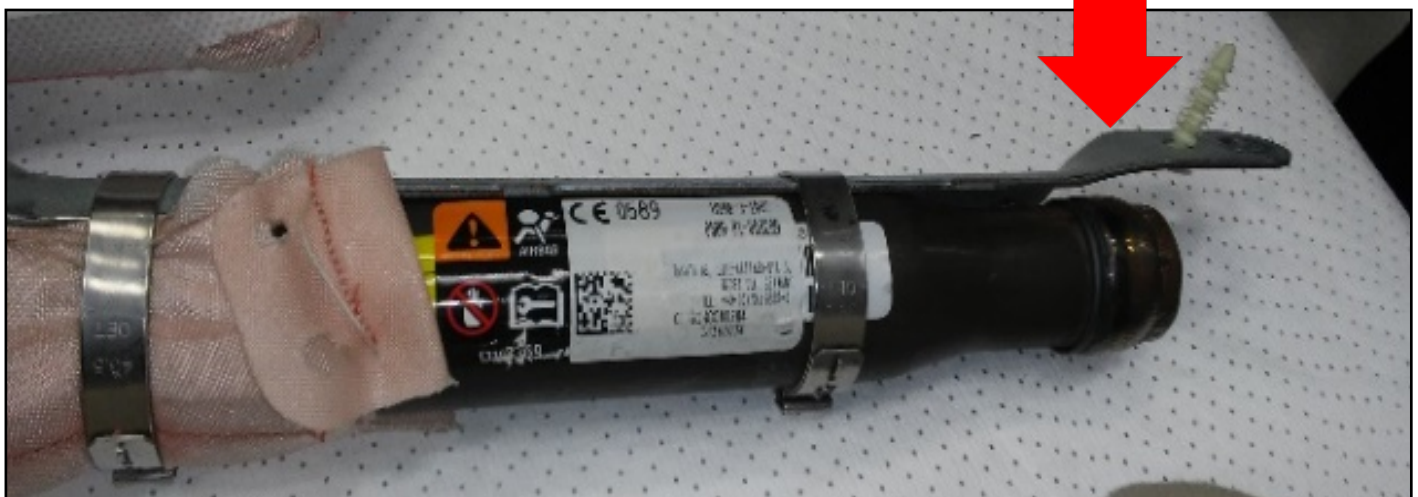
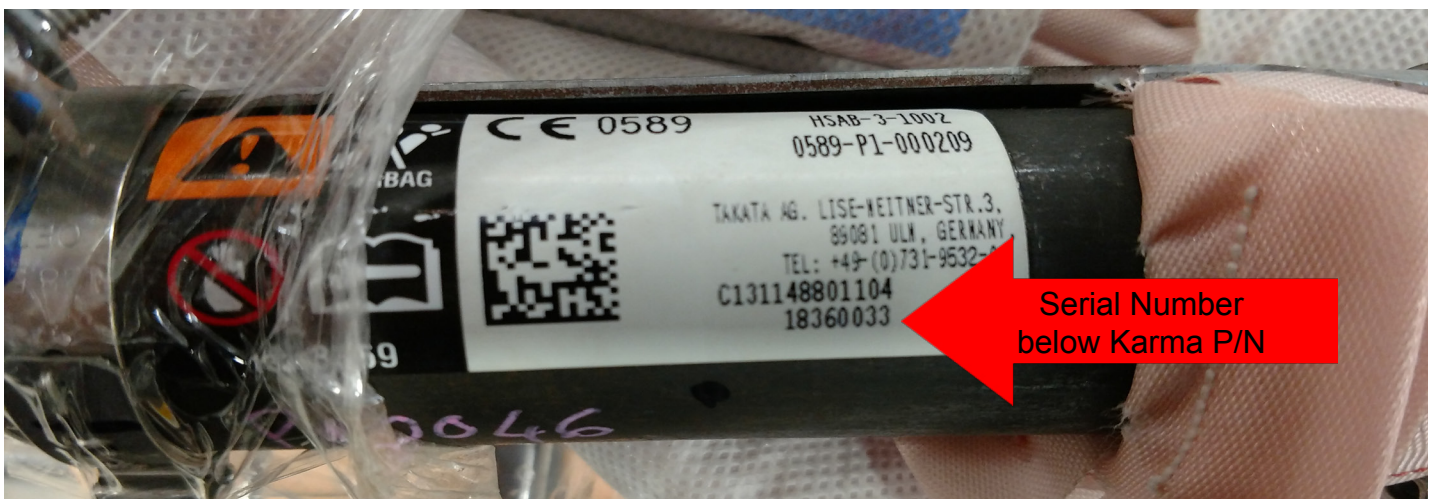
Remove both curtain side air bags. Deform the inflator mounting bracket (bend it with pliers as in fig. 16a) so that this part cannot be reused or mistakenly reinstalled (indicated in fig. 15c)

Again take pictures of the **airbag serial numbers (found below the Karma Part number)** and record these from the removed air bags (fig. 16b).

It is recommended to use a white paint pen and write the last six (6) digits of the VIN on the metal surface of the side curtain airbag inflator to indicate a no-use condition part and to identify this as removed to be returned to Karma Automotive.

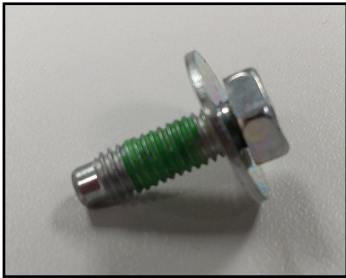
fig.17a

Remove captured bolts (one by one to ensure correct bolt position) from new Curtain Side Airbag C131148801105 (LH), C131148801205 (RH). **Use retrofit bolts** C141800803200 (Bolt-Hex SEMS Flat M6 X 1.0 X 19.5 PC10.9 with Adhesive included in each airbag service kit (fig.17a)

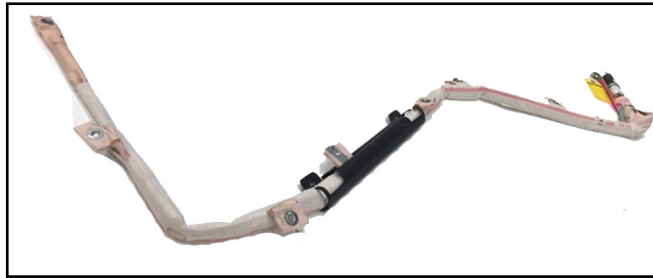
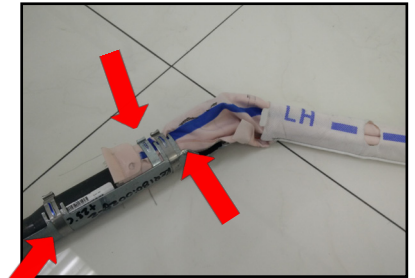
Place new airbag assemblies on a flat clean surface. (fig.17b, 17c note the three clamps on the inflator) and the anti twist stripe, on the cover, this should remain straight on install.
