MODEL:	TYPE:	SECTION/GROUP:	DATE:
D Series	Field Change Program	07- Electrical	May 28, 2018

ERGO M (AM80, AM72 & AM71)

SEAT BELT BUCKLE FIELD REPLACEMENT INSTRUCTIONS

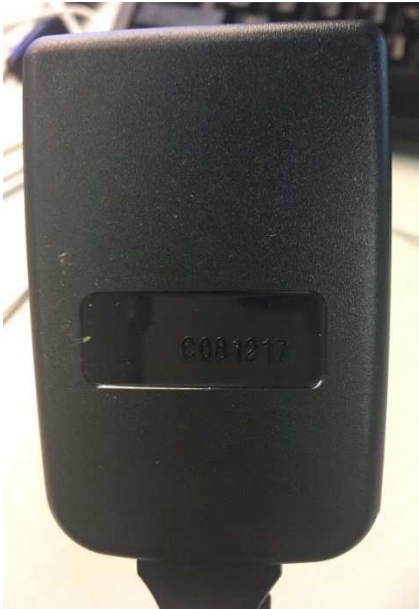
Intermittent electrical failure of buckle on Recaro driver's seats.

OLD BUCKLE IMAGE (Date code stamped on buckle cover):

MCI and Johnson Controls strongly recommend that the driver's seat buckles on the affected coaches be retrofitted, as per RECARO's instruction outlined in this bulletin. The parts needed to carry out the rework can be ordered from NFI.parts, MCI P/N **03-12-1331**.

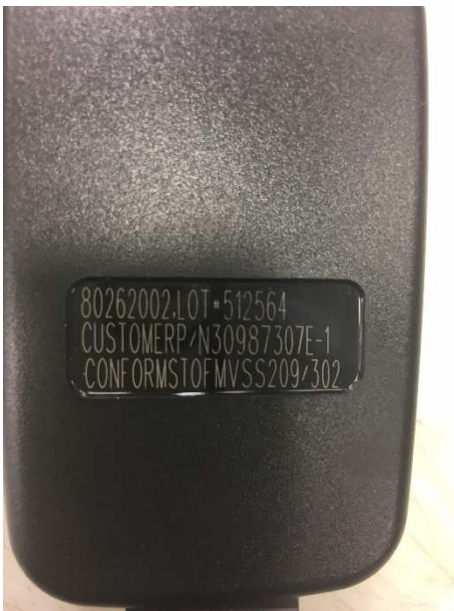
REPLACEMENT/NEW BUCKLE IMAGE (Part number stamped on buckle cover):

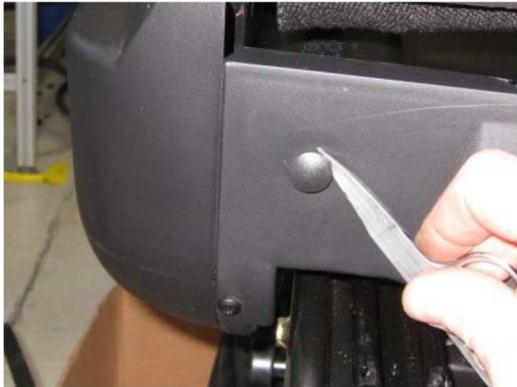
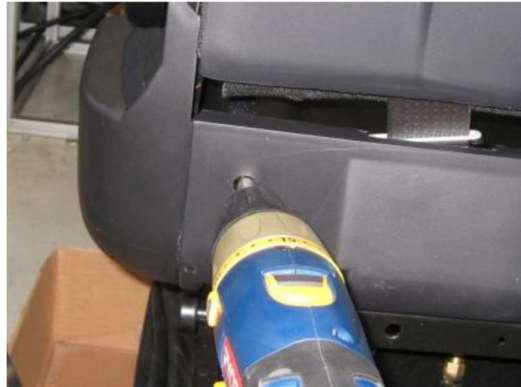
1. Remove the hole plugs from lower rear trim panel using small pick. Save for re-use. Remove rear lower trim panel using Phillips #2 screwdriver. Set aside caps, screws, and panel.

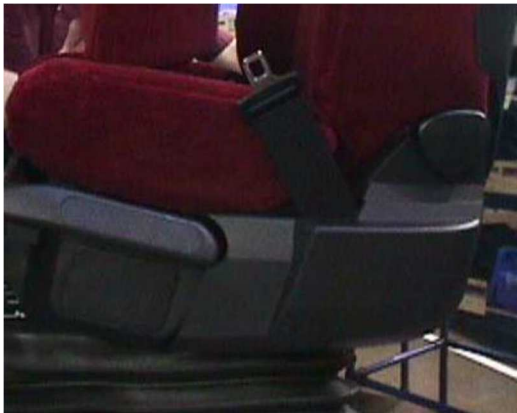
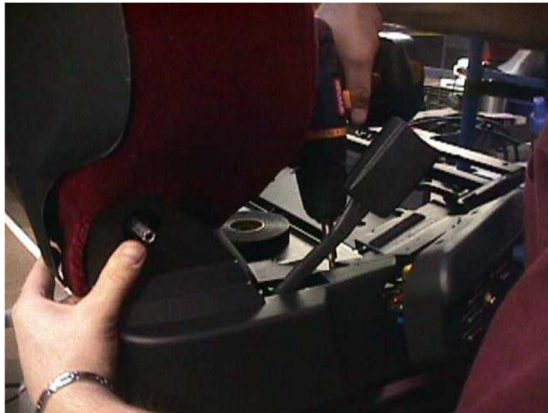
2. Remove hand wheel from the recliner on the same side as the buckle by prying gently with a large flat head screwdriver. Remove rear side trim panel using Phillips #2 screwdriver. Move to the side to gain access to the seat belt buckle bolt.

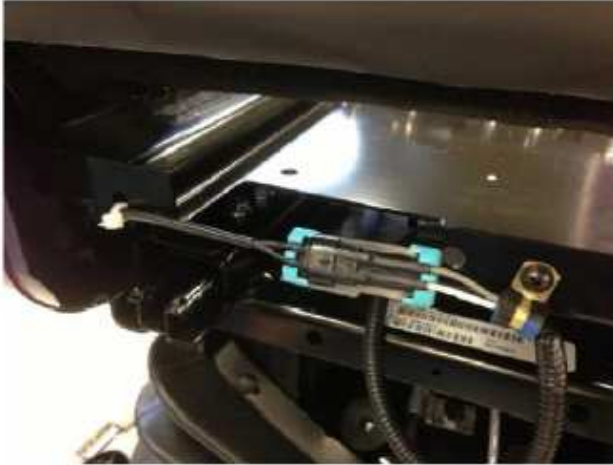
Buckle on LH side of seat

3. Disconnect the electrical connector from the seat belt buckle to the jumper harness, if the seat is equipped with a seat belt alarm. Cut the small zip tie with side cutters, ensuring the wire harness is not damaged.

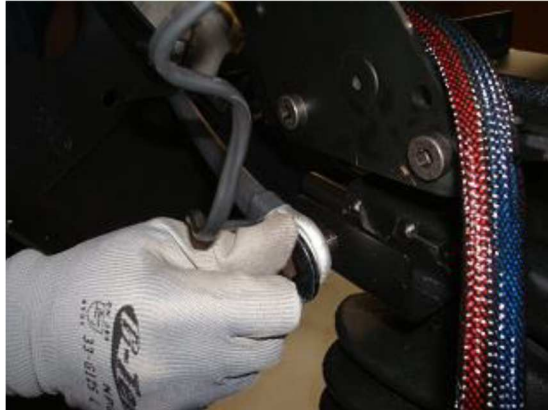
4. Using a 5/8" socket, remove the seat belt buckle bolt from the J bracket. (Option shown below is on the left hand side, the buckle can be installed on the left or right side.)

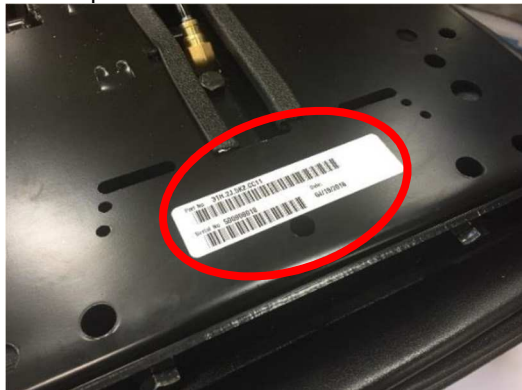
5. Remove the buckle and hardware from the seat. Set aside to return to RECARO. Record to serial number of the seat to tag the buckle. The serial number is located on the white 4X1 sticker located on the top rear plate of the suspension.

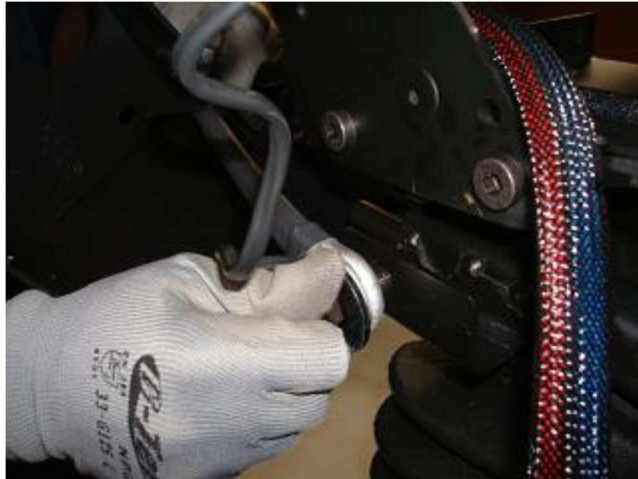
6. Obtain the new buckle and route the end of the buckle through the opening in the side rear trim panel. Place large washer & buckle on J bracket and hand start bolt. If the seat does not require a seat belt alarm, cut the wire off as close to the base of the heat shrink tubing as possible. If it does require an alarm, ensure the washer does not pinch the wire harness. Torque to 50 +/- 4 Nm.

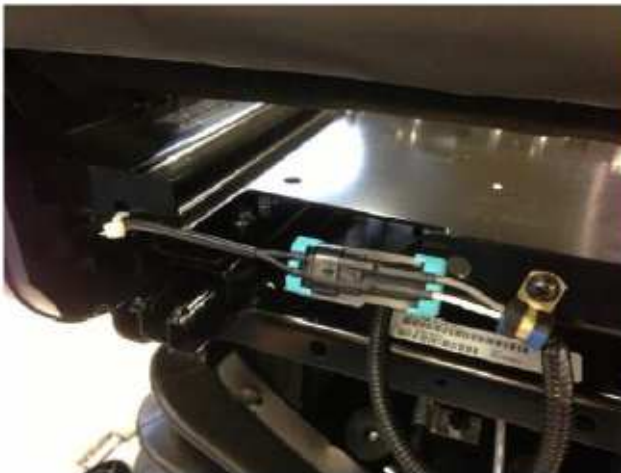
Buckle on LH side of seat

7. Connect the seat belt alarm on the buckle to the jumper harness on the seat. Loop the small zip tie around the cushion frame to ensure the wire harness is routed the same as it was previously.

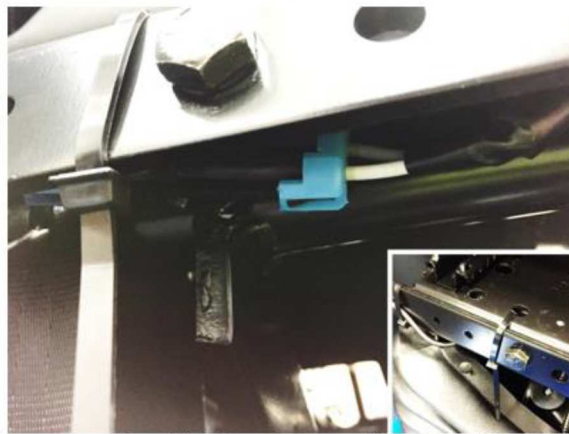
- Small pick
 - Side cutters
 - 5/8" hex wrench/socket
 - Torque wrench
1. Using a small pick, remove the cap from the seat belt buckle bolt on the side of the tether bar.
 2. If the seat is equipped with a seat belt alarm, cut the small zip tie with side cutters, ensuring the wire harness is not damaged. Raise the seat to full up to ensure access is maintained to the seat belt wire harness, in the back of the suspension. Disconnect the seat belt buckle from the jumper on the seat.

Example of left hand, normally-closed buckle

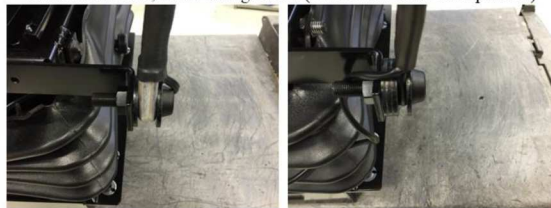
3. Using a 5/8" socket, remove the seat belt buckle bolt from the tether bar. (Option shown below is on the left hand side, the buckle can be installed on the left or right side.)

Standard LH belt, tether configuration (buckle side close to suspension)

Standard N/C buckle

Standard N/O buckle

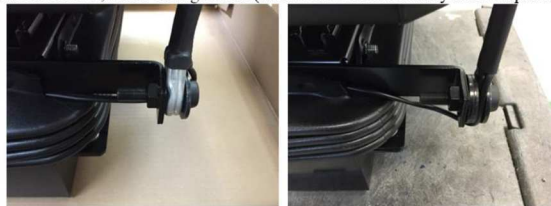
Shifted LH belt, tether configuration (buckle side extended away from suspension)

Shifted tether bar N/C buckle

Shifted tether bar N/O buckle

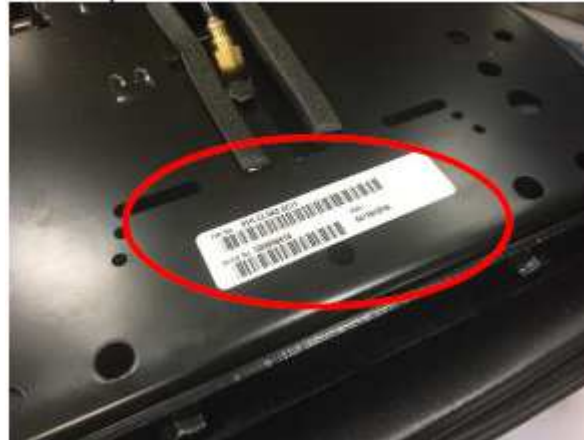
4. Remove the buckle and hardware from the seat. Set aside to return to RECARO. Record to serial number of the seat to tag the buckle. The serial number is located on the white 4X1 sticker located on the top rear plate of the suspension.

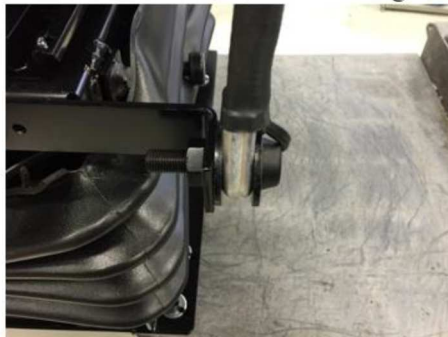
5. Install seatbelt buckle (N/C standard-30822807E-01, N/O-30987307E) with bolt (30819307) and washer (30822707) under the head of the bolt and one of the following (ensuring the wire harness does not get pinched between any of the washers):

Washer stack between buckle and tether bar	
	N/C buckle (normally closed)	N/O buckle (normally open)
Standard tether bar config.	1	3
Shifted tether bar config.	0	2

Standard LH belt, tether configuration (buckle side close to suspension)

Standard N/C buckle

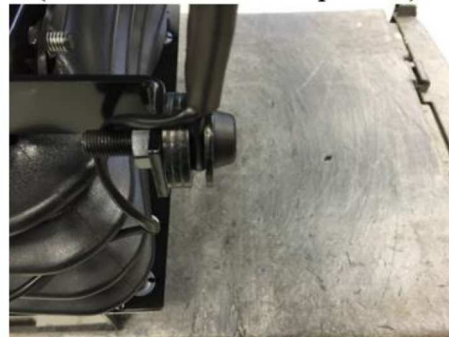
Standard N/O buckle

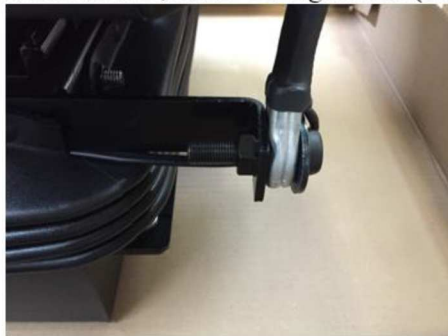
Shifted LH belt, tether configuration (buckle side extended away from suspension)

Shifted tether bar N/C buckle

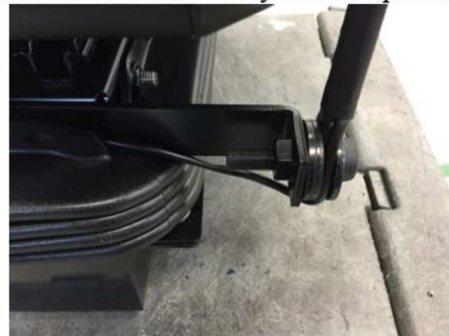
Shifted tether bar N/O buckle

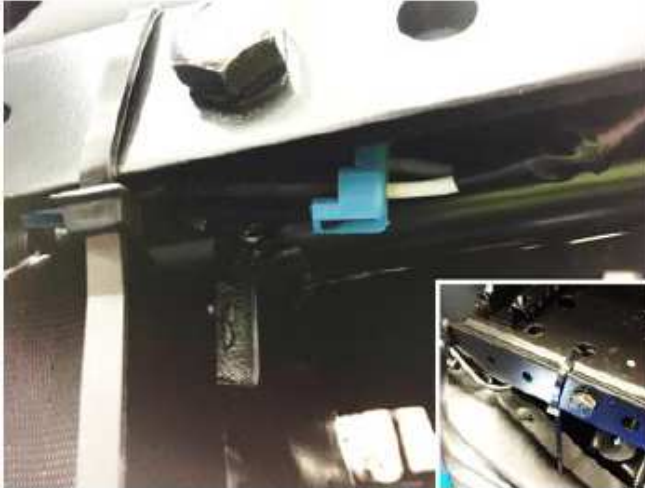
6. Connect the seat belt alarm on the buckle to the jumper harness on the seat. Loop the small zip tie around the cushion frame to ensure the wire harness is routed the same as it was previously. Secure the buckle wire high on the back side of the tether bar with a zip tie at the 90° bend of the bar. Angle the

routing of the buckle wire down toward the bottom edge of the tether bar and secure with a second wire tie as close to the suspension as possible. Clip off the excess ends of the wire ties.

Example of left hand, normally-closed buckle

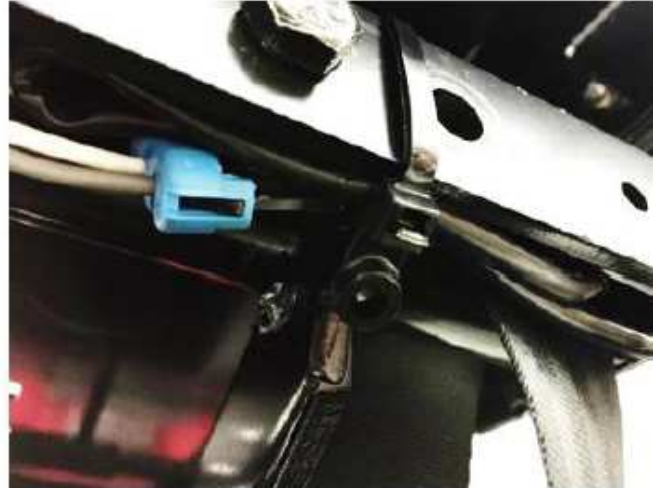
Example of right hand, normally-open buckle
