## SERVICE BULLETIN

**APPLICABILITY:** 2014-2017MY Forester 2.0L Turbo  
2015-2017MY WRX 2.0L Turbo

**NUMBER:** 02-173-18

**SUBJECT:** Turbocharger Intake Duct for Use in Extremely Cold Locations

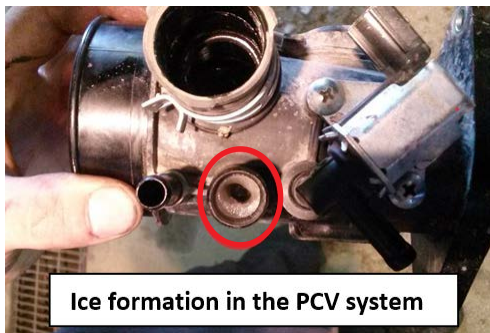
This bulletin announces availability of a special turbocharger air intake duct designed to prevent EXTREMELY RARE occurrences of ice formation from condensation in the duct's PCV system passages.

Ice formation in the PCV system

If these ice crystals were to become dislodged, internal components of the turbocharger, primarily the compressor wheel could be damaged. To prevent ice formation, the duct material is changed from resin to cast aluminum. The new part also incorporates an extra coolant passage to promote faster warm-up after cold start.

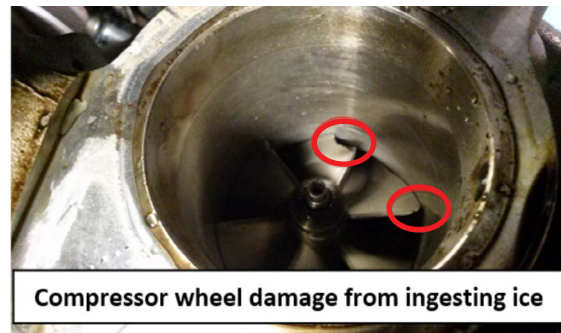
Compressor wheel damage from ingesting ice

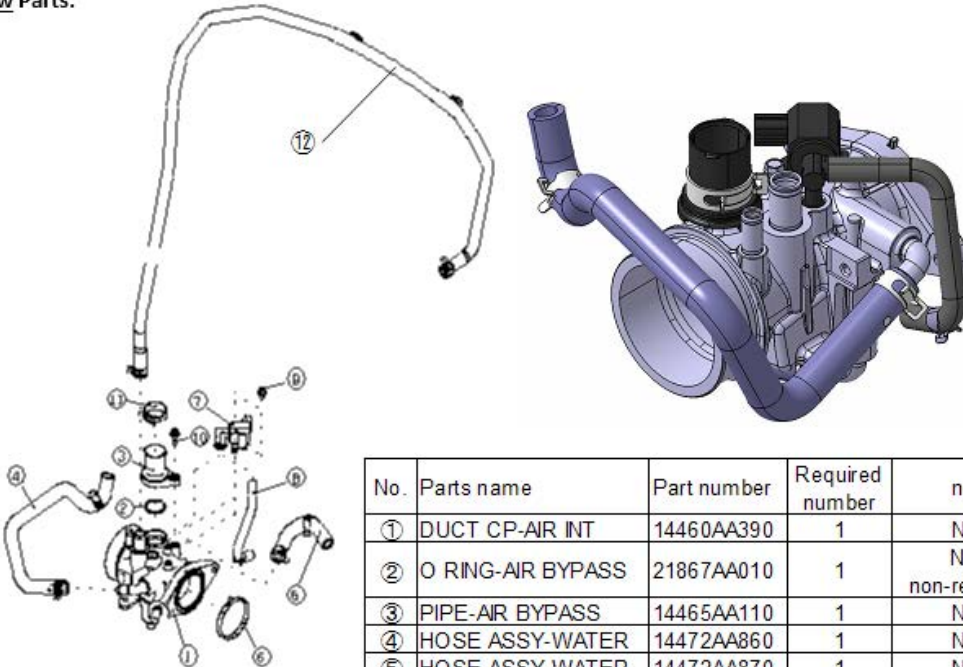
**New Parts:**

For **2014-2016MY** Vehicles:

**Step 5:** Assemble the new aluminum intake duct using the exploded view supplied with the Parts Information section of this bulletin as a guide.

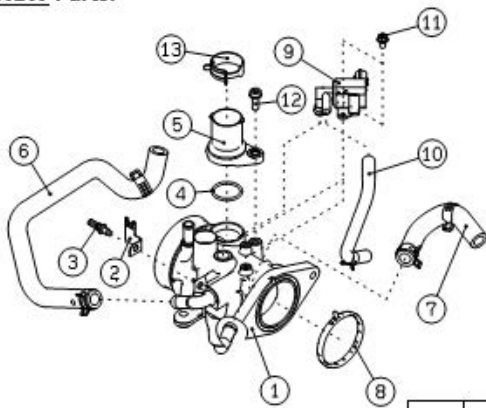
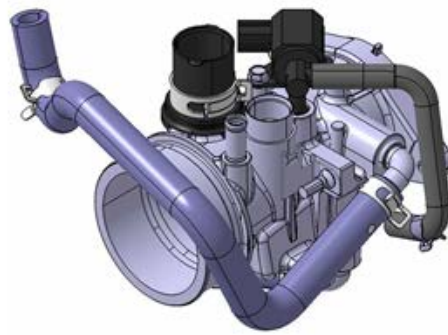
**NEW Parts:**

For **2017MY** Vehicles:

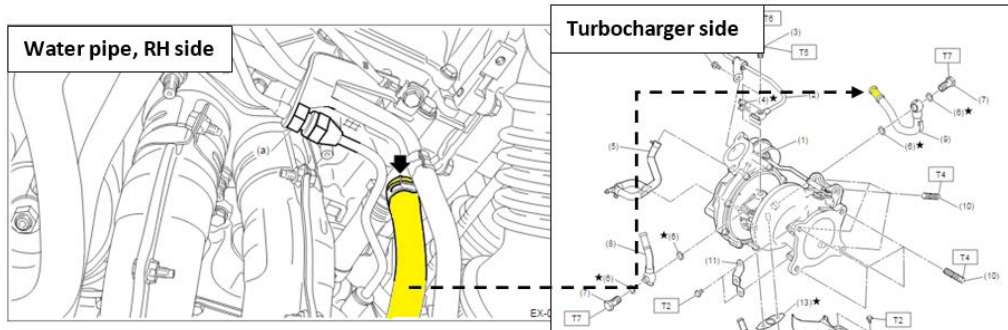
**Step 3:** Remove the engine water hose (highlighted) from the water pipe RH and Turbocharger.

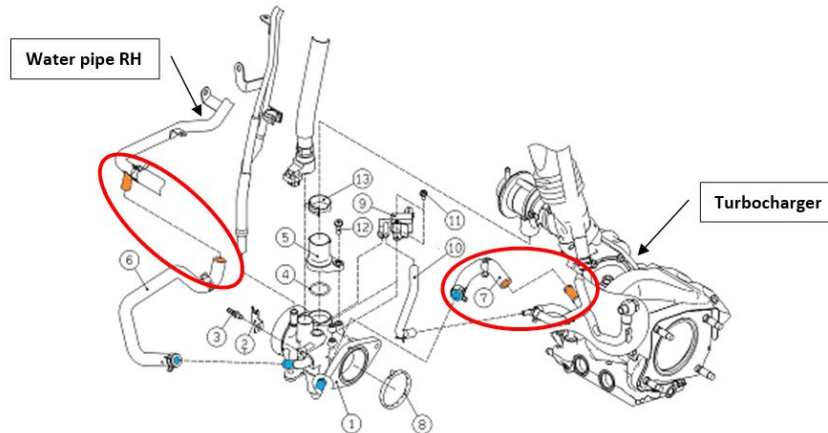
**Step 7:** Install the new aluminum intake duct and related components in reverse order of removal **BUT**, refer to the illustration below for installation of the new water hose to the water pipe RH and Turbocharger.
