SC-17-20-08**MODEL:** Karma Revero**DATE:** June 2017**TITLE:** Radiator Fan Inspection**Revised April 2018**

PRIORITY: On Complaint**APPLICABILITY:** MY17 and MY18 Revero**MARKET REGION:** North America**PURPOSE:** Inspection of Radiator and Fan Assembly

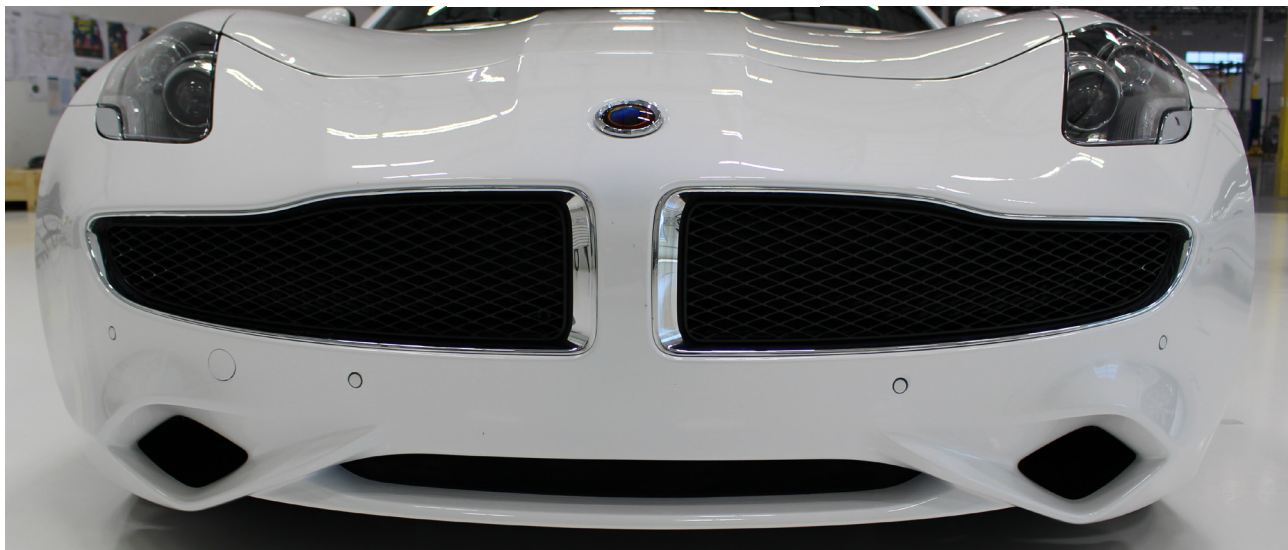
Vehicles exhibiting a vibration in several areas:

- Very slight vibration felt in steering wheel or instrument panel while vehicle is stationary and in stealth mode
- Vibration felt in front fascia and front fenders when A/C compressor is active
 1. Verify the fan operation through Karma Sync- by operating “Fan 3” on high
 2. Inspect the vehicle to verify fan installation is correct
 3. Verify fan is not binding and it spins freely

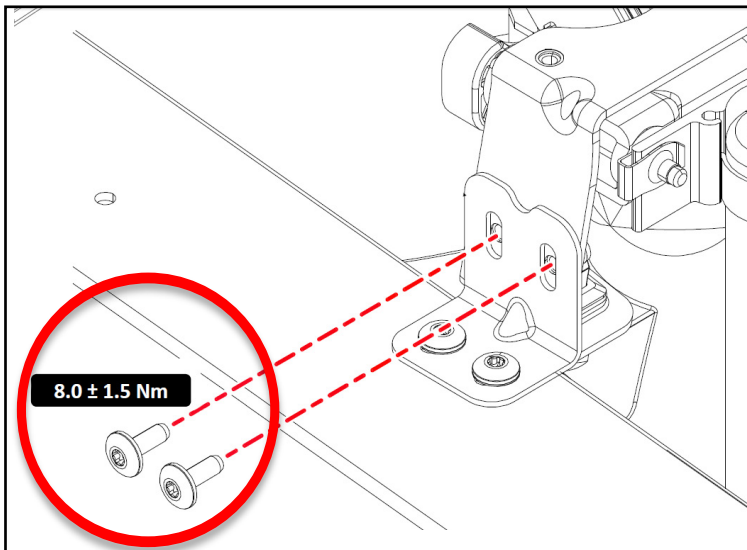
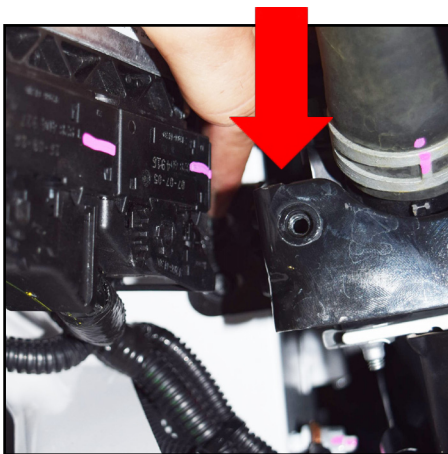
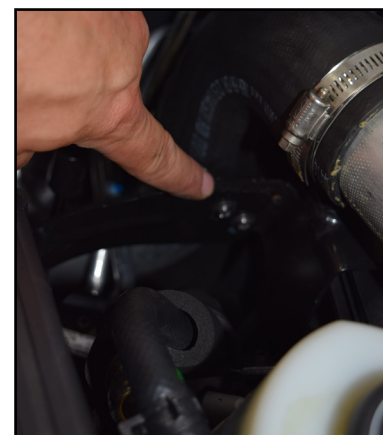
If the fan continues displaying vibration, loosen bolts #3 as indicated. Turn the vehicle on and set the AC to low, then force the engine ON for 2-5 minutes and then turn off. Tighten the bolts. Re-torque to 8 ± 1.5 Nm (fig.3a 3b) and seen in fig.3c and 3d.

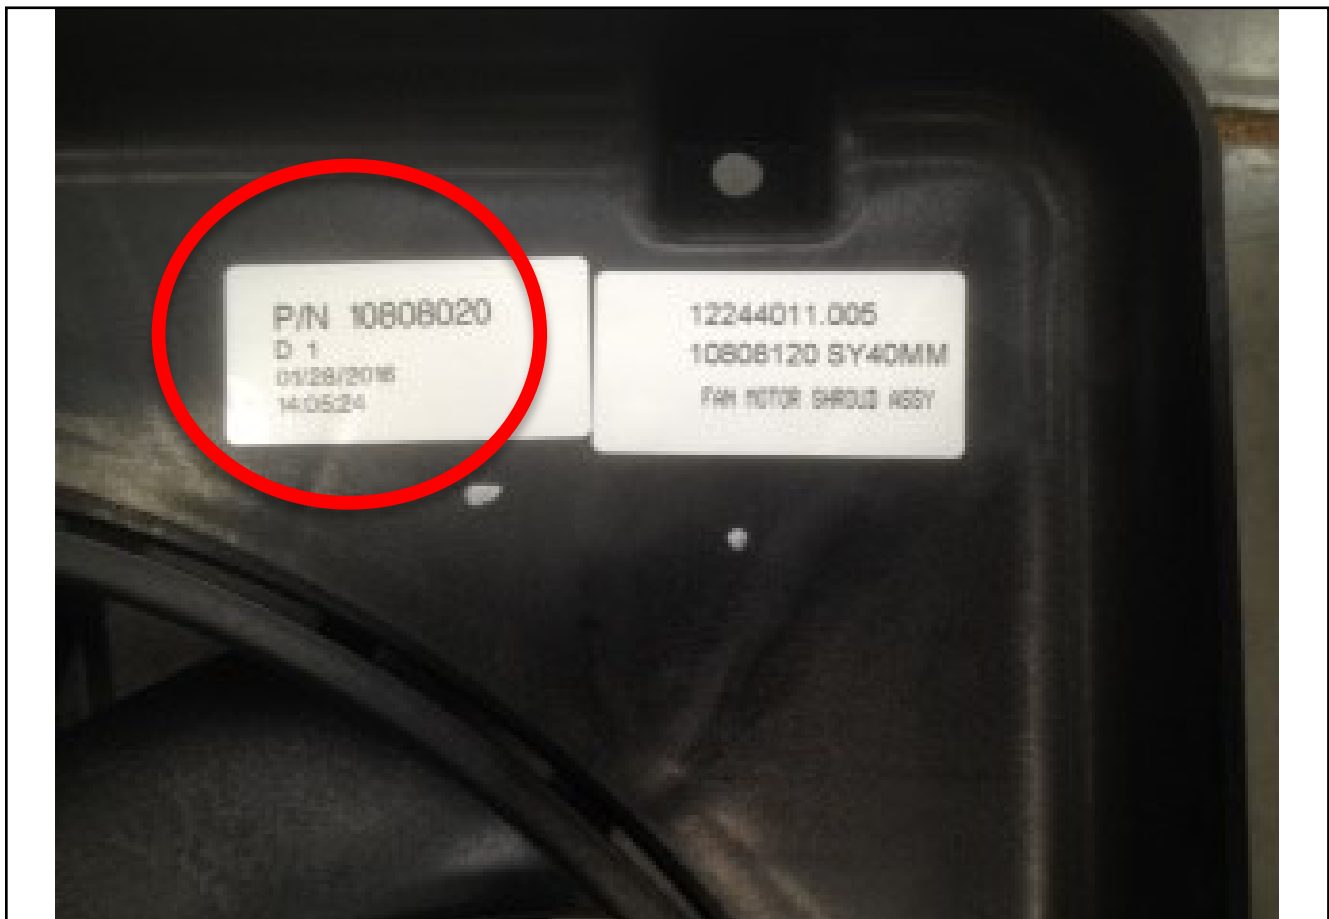
fig.4

Record the check label (fig.4) for both the new (this must be after February 2016 for replacement fans) and problem fans and provide the numbers and image in the TSS Case.

If the fan continues to display the concern create a TSS case and replace the fan and shroud assembly, using part number C131111106001.
