Mack Model LR , MRU , Anthem , CHU , CXU , GU

Volvo Model VNR , VNX , VNL , VNM , VHD , VAH

Engine family 11L Engine , 13L Engine , MP7 , MP8

Title Secondary Fuel Filter Damaged Lip Seal; High Pressure Fuel System Learning And Control Limit and System Pressure Diagnostic Trouble Codes (DTC), Possible Uneven Operation - **US17+OBD16 And Newer Emissions (Common Rail Fuel System), Commonly Model Year 2018 And Newer**

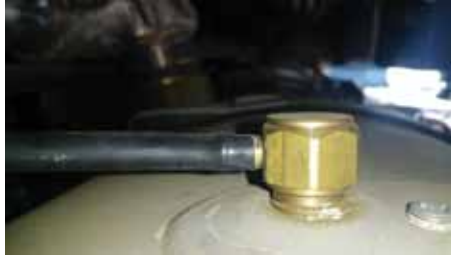
Fuel tank connection

- Take pictures of the vent filter hose connection at the filter housing and at the fuel tank.
- Verify that the filter present and is not clogged
- Attach the pictures to the eService case that was opened when the unit arrived (required for GHG17 chassis).
- An example of the pictures required can be seen below:

3. Take pictures of the Fuel Tank Vent Filter Connections.

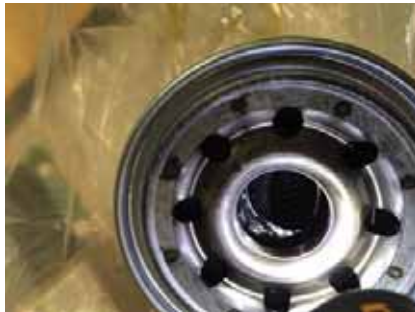
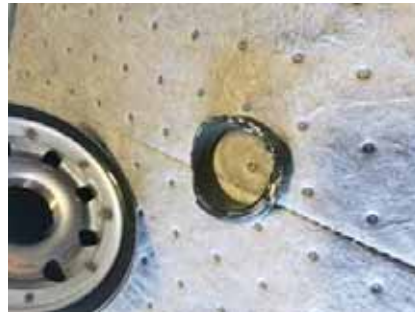
Cause A compromised lip seal on the secondary fuel filter may result in unfiltered fuel bypassing the filter and entering into the high pressure fuel system. This may result in fault codes or other symptoms related to fuel pressure.

- An example of a filter with a damaged lip seal and the lip seal appearance can be seen below:

4. Remove the Secondary Fuel Filter and inspect the lip seal for damage.

- **If damage to the lip seal is found**, the eService case that was opened when the unit arrived (required for GHG17 chassis) should be updated with the following:

- A picture of the filter lip seal
- A picture of the date code on the canister of the fuel filter canister
