SERVICE BULLETIN

Classification: EC16-003d	Reference: NTB16-027d	Date: May 25, 2018
------------------------------	--------------------------	-----------------------

2013 – 2018 SENTRA; MIL ON WITH DTC P0101

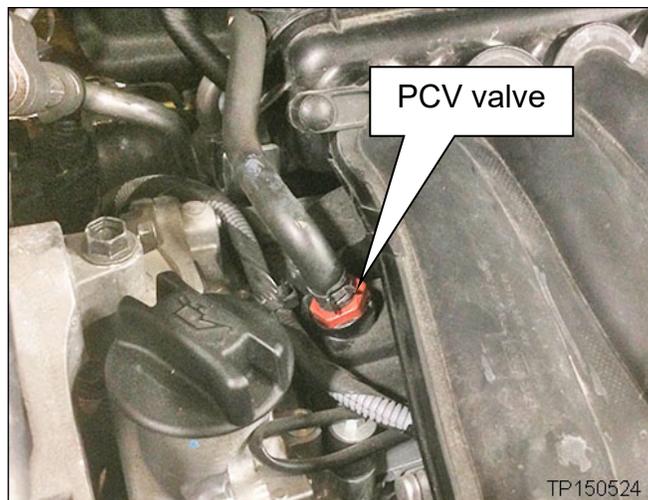
Figure 1a

If the PCV valve is orange, as shown in Figure 1a:

NOTE: The new PCV valve is “black” color.

- Replace the PCV valve.
- Refer to the Electronic Service Manual (ESM), section **EM-Engine Mechanical**, for replacement information.
- Install the new PCV valve listed in the **PARTS INFORMATION**.

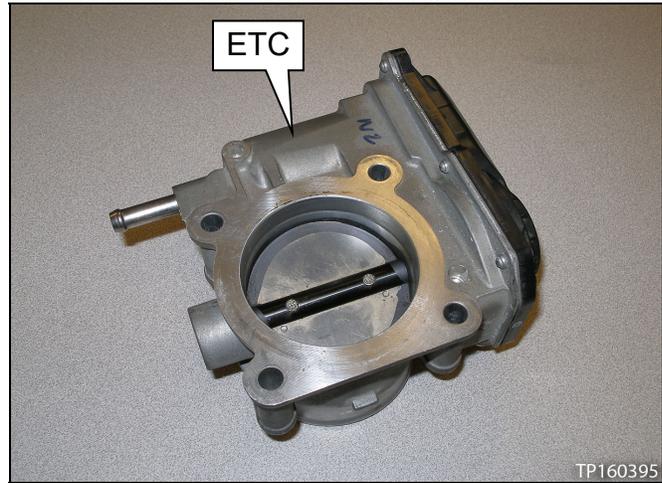
Figure 2a

1. Remove the electronic throttle control actuator (ETC).
 - Refer to the ESM, section **EM-Engine Mechanical**, for ETC removal.
2. On the engine-side of the ETC, clean off deposits on the chamber and throttle valve.

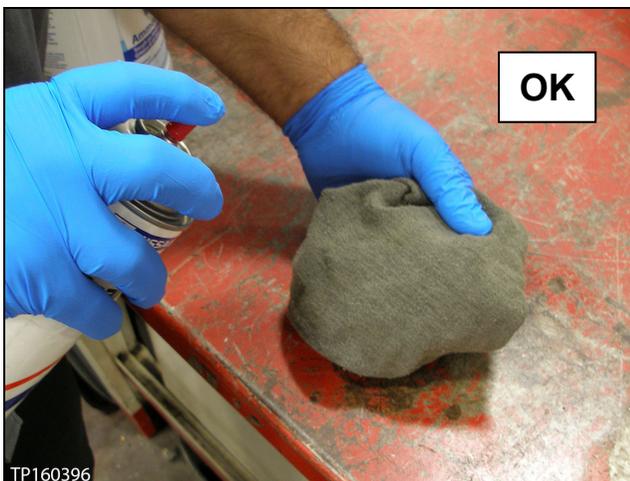
Figure 3a

3. Spray “carburetor” cleaner on a clean cloth towel.
 - Do not use a paper towel.
 - For warranty repairs, use only Nissan Genuine Low VOC Non-Chlorinated Carburetor Cleaner.
 - For non-warranty repairs, Nissan Genuine Low VOC Non-Chlorinated Carburetor Cleaner is recommended, but an equivalent “carburetor” cleaner may be used.
 - See the **PARTS INFORMATION** for further details.

CAUTION: Do not spray directly on the ETC chamber. Damage may occur to the electronics of the ETC.

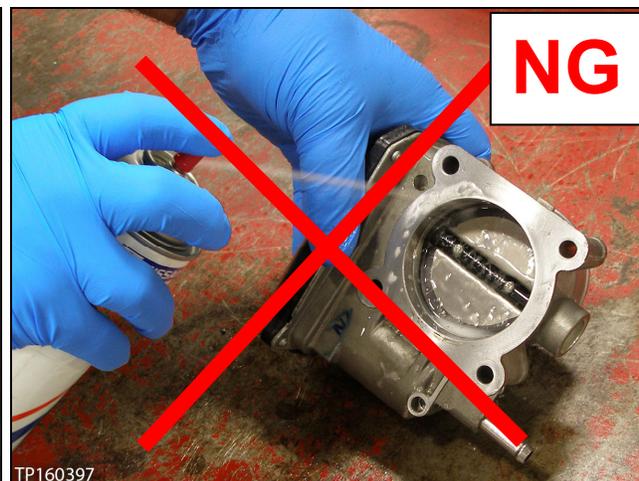
Figure 4a

4. Clean the throttle valve and chamber with the soaked cloth towel.

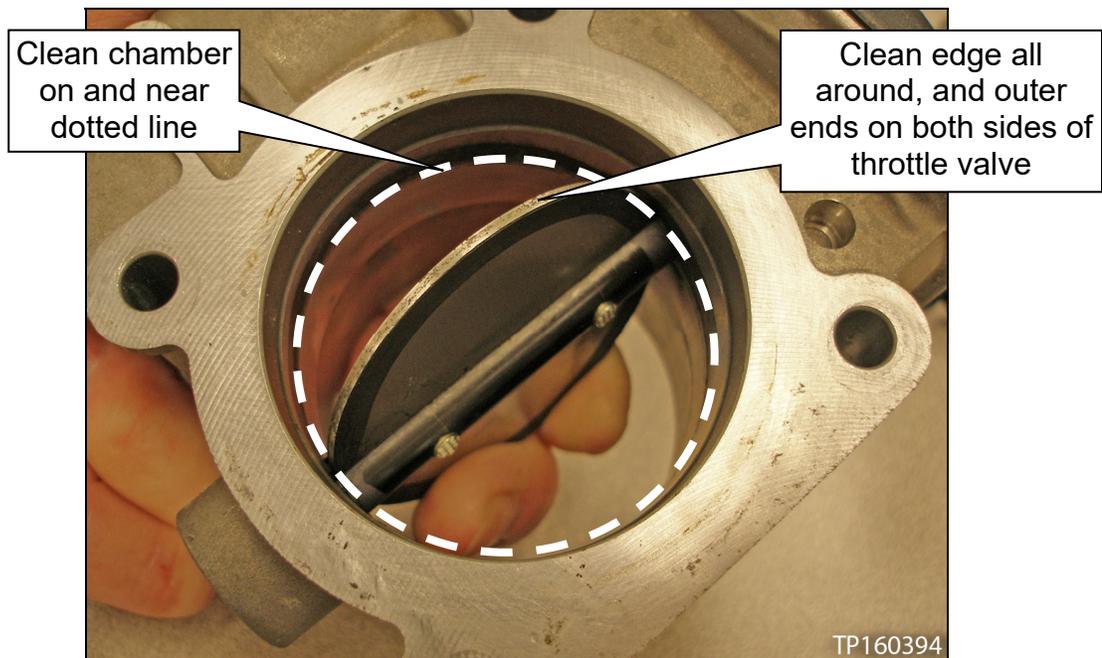
Figure 5a

- Clean off the deposits from the edges and outer ends of the throttle valve (see Figure 5a).
- Clean off the areas of the chamber where the throttle valve meets up to and around it.
 - Hold the valve open to access these areas.

- Do not use excessive force when opening the throttle valve.
- Be careful not to scratch the throttle valve or chamber areas during cleaning.

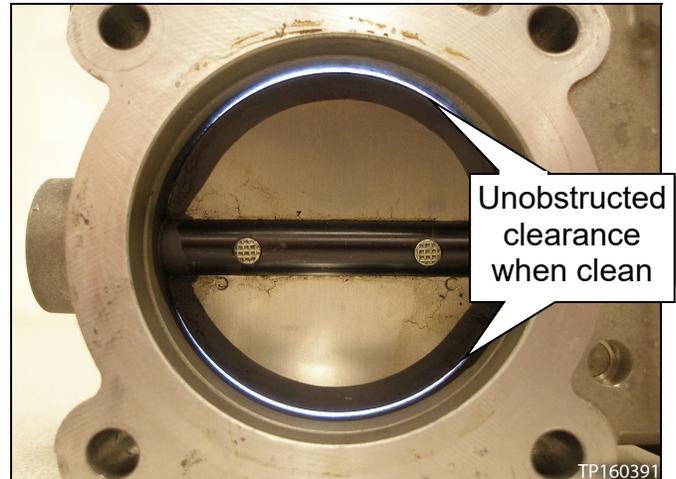
Figure 6a

5. The cleaning is complete when unobstructed clearance is seen between the throttle valve and chamber (see Figure 6a).

- Looking at the clearance while shining a light from behind will help confirm proper cleaning.

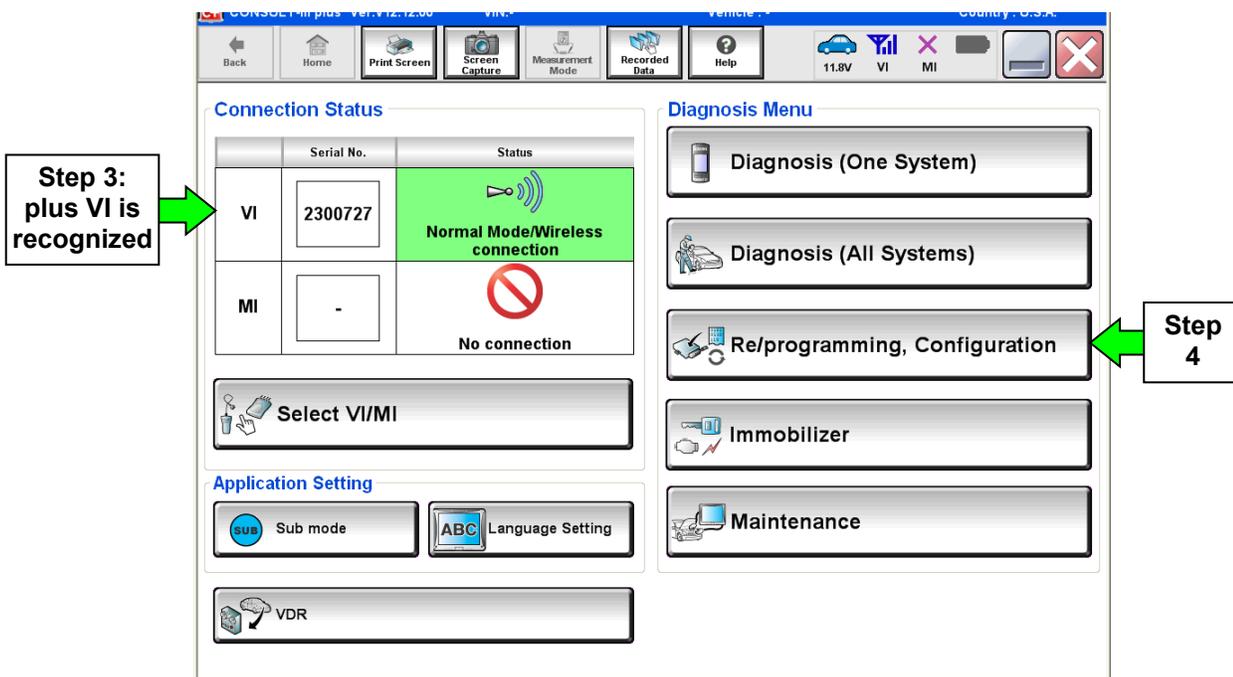
Figure 1

1. Connect the CONSULT PC to the vehicle to begin the reprogramming procedure.
2. Start C-III plus.
3. Wait for the plus VI to be recognized.
 - The serial number will display when the plus VI is recognized.
4. Select **Re/programming, Configuration**.

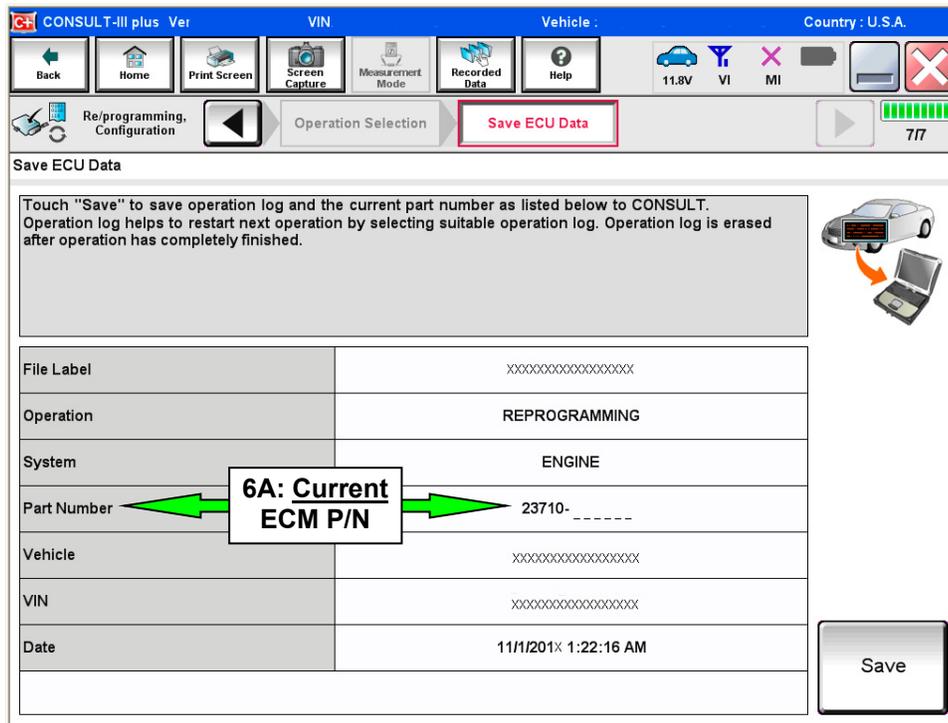
6. When you get to the screen shown in Figure 2, confirm this bulletin applies as follows.
 - A. Find the ECM **Part Number** and write it on the repair order.

NOTE: This is the current ECM Part Number (P/N).

5. Follow the on-screen instructions and navigate C-III plus to the screen shown in Figure 2 on the next page.

- B. Compare the P/N you wrote down to the numbers in the **Current ECM Part Number** column in **Table A** on pages 10 and 11.
 - If there is a match, continue with the reprogramming procedure.
 - If there is not a match, reprogramming is not needed.

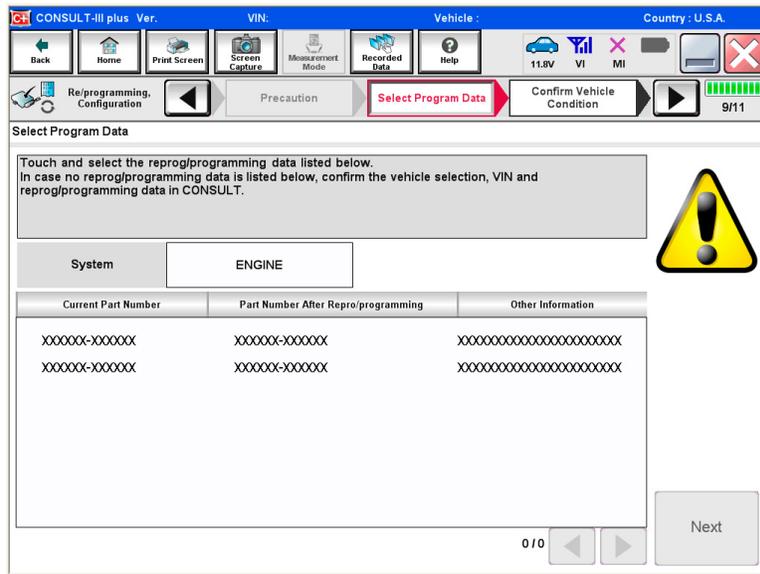
- In some cases, more than one new P/N for reprogramming is available.
 - If there is more than one new P/N, the screen in Figure 3 displays.
 - Select and use the reprogramming option that **does not** have the message “Caution! Use ONLY with NTBXX-XXX”.
- If you get this screen and it is blank (no reprogramming listed), it means there is no reprogramming available for this vehicle.

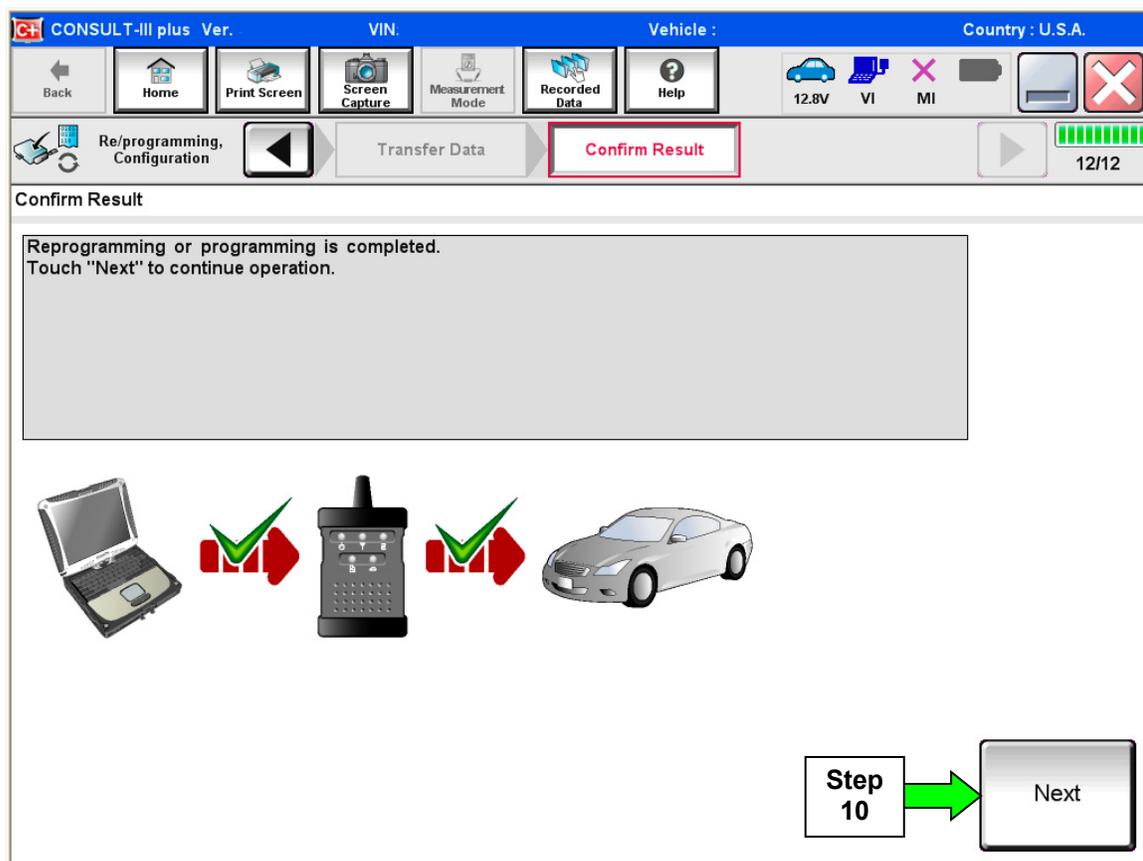
8. When the screen in Figure 5 displays, reprogramming is complete.

NOTE: If the screen in Figure 5 does not display (indicating that reprogramming did not complete), refer to the information on page 14.

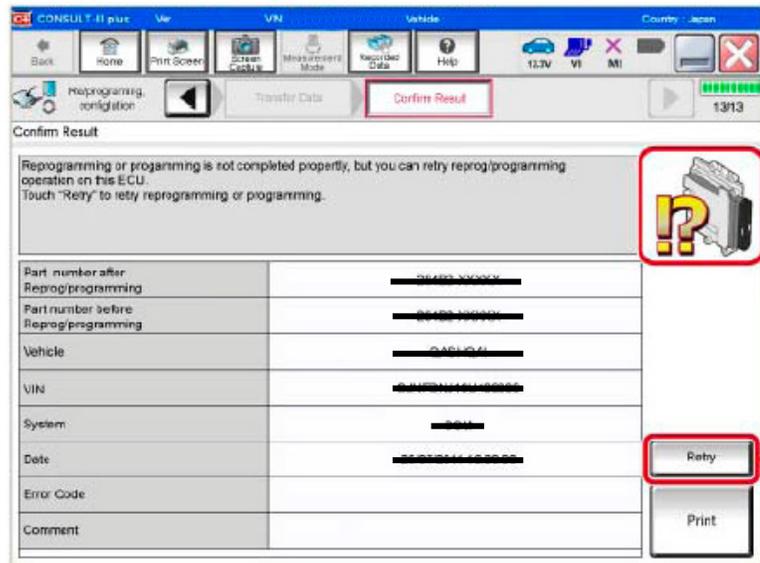
Figure 6

If reprogramming does not complete and the “!?” icon displays as shown in Figure 6:

- Check battery voltage (12.0–15.5 V).
- Ignition is ON, engine OFF.
- External Bluetooth® devices are OFF.
- All electrical loads are OFF.
- **Select retry and follow the on screen instructions.**
- “Retry” may not go through on first attempt and can be selected more than once.

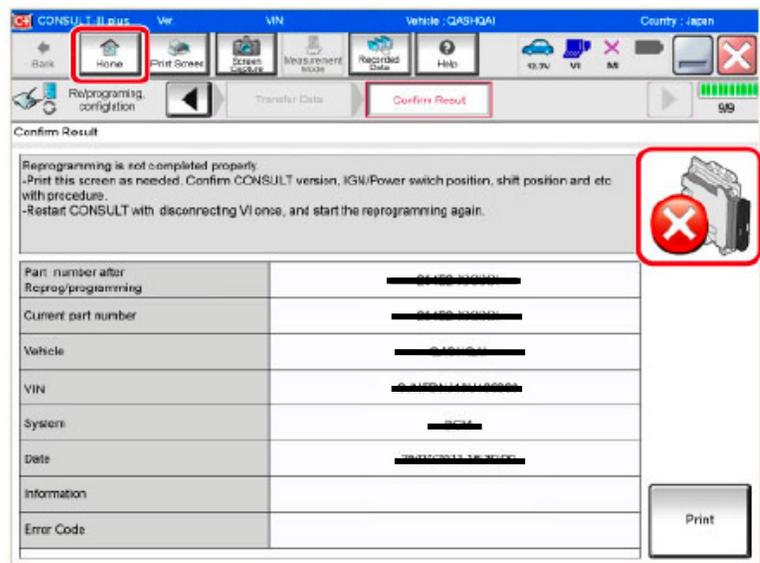
Figure 7

If reprogramming does not complete and the “X” icon displays as shown in Figure 7:

- Check battery voltage (12.0 – 15.5 V).
- CONSULT A/C adapter is plugged in.
- Ignition is ON, engine OFF.
- Transmission is in Park.
- All C-III plus / VI cables are securely connected.
- All C-III plus updates are installed.
- **Select Home, and restart the reprogram procedure from the beginning.**

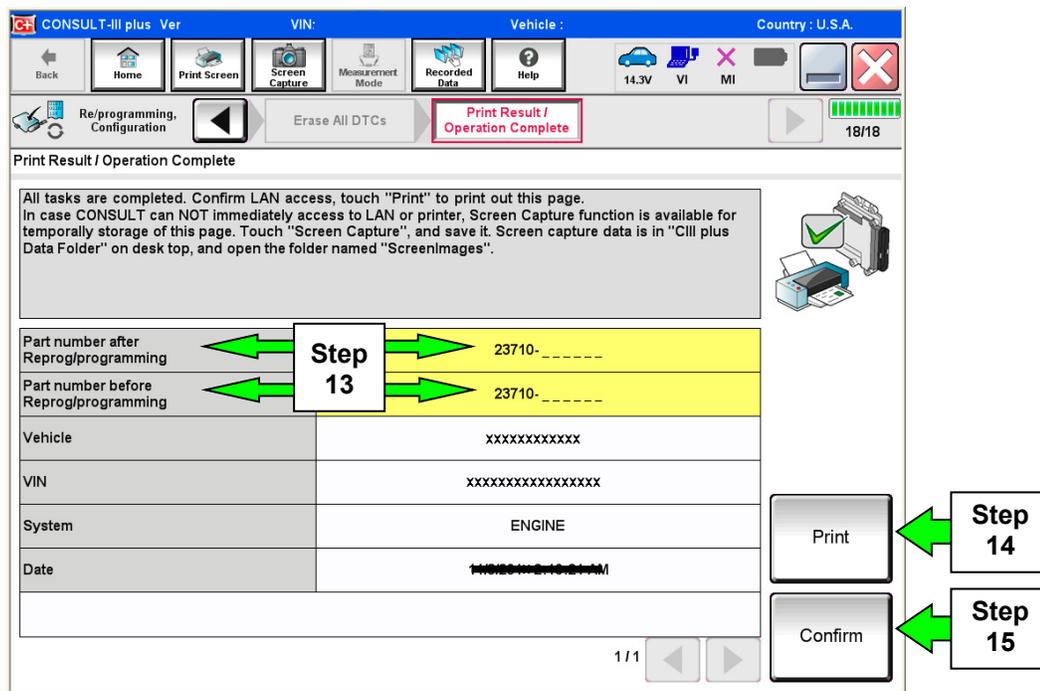
12. When the entire reprogramming process is complete, the screen in Figure 8 will display.

13. Verify the before and after part numbers are different.

14. Print a copy of this screen (Figure 8) and attach it to the repair order for warranty documentation.
