SERVICE BULLETIN

Classification: EL17-029a	Reference: NTB17-121a	Date: May 16, 2018
------------------------------	--------------------------	-----------------------

2009 – 2014 MAXIMA DOOR MIRROR TURN SIGNAL REPLACEMENT

APPLIED VEHICLES: 2009 – 2014 Maxima (A35)

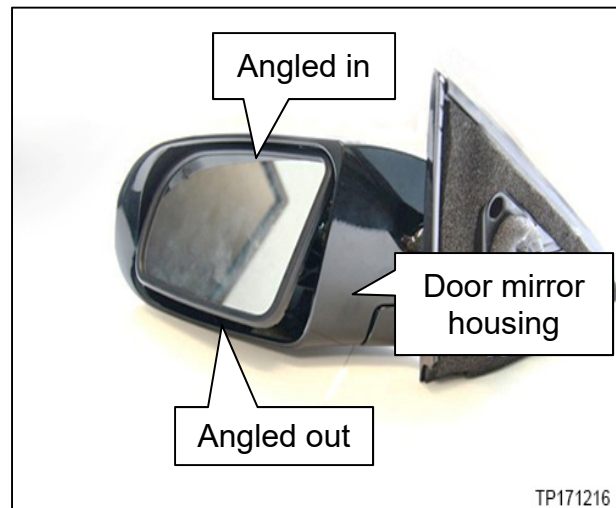
Figure 1

1. Angle the affected door mirror glass (mirror) as shown, with the lower half of the mirror pulled out and the top half of the mirror pushed in.

NOTE: Door mirror assembly has been removed for clarification purposes only. Door mirror assembly does not need to be removed to replace the turn signal.

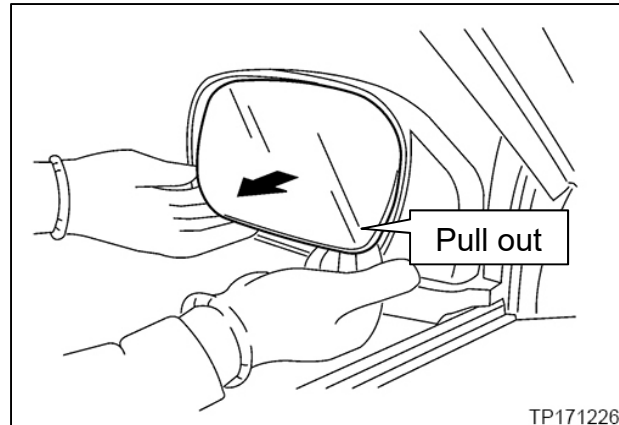
Figure 2

2. Pull from the bottom of the mirror to release the mirror lower clips.

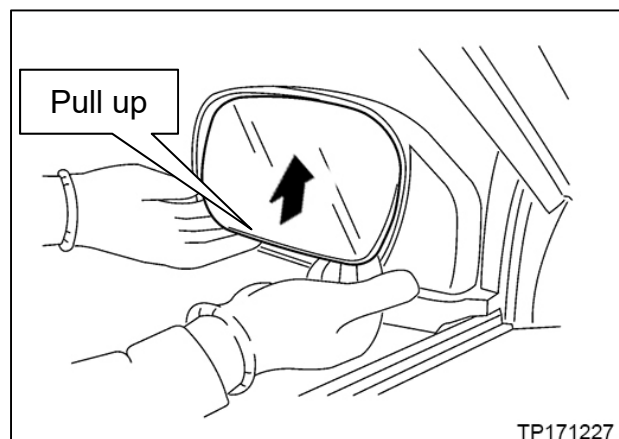
Figure 3

3. Once the mirror lower clips are released, lift the mirror to release the mirror upper hooks.

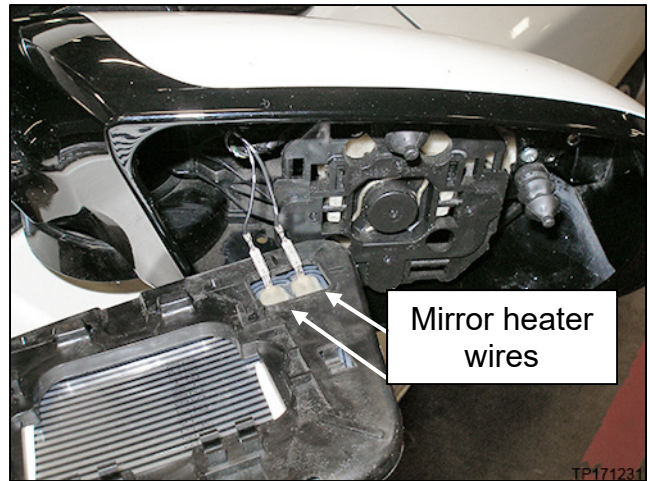
Figure 4

4. Disconnect the 2 mirror heater wires.

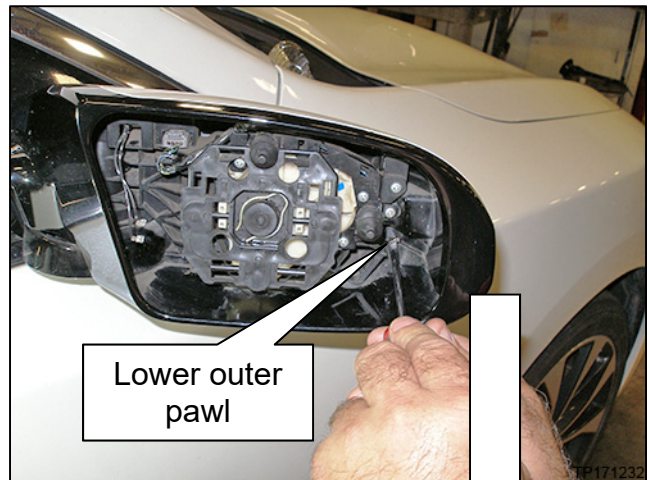
Figure 5

5. Look inside the mirror housing to locate the lower outer pawl.

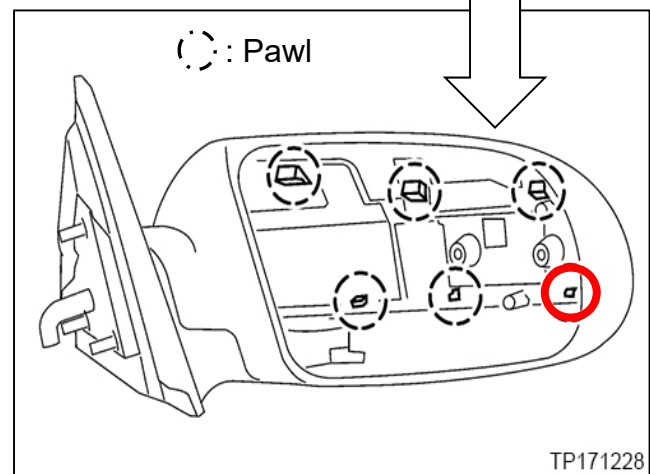
Figure 6

6. Using a small flat blade screwdriver or equivalent, release the lower outer pawl (circled in red) from the inside of the mirror housing.

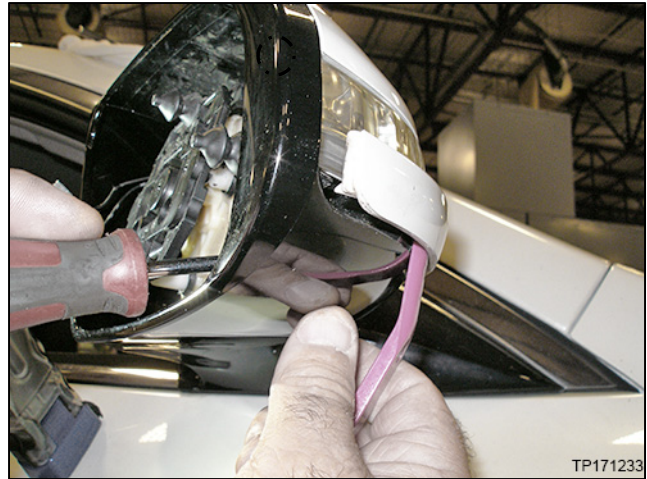
Figure 7

7. Gently insert a trim tool in the gap provided by releasing the lower outer pawl.

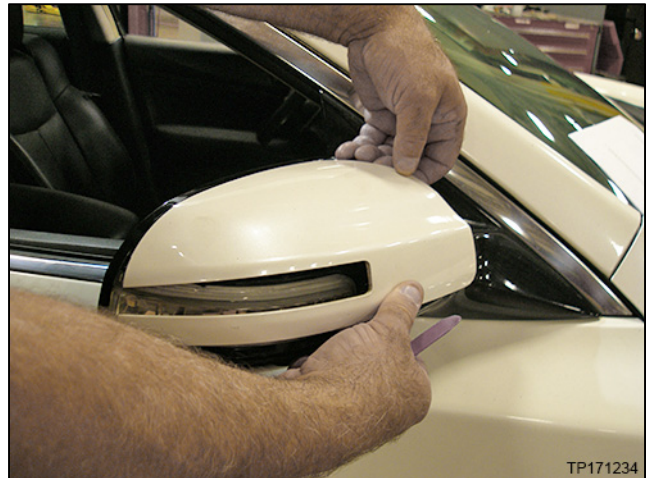
Figure 8

8. Continue working around the perimeter of the mirror cover to gently release all cover pawls.

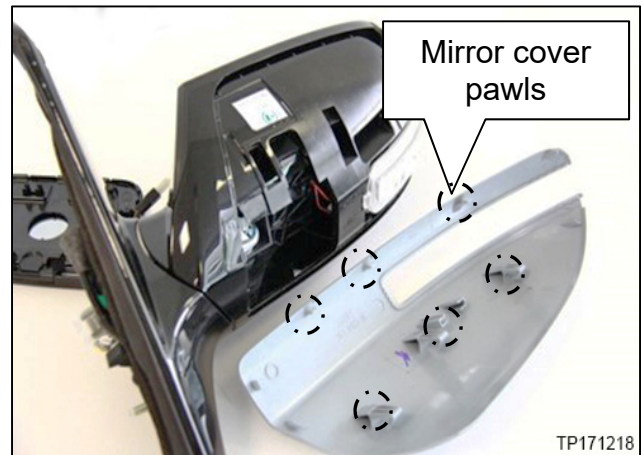
Figure 9

9. Inspect the 6 mirror cover pawls to ensure they have not been damaged.

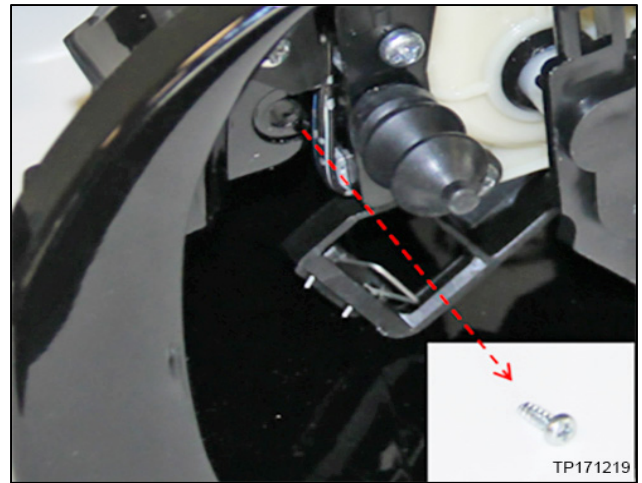
Figure 10

10. Remove the turn signal screw and set aside for use when installing new turn signal lamp.

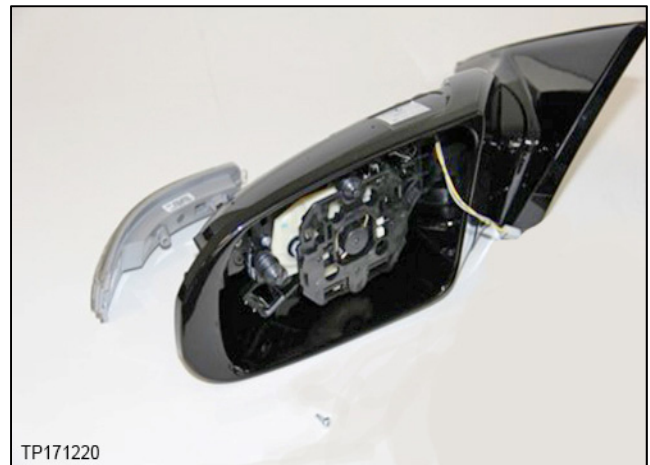
Figure 11

11. Remove the turn signal and disconnect the turn signal electrical connector.

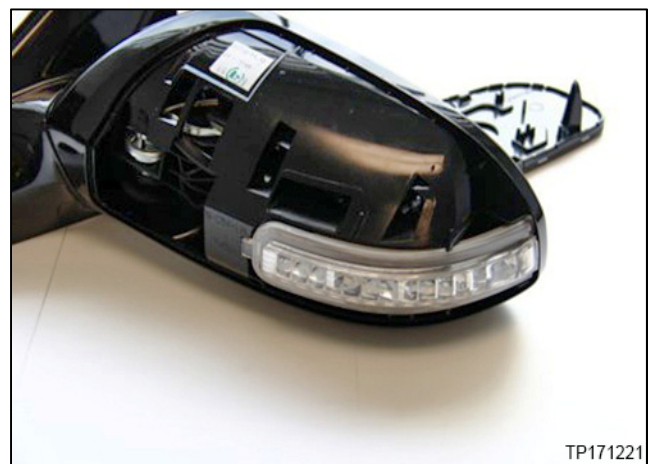
Figure 12

12. Install new turn signal.

13. Connect turn signal electrical connector.

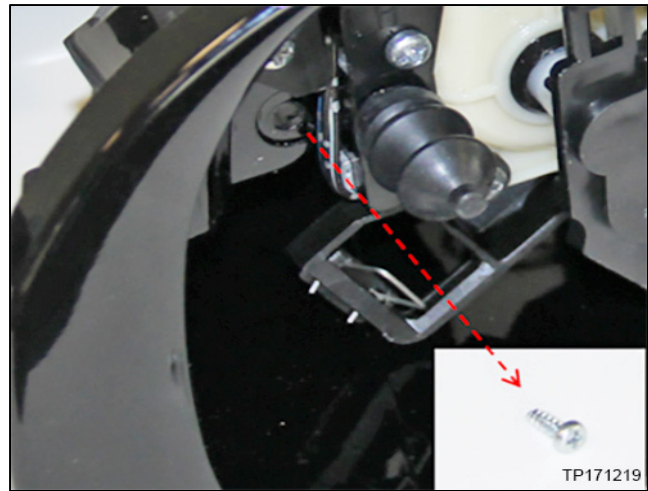
Figure 13

14. Reinstall the turn signal screw.

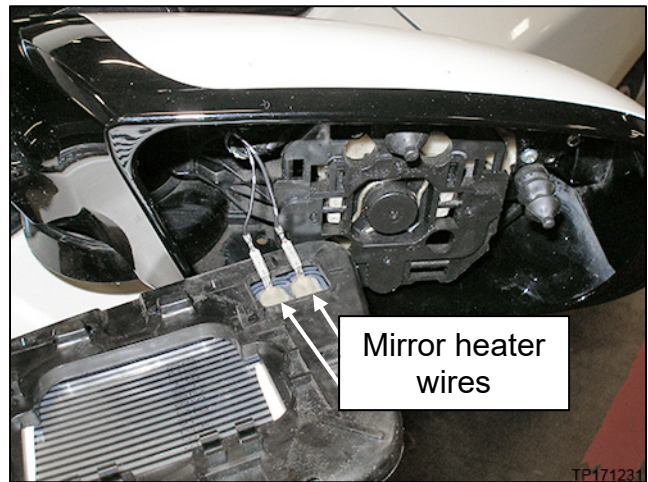
Figure 14

15. Reconnect the mirror heater wires.

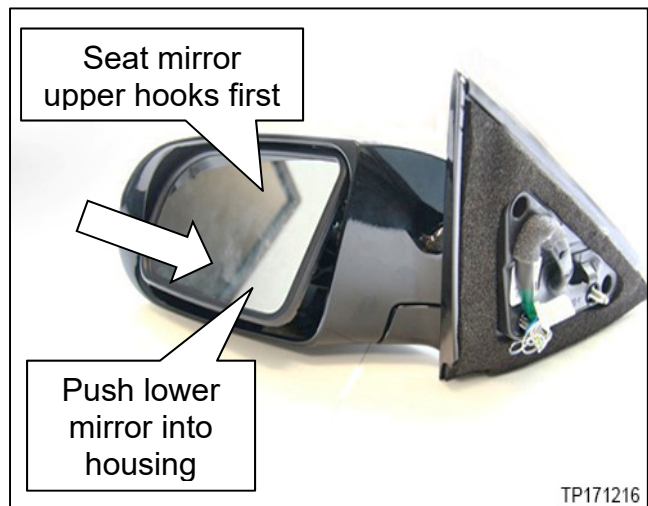
Figure 15

16. Seat the mirror upper hooks.

17. Gently push the lower mirror into the door mirror housing to secure the lower mirror clips.

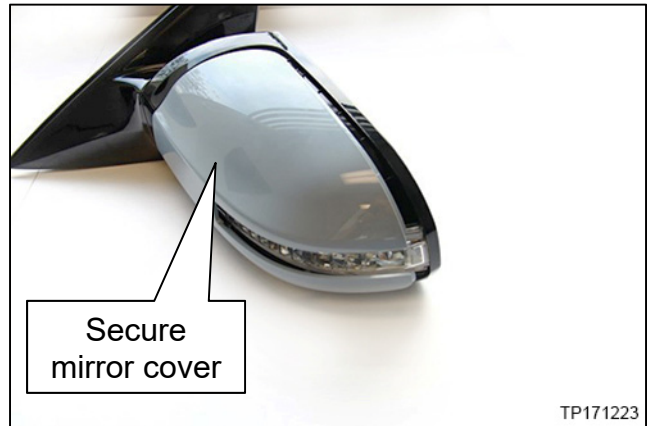
Figure 16

18. Gently seat mirror cover pawls into mirror housing.
