**Mack Models**

**Volvo Models**

**Title** Secondary Fuel Filter Damaged Lip Seal; High Pressure Fuel System Learning And Control Limit and System Pressure Diagnostic Trouble Codes (DTC), Possible Uneven Operation - **US17+OBD16 And Newer Emissions (Common Rail Fuel System), Commonly Model Year 2018 And Newer**

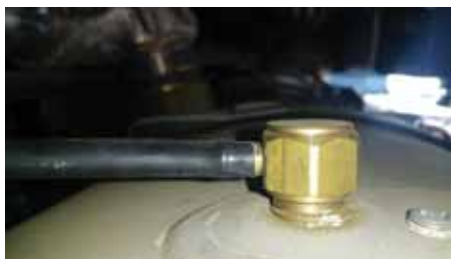
Fuel tank connection

- Take pictures of the vent filter hose connection at the filter housing and at the fuel tank.
- Verify that the filter present and is not clogged
- Attach the pictures to the eService case that was opened when the unit arrived (required for GHG17 chassis).
- An example of the pictures required can be seen below:

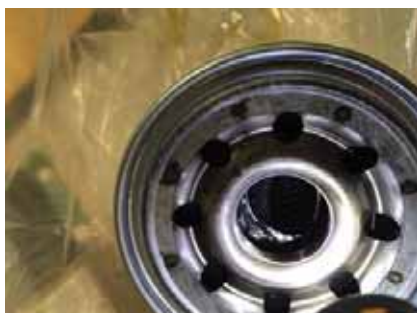
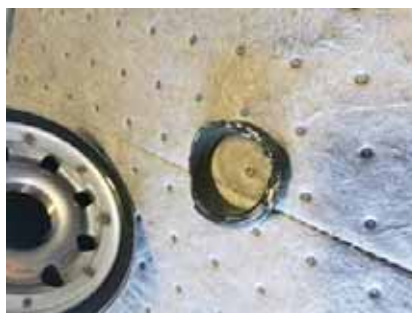
**Cause** A compromised lip seal on the secondary fuel filter may result in unfiltered fuel bypassing the filter and entering into the high pressure fuel system. This may result in fault codes or other symptoms related to fuel pressure.

- An example of a filter with a damaged lip seal and the lip seal appearance can be seen below:

- **If damage to the lip seal is found**, the eService case that was opened when the unit arrived (required for GHG17 chassis) should be updated with the following:

- A picture of the filter lip seal
- A picture of the date code on the canister of the fuel filter canister
