# Front Brake Vibration

YEAR(S)	MODEL(S)	ADDITIONAL INFORMATION
2011 - 2018	Sienna

Some 2011 – 2018 model year Sienna vehicles may exhibit a vibration/pulsation from the front brakes that can be felt in the brake pedal while lightly applying the brake pedal. Follow the Repair Procedure in this bulletin to address this condition.

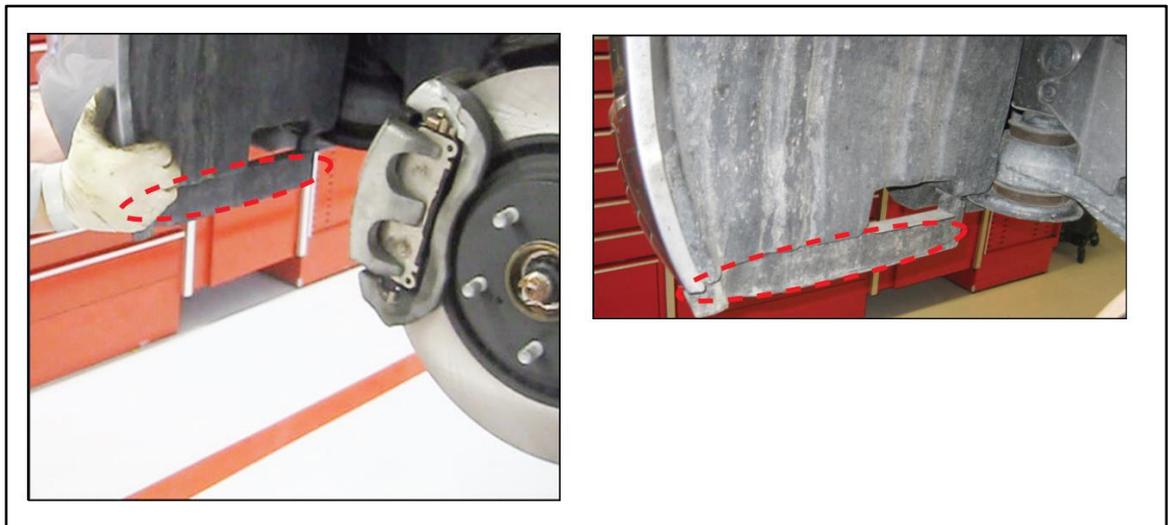
**Figure 1.**

- A. Locate the front wheel opening extension pad.

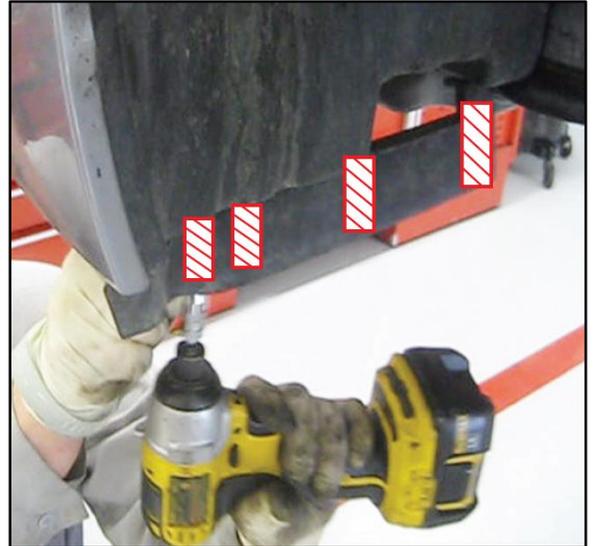
**Figure 2.**

- B. Remove the four bolts and the extension pad.

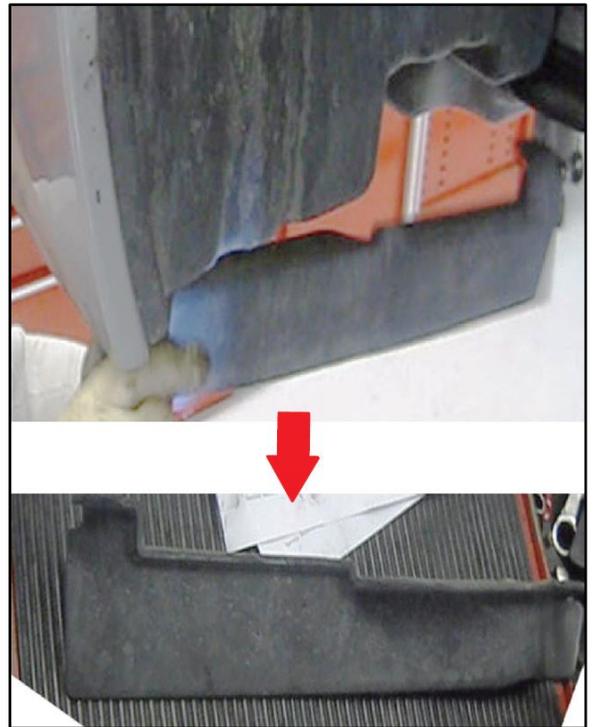
**Figure 3.**

- C. Place the extension pad on a flat surface for modification.

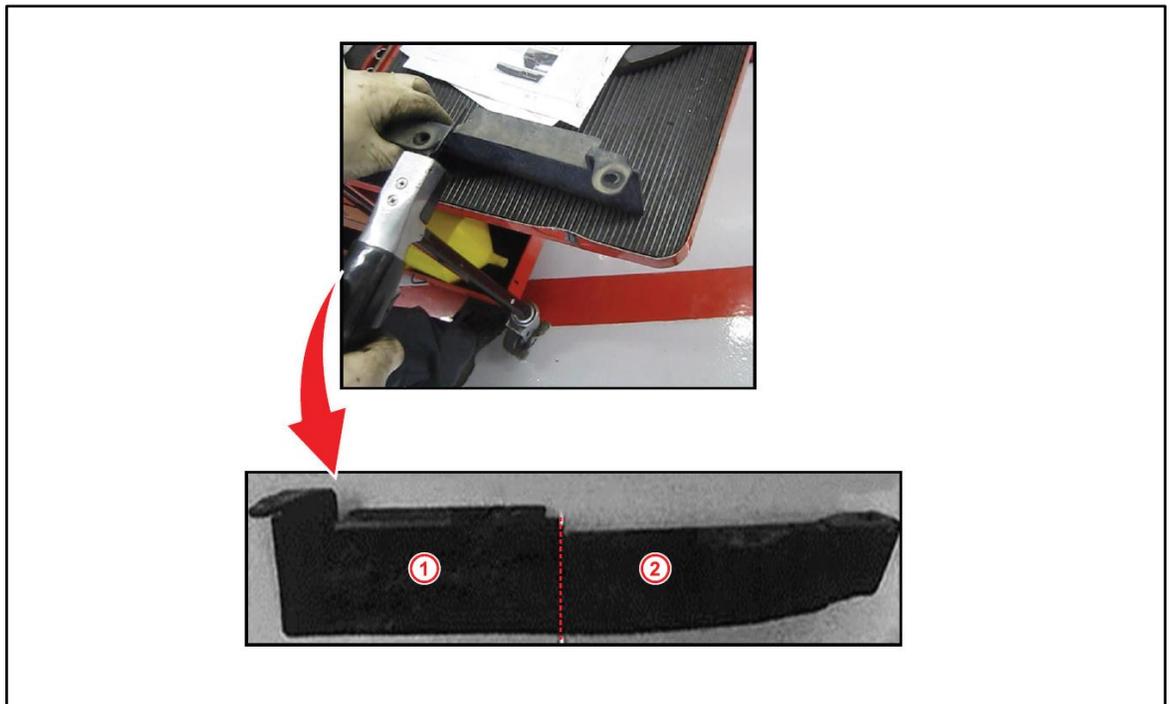
**Figure 4.**

D. Using a power saw, cut at the location shown.

- It is recommended to draw a straight line where the cut will be made.
- Callout 1 as shown should be discarded.

<b>1</b>	<b>Discard</b>
----------	----------------

<b>2</b>	<b>Reinstall on the Vehicle</b>
----------	---------------------------------

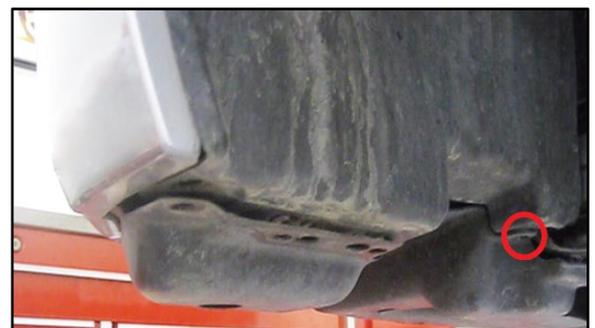
**Figure 5.**

E. Install the modified extension pad back on the vehicle and reinstall the fourth remaining bolt to the original location as shown.

Make sure modification is completed on both sides.

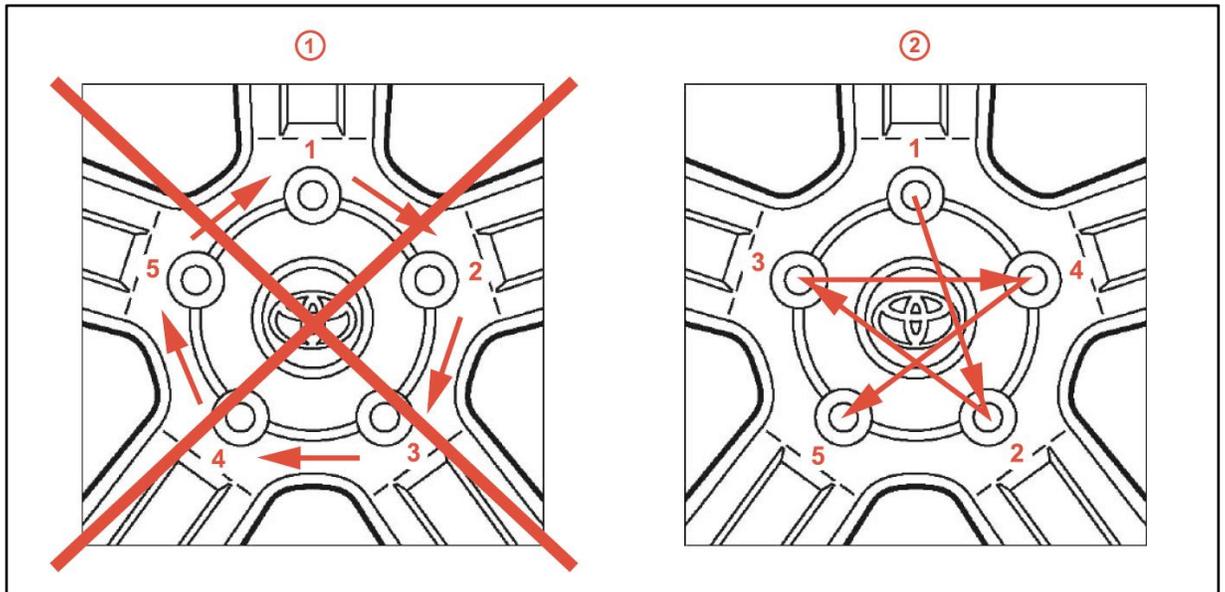
Figure 6.

3. The NEW rotor MUST be phase matched to the hub assembly.
  - A. Mount the rotor onto the hub assembly and note the starting lug position.
  - B. Measure the runout of the hub and rotor assembly at the outermost point of the rotor surface and record the runout measurement.
  - C. Rotate the rotor clockwise on the hub to the next lug position.
  - D. Repeat step B at each lug position.
  - E. The rotor position will be determined based on the lowest runout measurement obtained.  
**Max Runout Allowed: 0.05 mm (0.00197 in.)**
4. Replace the original brake pads with the NEW brake pads and shim kit.
5. Install the front wheel and torque to specification using the correct tightening sequence.  
**Torque: 103 N\*m (1050 kgf\*cm, 76 ft\*lbf)**

1	Incorrect
---	-----------

2	Correct
---	---------

Do NOT use an impact gun to tighten the lug nuts; use a torque wrench and follow the correct sequence to tighten the wheels.
