T-SB-0039-15

# Instrument Panel (Dashboard) Cracked and/or Sticky

YEAR(S)	MODEL(S)	ADDITIONAL INFORMATION
2003 – 2005	4Runner	
2005 – 2010	Avalon	
2007 – 2011	Camry, Camry HV	
2004 – 2010	Sienna	
2004 – 2008	Solara

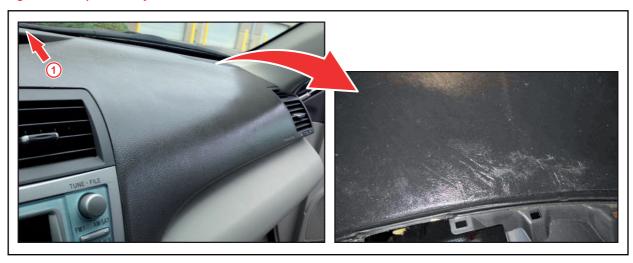
Figure 1. Example of Sticky Condition

1. Confirm the dashboard exhibits the cracked and/or sticky appearance condition. Refer to Figures 1 – 3 for examples of these conditions.

1 Front of Vehicle

- 2. Replace the instrument panel safety pad sub-assembly.
  - A. Replace the panel safety pad sub-assembly for the vehicles below.

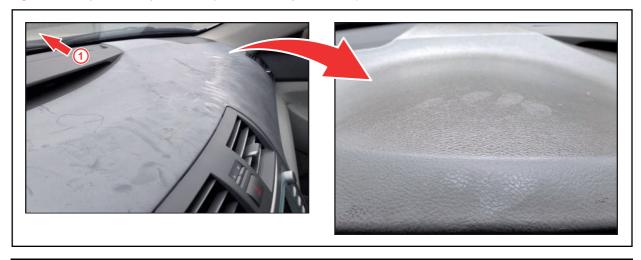
Figure 2. Example of Chalky Condition (Becomes Sticky in the Heat)

1 Front of Vehicle

When a vehicle with a sticky dashboard is parked out of heat and humidity for more than a few hours, the dashboard surface becomes chalky. Once the vehicle is exposed to heat again, the sticky condition returns.

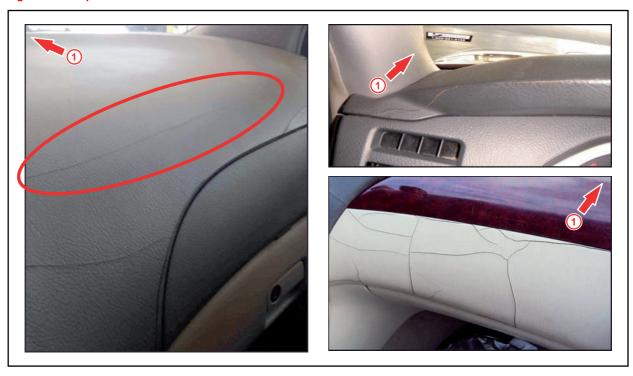
Figure 3. Examples of Cracked Condition

Front of Vehicle
